DEVELOPMENT PERMIT

NO. DP-2019-25

Civic Address: 438-444 Gower Point Road

Geotechnical Assessment – Proposed Auxiliary Structure (Greenhouse), dated August 9, 2019., stamped by Benjamin Tomaz, P.Eng #48432, and the subsequent memos listed below:

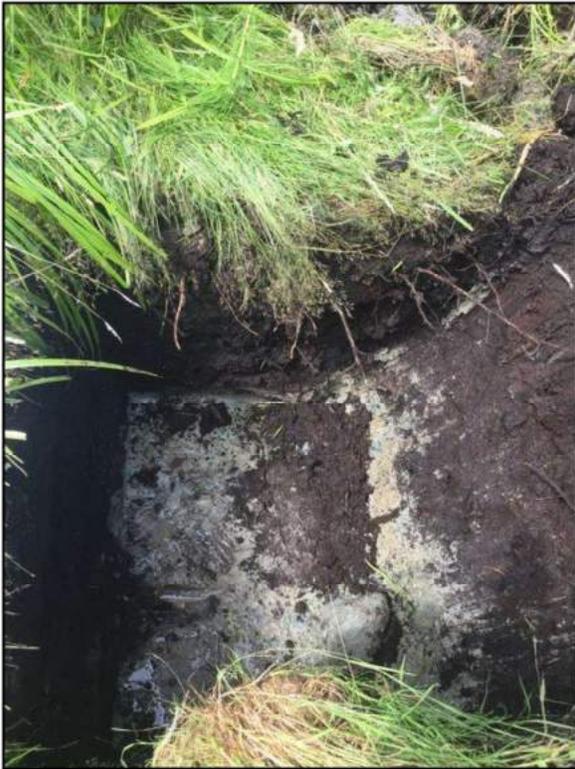
Photograph 1 – TP19-01 at Maximum Depth

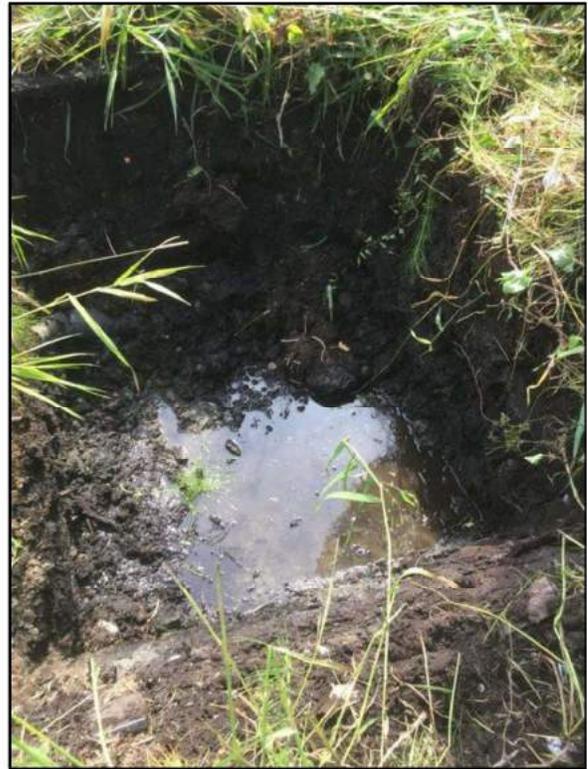
Test pitting, and subsequent groundwater elevation monitoring in an open pit and drainage swales on the property (advanced by others), were conducted after several weeks of minimal, local precipitation. During Arya's site investigation, each test pit advanced revealed indications of groundwater at the contact of the compact to dense silty sand deposits encountered. The uppermost 0.1 m to 0.3 m of silty sand encountered was observed to be loose/soft and very moist to wet. Test pits were left open during

excavation, and less than 10 mm of standing water was observed in each test pit location after a 1 hour period.

**Photograph 2 – Groundwater Encountered in
TP19-05**

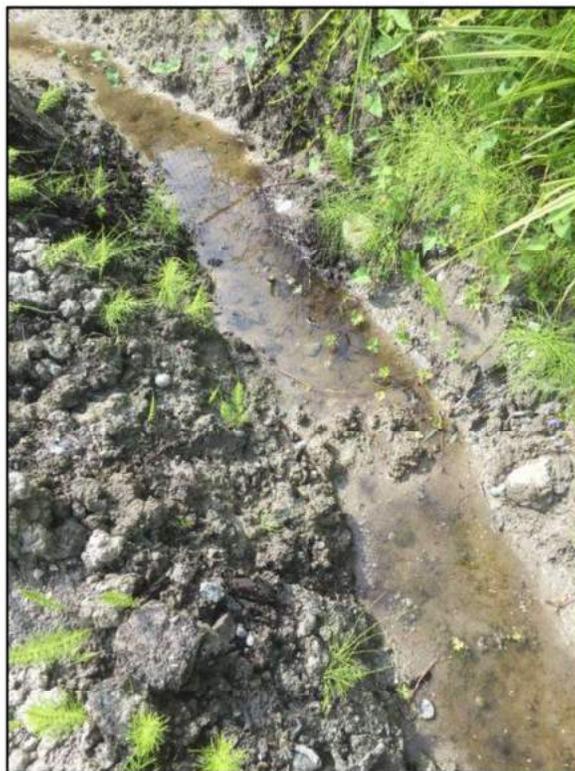
At the time of the geotechnical site investigation, very moist surface soils were observed across the parcel. Surface water in the form of localized ponding was observed on the western extent of the parcel in a drainage ditch that had been excavated in this area prior to our site investigation. The drainage ditch was observed to convey concentrated surface water from south to north along the western property boundary to another drainage swale that was observed to extend approximately mid-lot from west to east, conveying water in this direction. The swale exhibited a depth of approximately 0.6 m, and a width ranging from 1.2 m to 1.5 m. At the time of the site investigation, the swale was measured to contain approximately 100 mm of standing water.

Photograph 3 – Drainage Swale

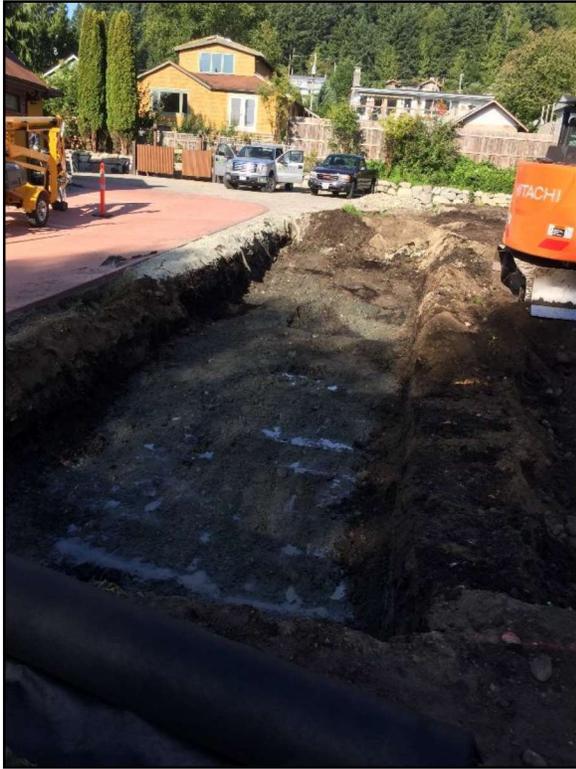
- The subgrade was generally observed to be compact. Localized sections of the subgrade were observed to be loose to an approximate depth ranging from 150 mm to 300 mm. These areas generally coincided with those portions of the subgrade where saturated soils and ponding (10 mm to 25 mm) of surface water was encountered. The general contractor was instructed to remove loose material and surface water in these areas as needed to uncover a compact subgrade prior to the placement of geotextile fabric (Nilex 4545).

Photograph 1 – Southeastern Extent of Exposed Subgrade

- To prevent saturation and loosening of subgrade materials the general contractor was instructed to backfill areas of exposed subgrade at end of day.
- It is important to note that contingent upon groundwater levels encountered during excavation and contingent upon subgrade conditions and the amount of precipitation anticipated during construction, additional groundwater management and/or dewatering recommendations may be warranted.
- Our office should be contacted upon construction continuation to continue to assess subgrade conditions and engineered fill placement compaction.

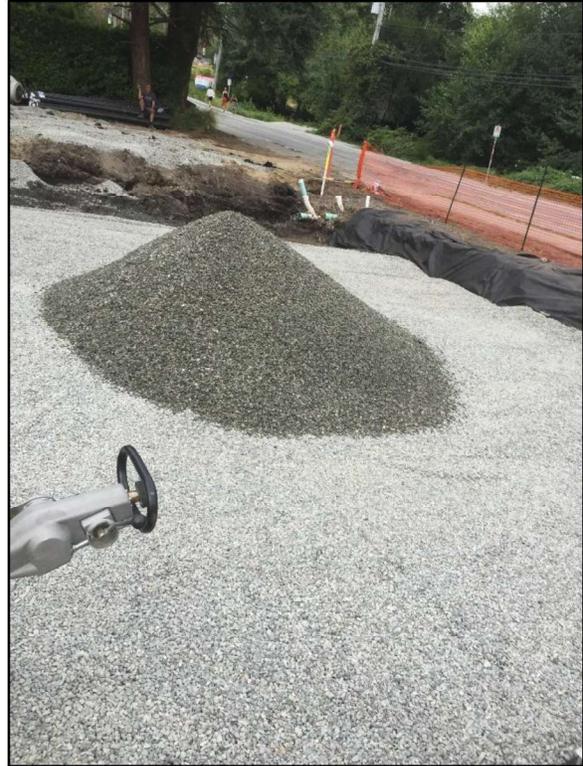
- Upon exposure of suitable subgrade material, non-woven geotextile fabric (Nilex 4545) was placed directly atop the subgrade. Adjacent sections of the fabric were placed with a 300 mm overlap.
- 19 mm, clear, open-graded gravel was placed in loose, 200 mm to 300 mm lifts that were compacted, and moisture conditioned upon placement.
- The first three lifts were implemented on the southeastern corner of the site during the site visit.
- Generally, the engineered fill material met compaction specifications throughout the course of construction monitoring as measured with a soil density gauge.

Photograph 2 – Compacted Engineered Fill and Stockpile

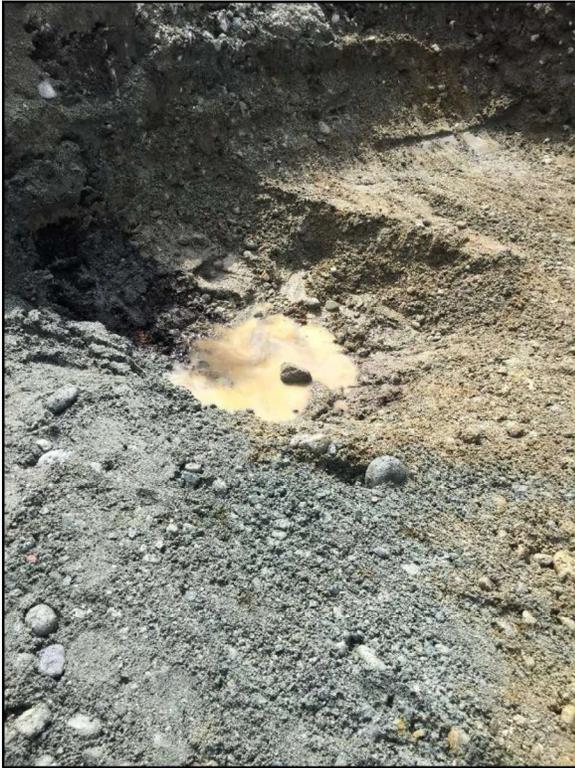
Photograph 1 – August 22, 2019 - Loose soils and debris encountered in previous test hole location

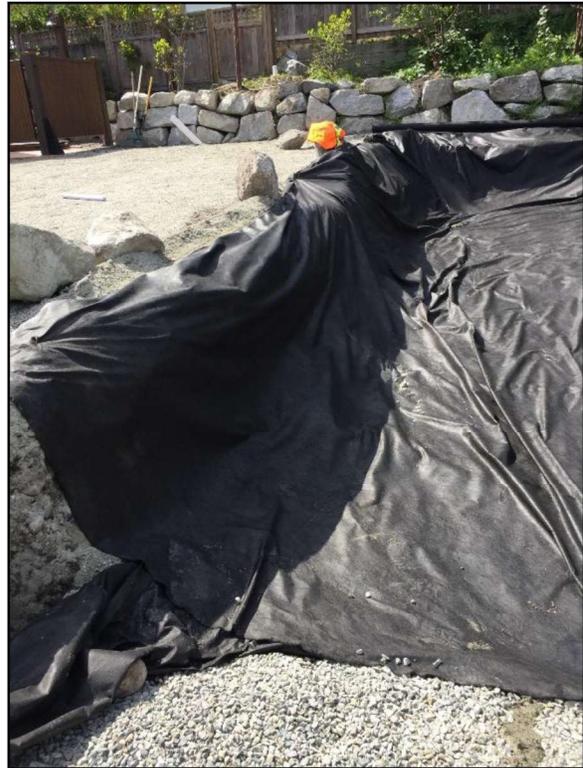
Photograph 2 – August 22, 2019 – Geotextile placement on southwestern corner of site

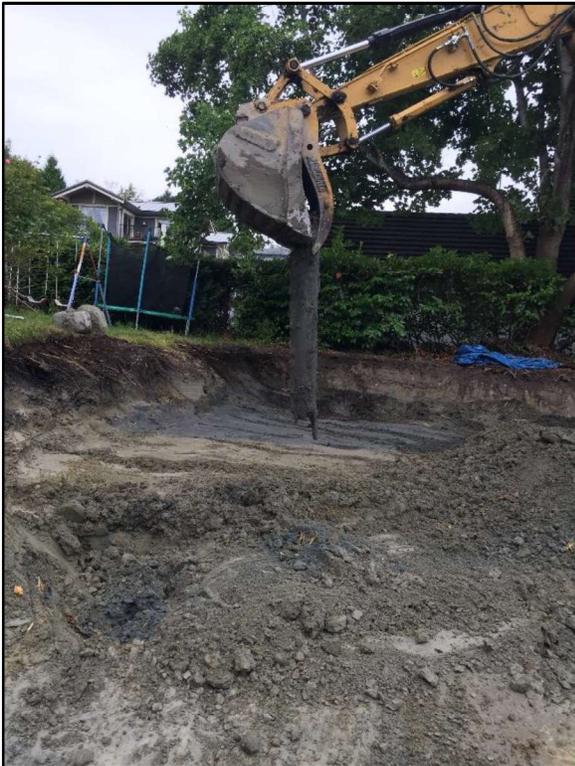
Photograph 3 – August 23, 2019 – Log removed from northwestern extent of subgrade

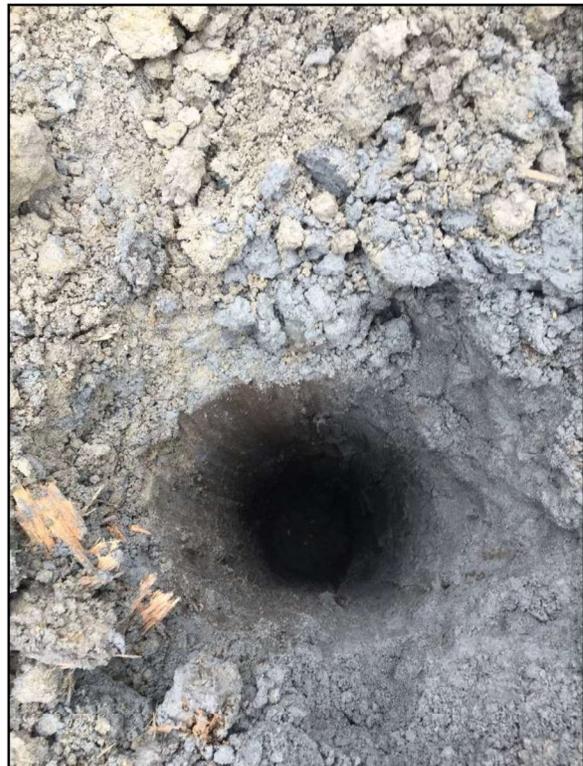
Photograph 4 – August 23, 2019 – Void in log location

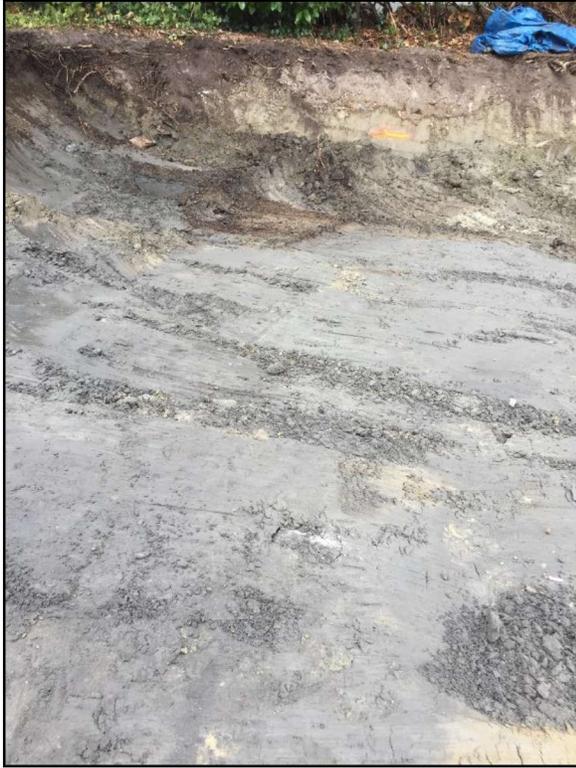
Photograph 5 – August 23, 2019 - Northwestern extent of subgrade

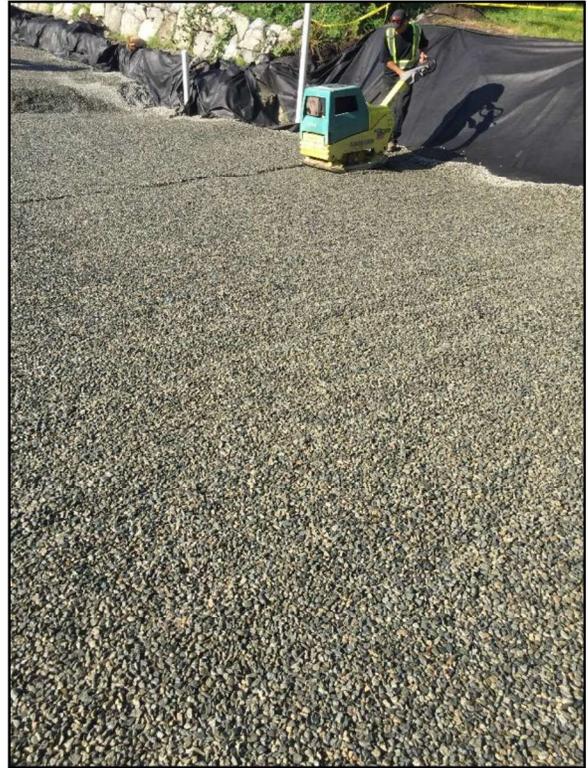
Photograph 6 – August 23, 2019 – Compaction of clear crush (northwestern extent of site)

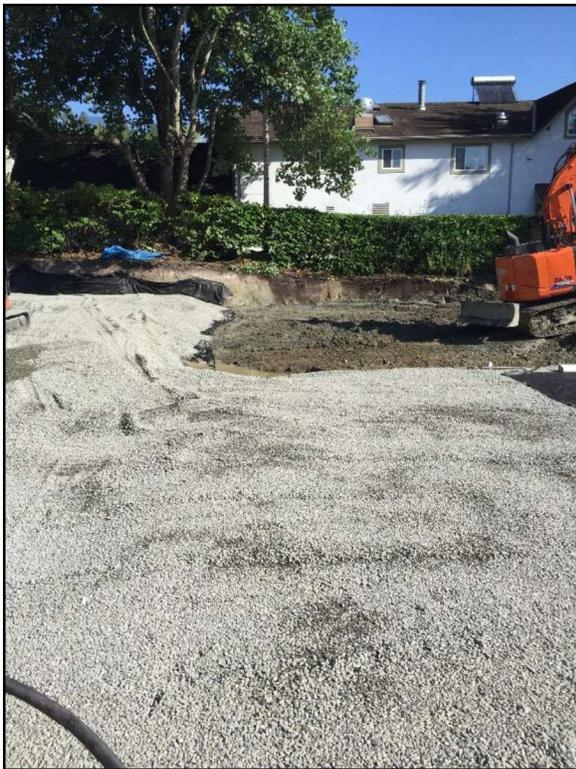
Photograph 7 – August 26, 2019 – Sequential subgrade exposure

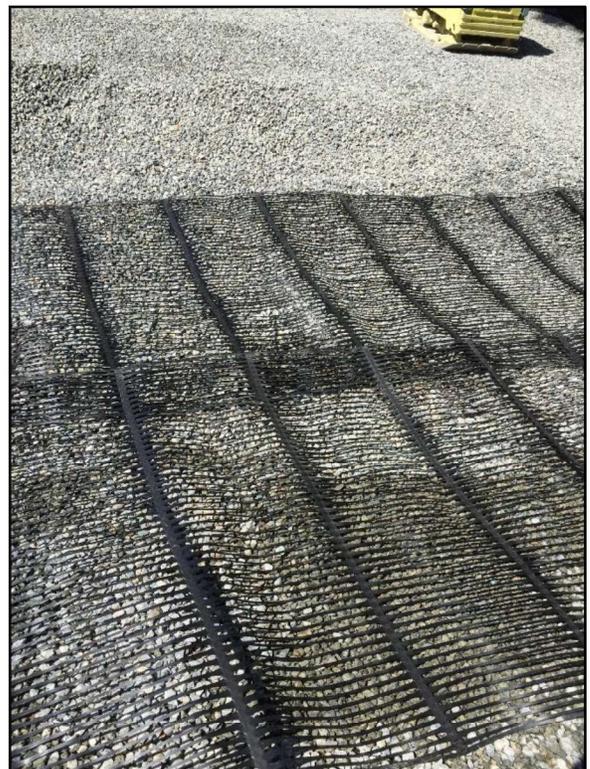
Photograph 8 – August 26, 2019 – Geogrid implemented on loose portion of subgrade

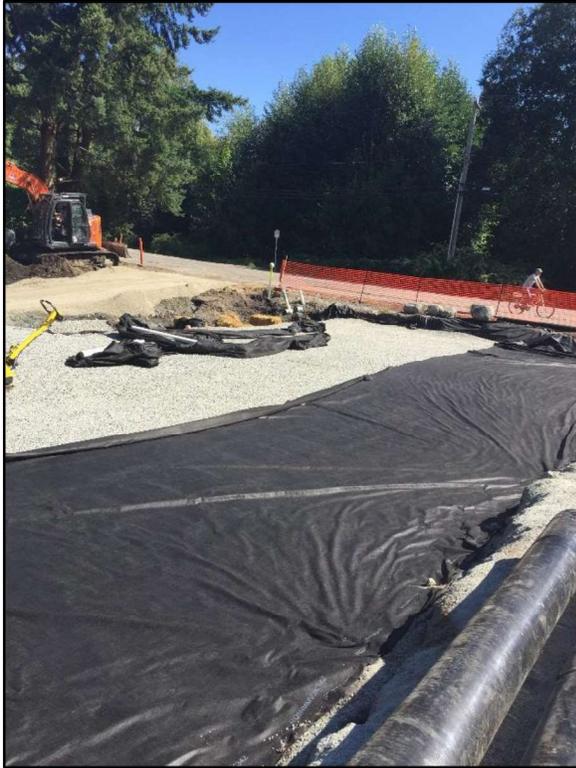
Photograph 9 – August 27, 2019 - Implementation of geotextile atop clear crush

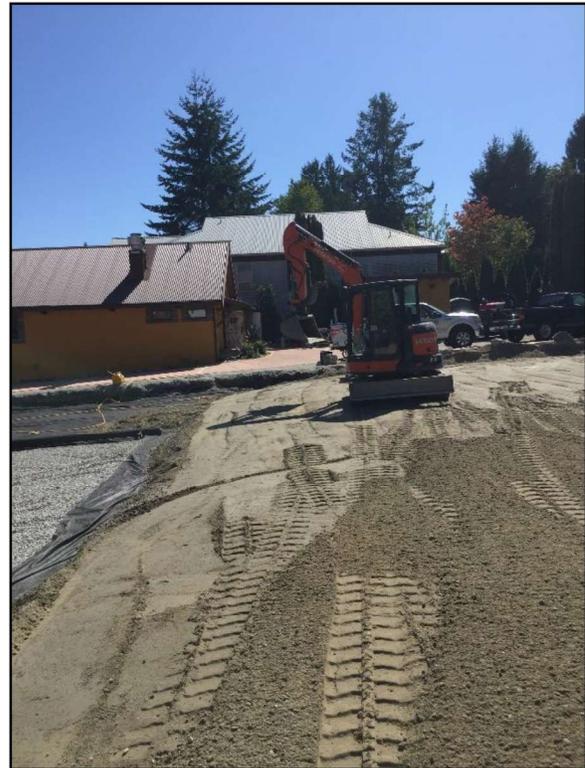
Photograph 10 – August 27, 2019 - Implementation of first lift of road base

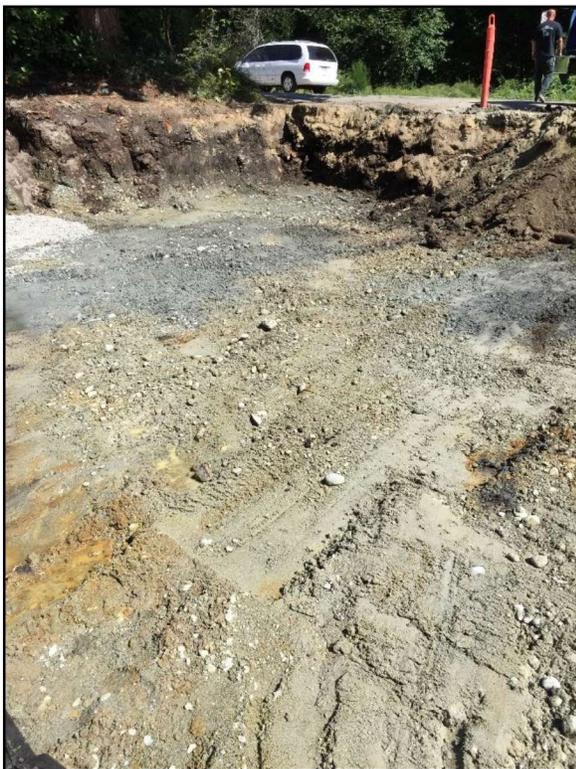
Photograph 11 – August 28, 2019 – Subgrade on northeastern corner of site

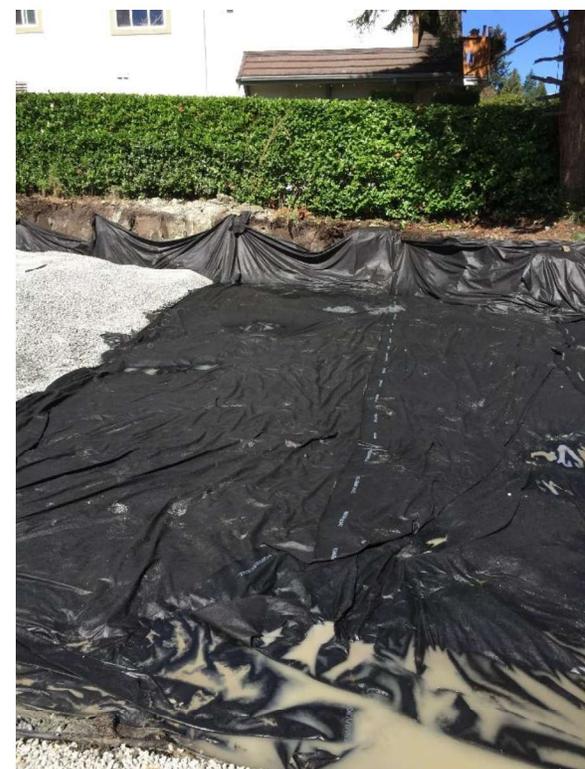
Photograph 12 – August 28, 2019 – Geotextile (Nilex 4545) on northeastern extent of site

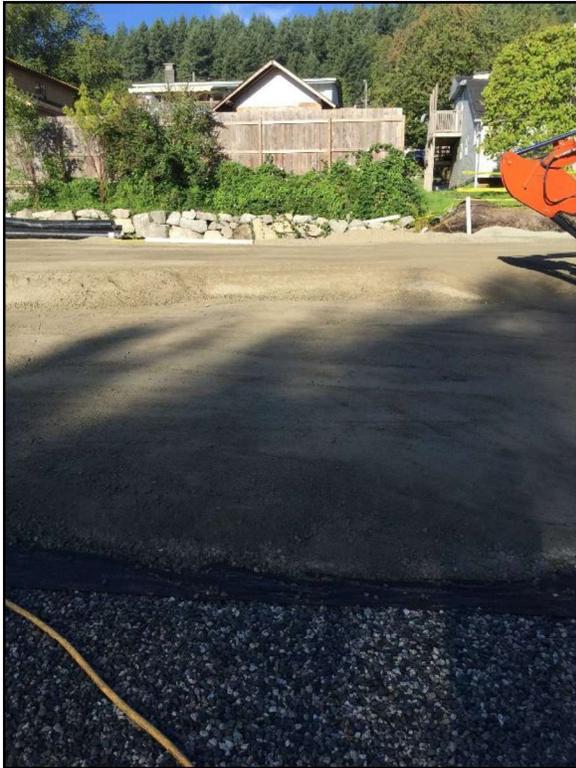
Photograph 13 – August 29, 2019 – Compaction of engineered fill continued

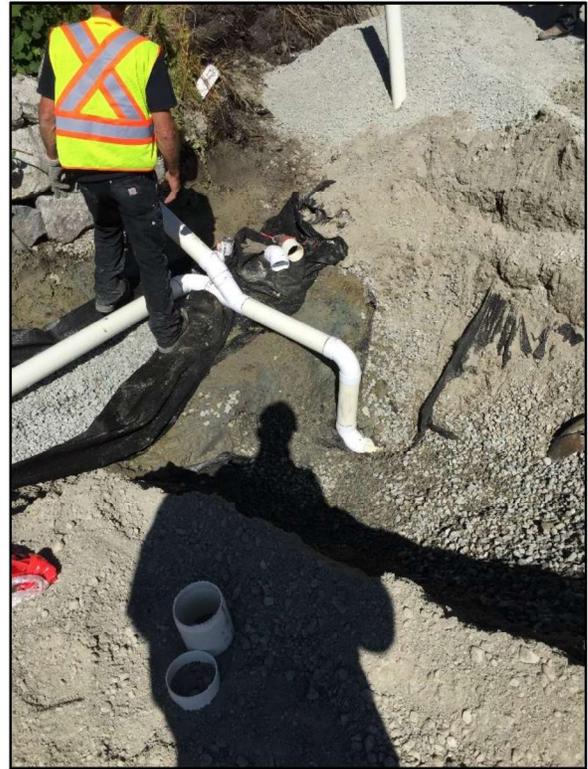
Photograph 14 – August 29, 2019 – Drainage connection repair

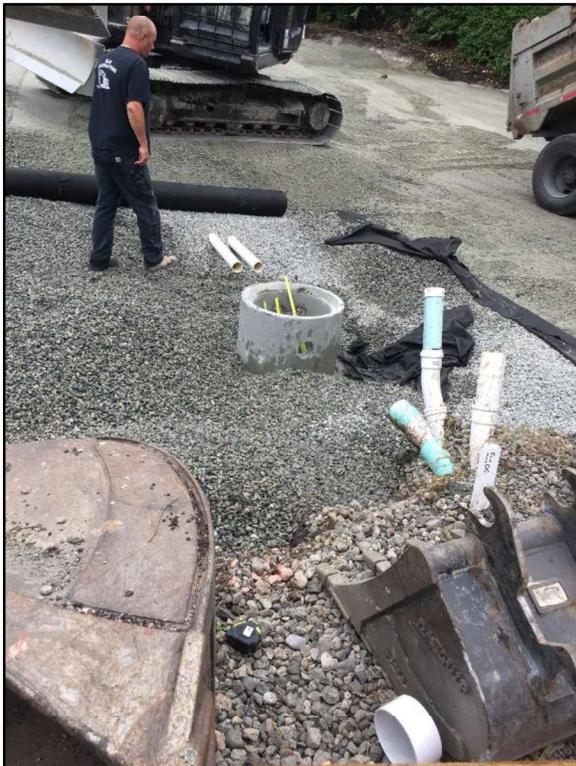
Photograph 15 – August 30, 2019 – Catch basin

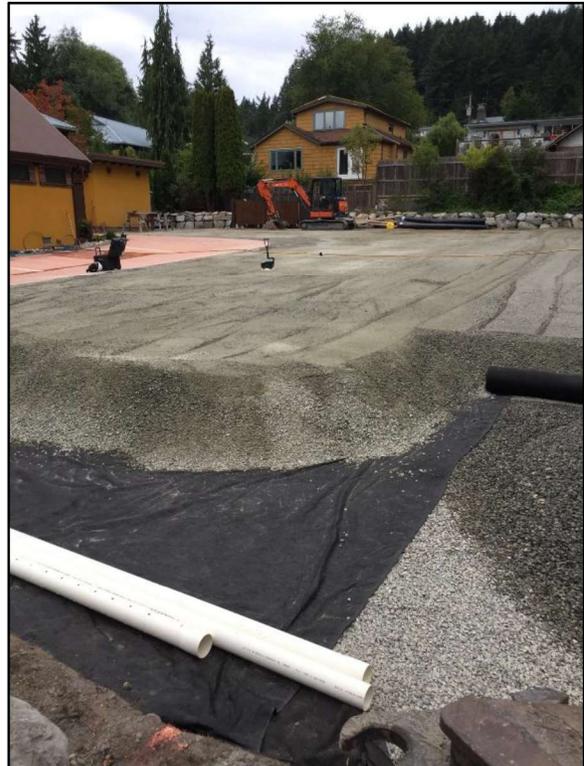
Photograph 16 – August 30, 2019 – Subgrade preparation

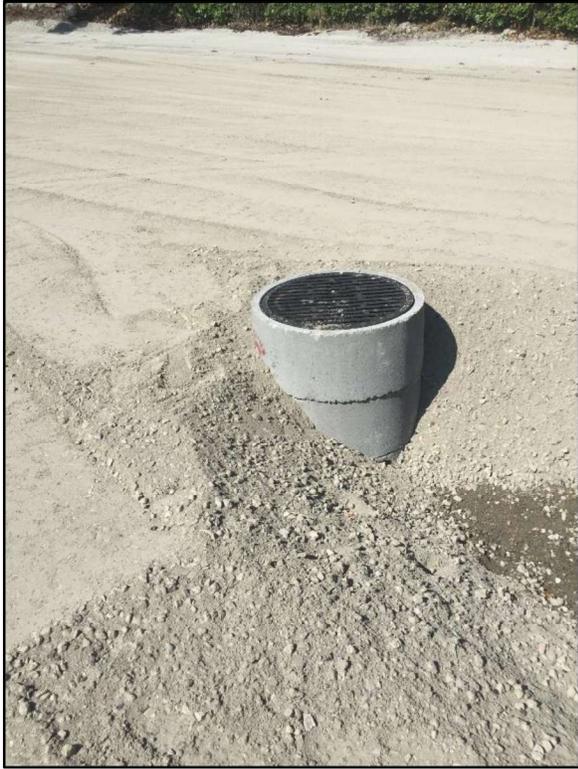
*Photograph 17 – September 4, 2019 – Catch basin
(not connected to municipal system)*

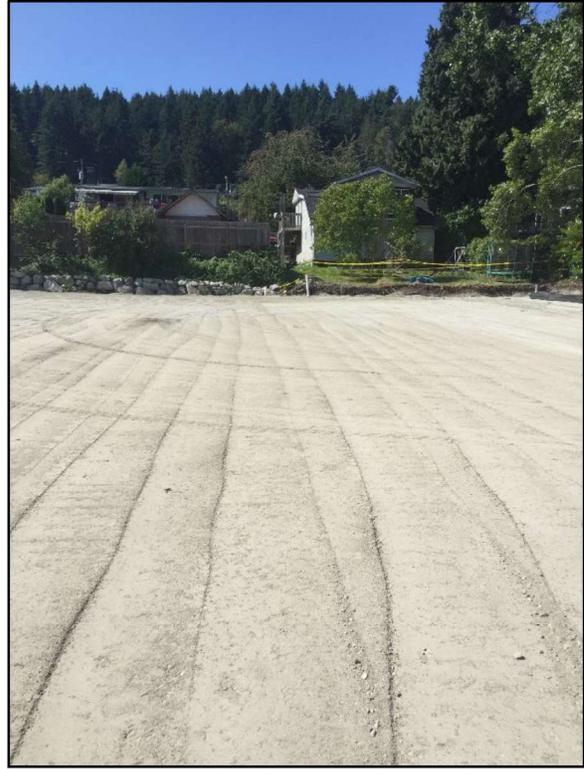
*Photograph 18 – September 4, 2019 – Prepared
Subgrade*
