November 30, 2021

Our File No.: FSCI-21-0023

**Re: Habitat/Condition Assessment of Charman Creek, Gibsons, BC, an Urbanized Stream**

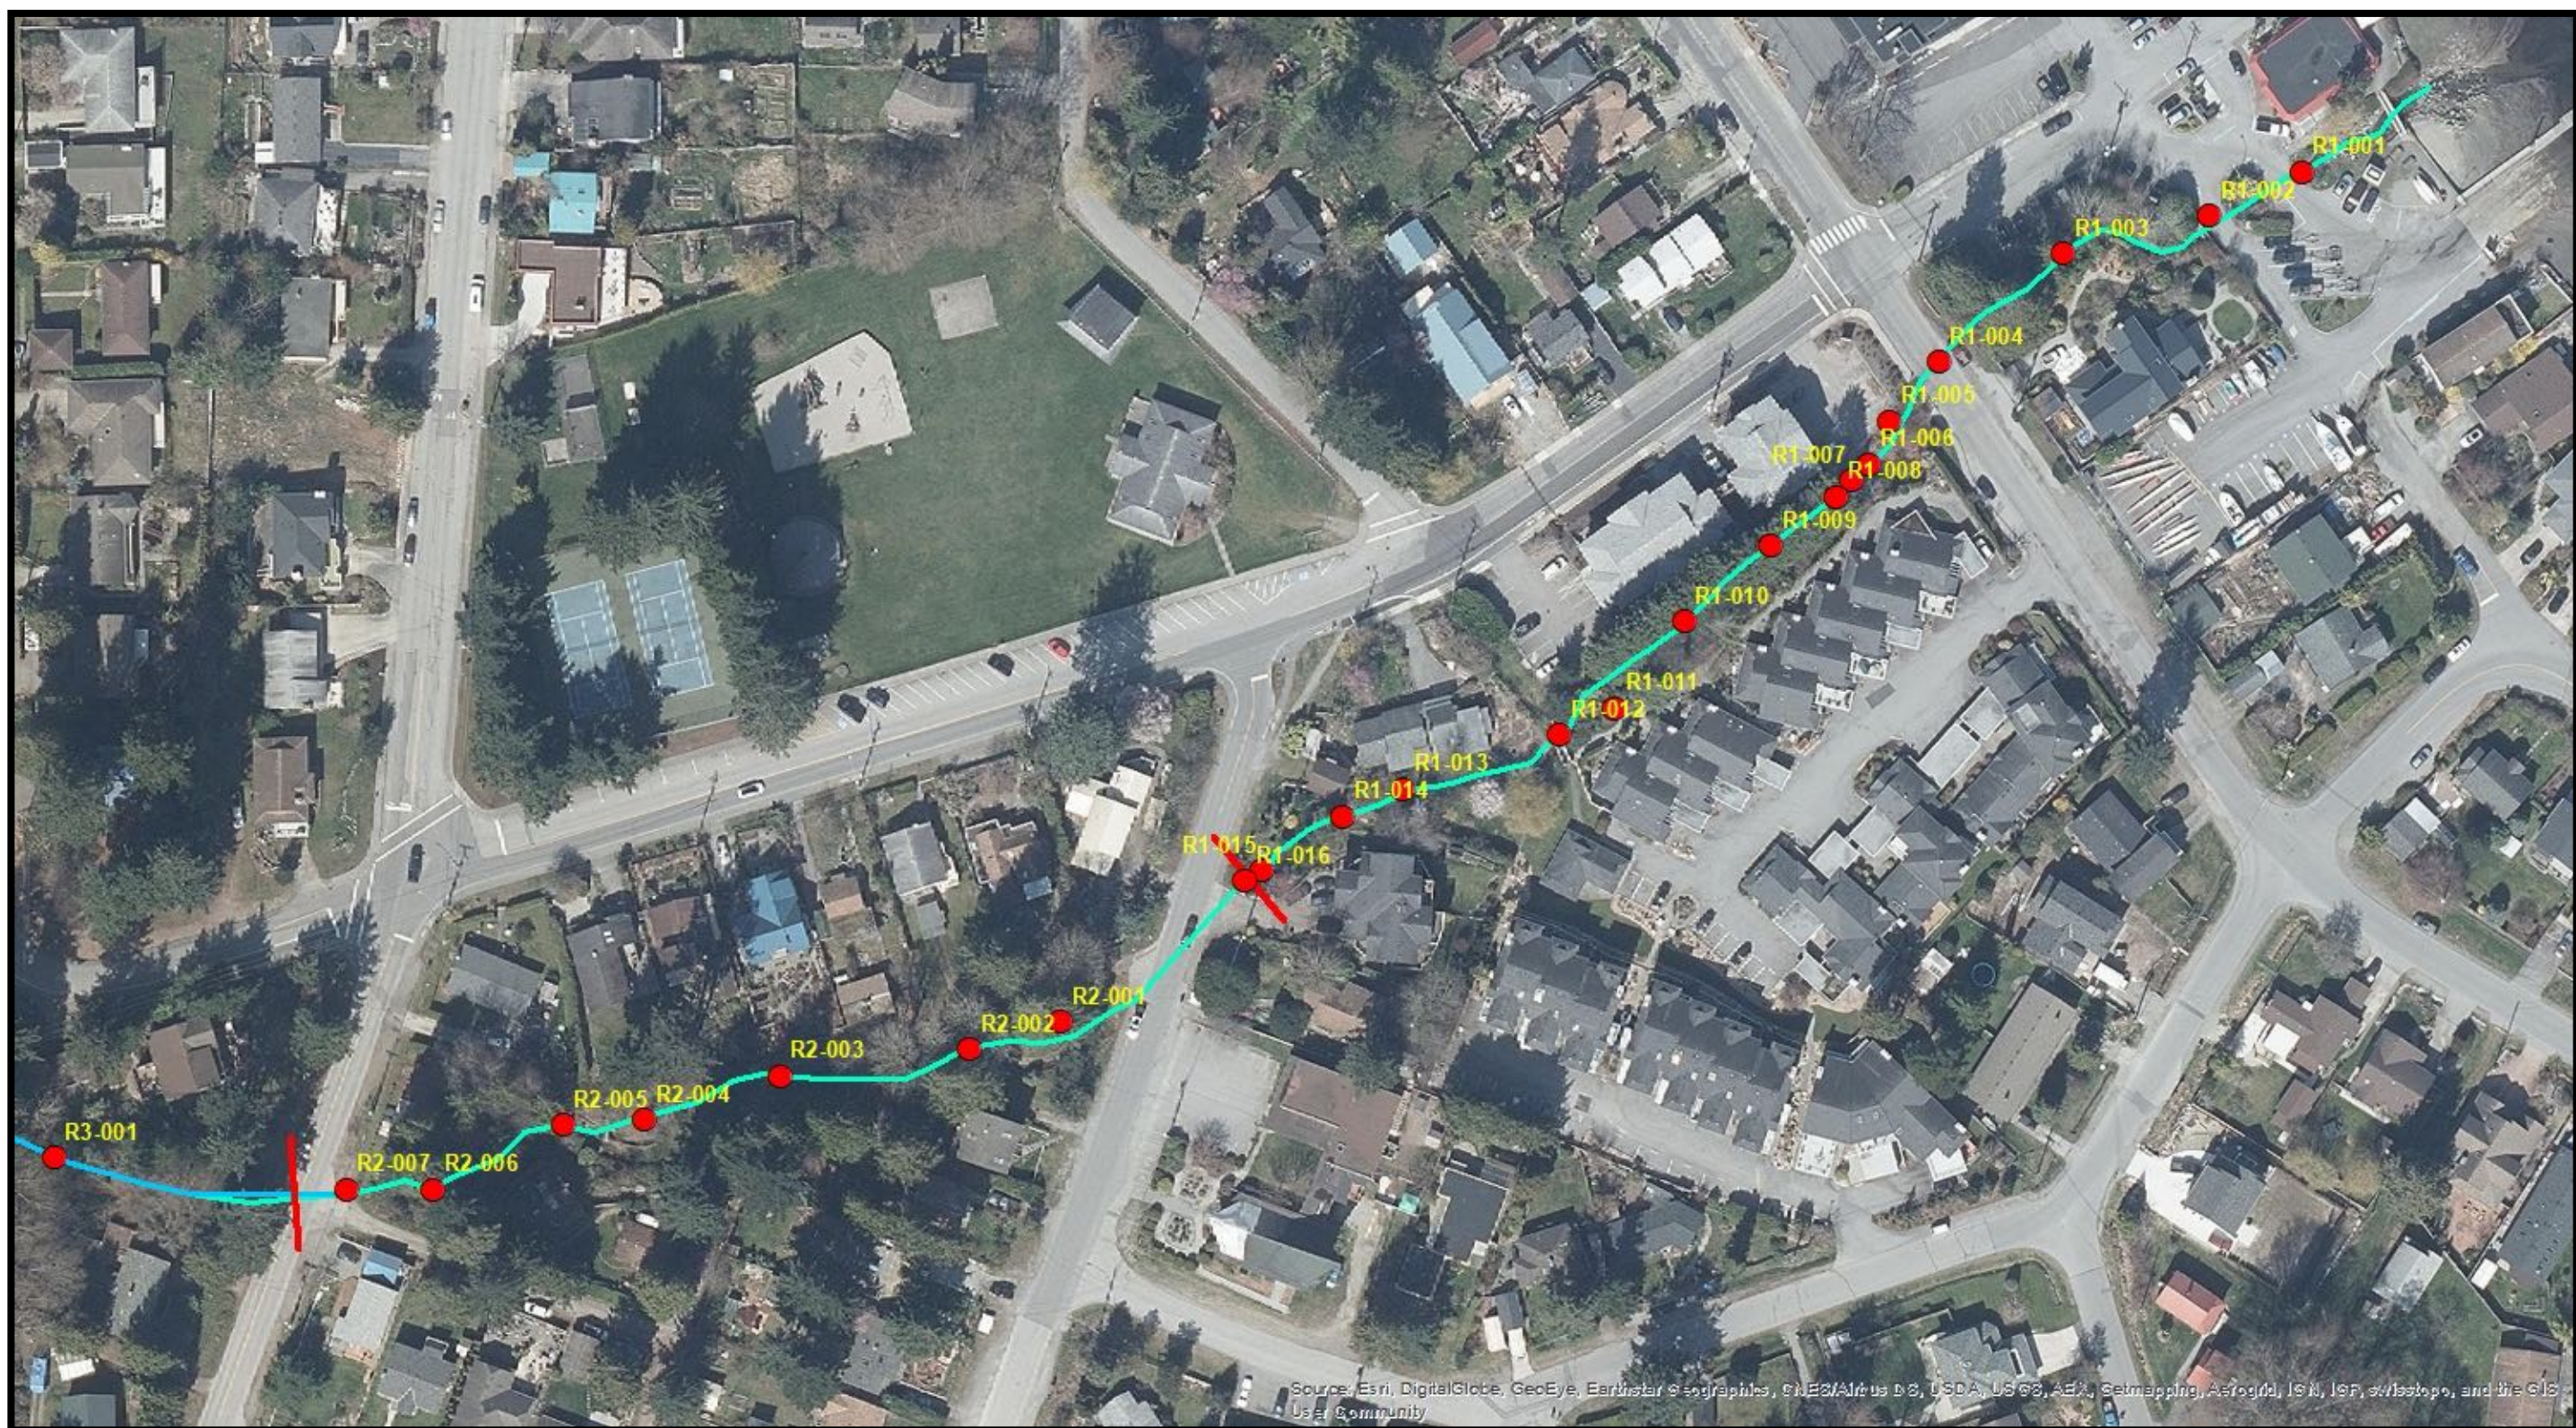
**Figure 4:** Reach 1 and 2 of Charman Creek showing the approximate locations of structure, unauthorized instream works and passage obstructions. Many of the structures have resulted in channel and habitat degradation.

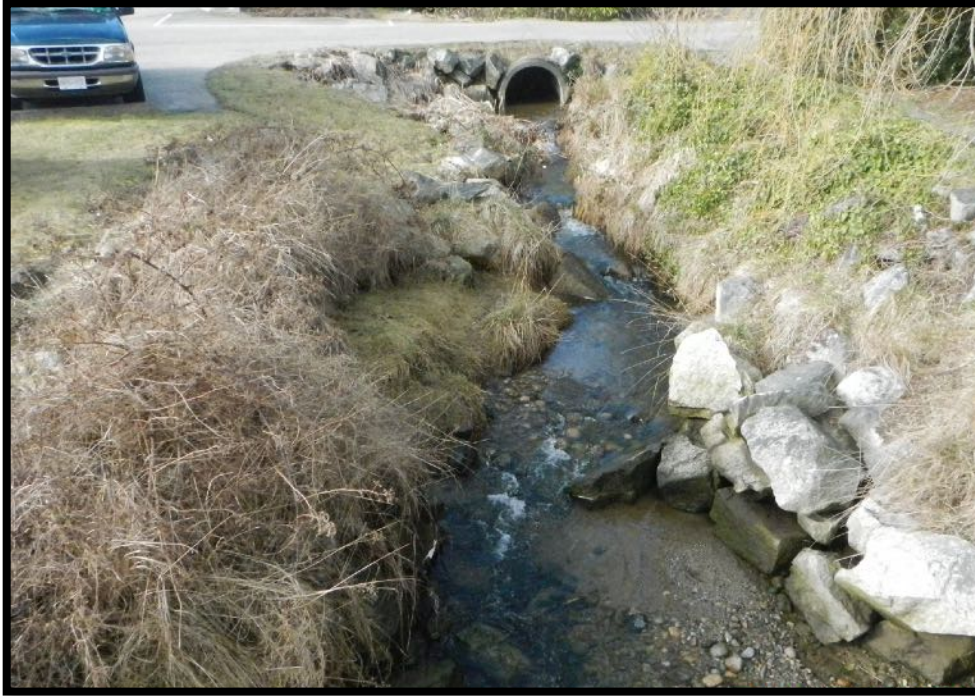
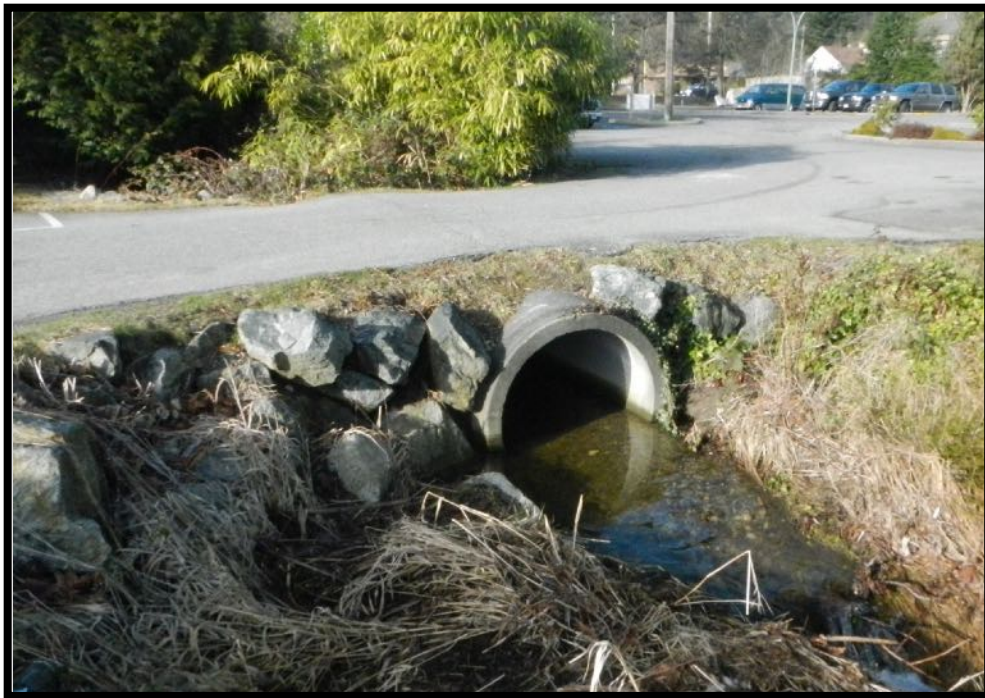
**Figure 5:** Station R1-001 and 002. Culverts under road ways at Gibsons Marina. The concrete pipes are embedded and appear to backwater sufficiently to allow access for migrating adult salmonids. There is a possibility the pipe may be undersized.

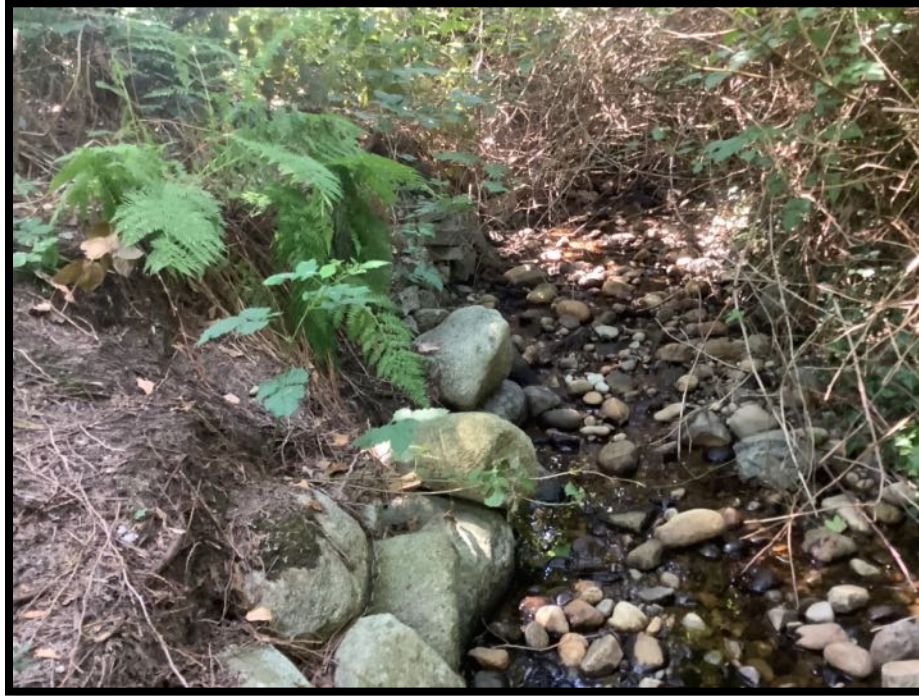
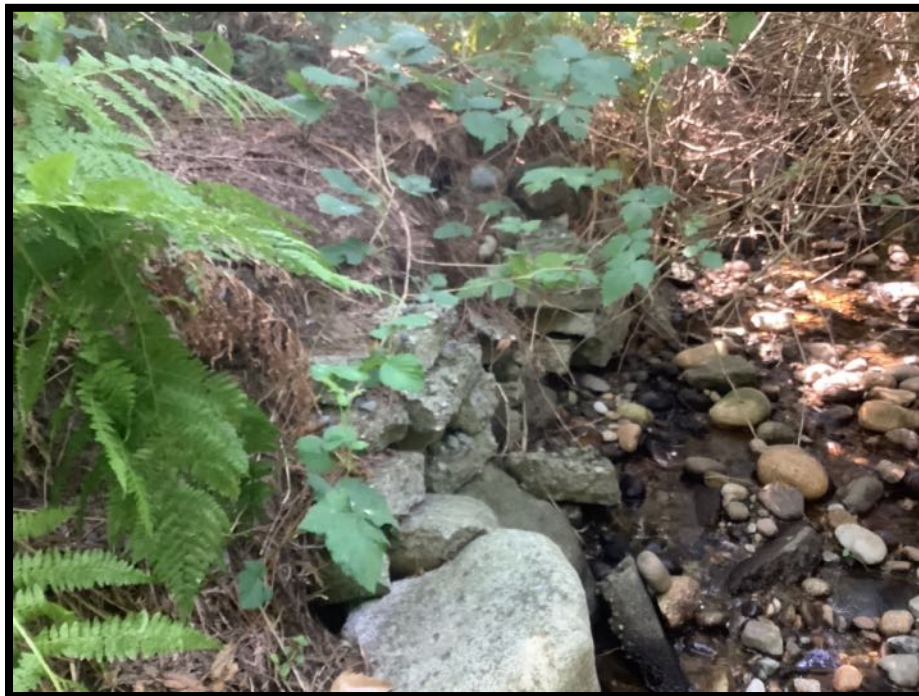
**Figure 6:** Station R1-003 downstream of the Dougall Road culvert. The channel is confined by an old rock and concrete pieces “retaining wall. The channel is confined through this area by the wall and a parking lot.

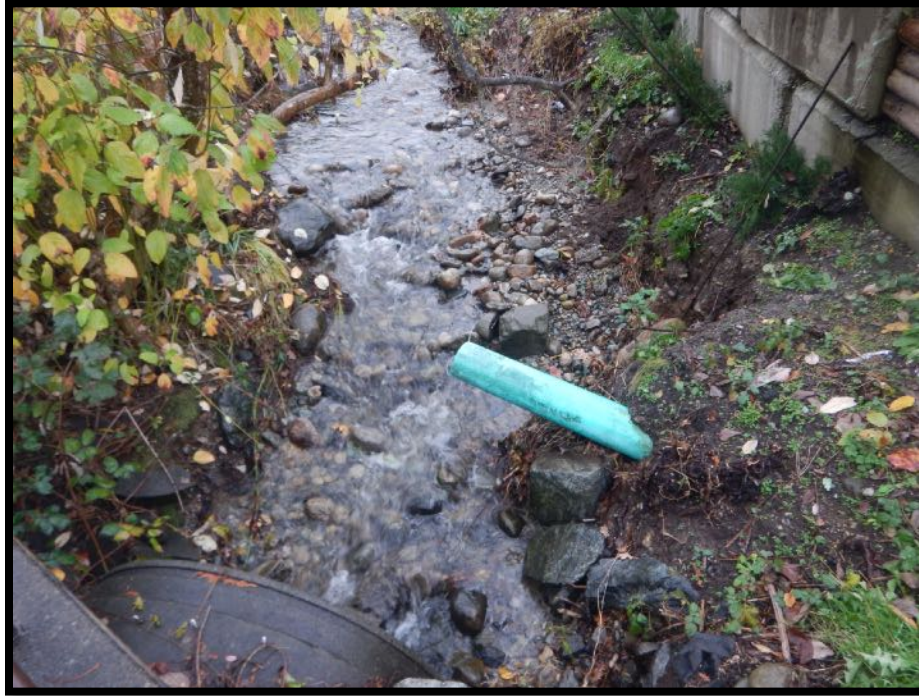
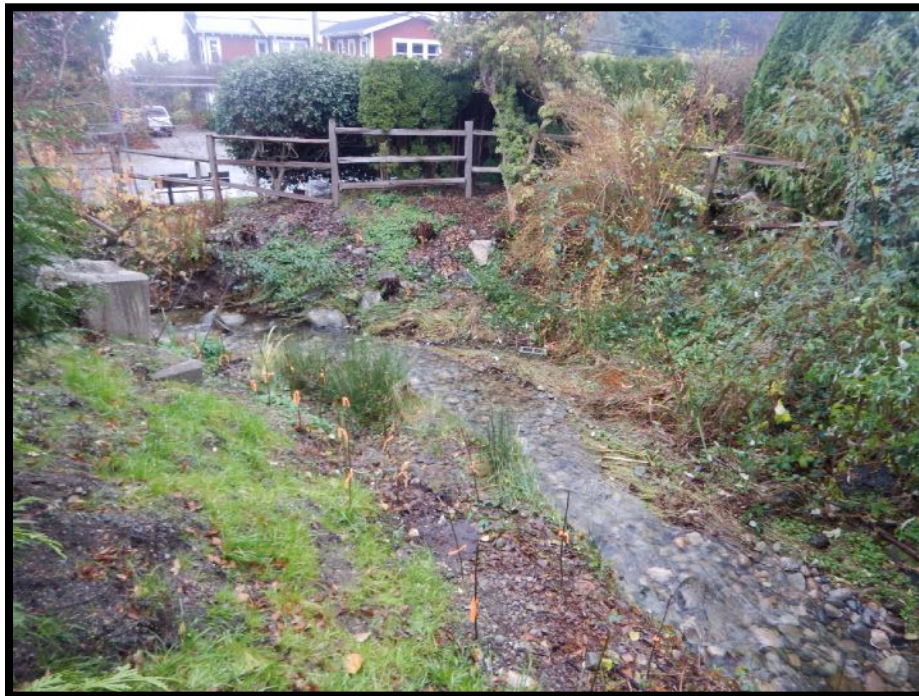
**Figure 7:** Station R1-004, the Dougal Road Culvert. This s a concrete pipe under the road that may be undersized during highwater events. The culvert backwaters and there is evidence of increased erosion. The culvert may present a passage barrier at low water.

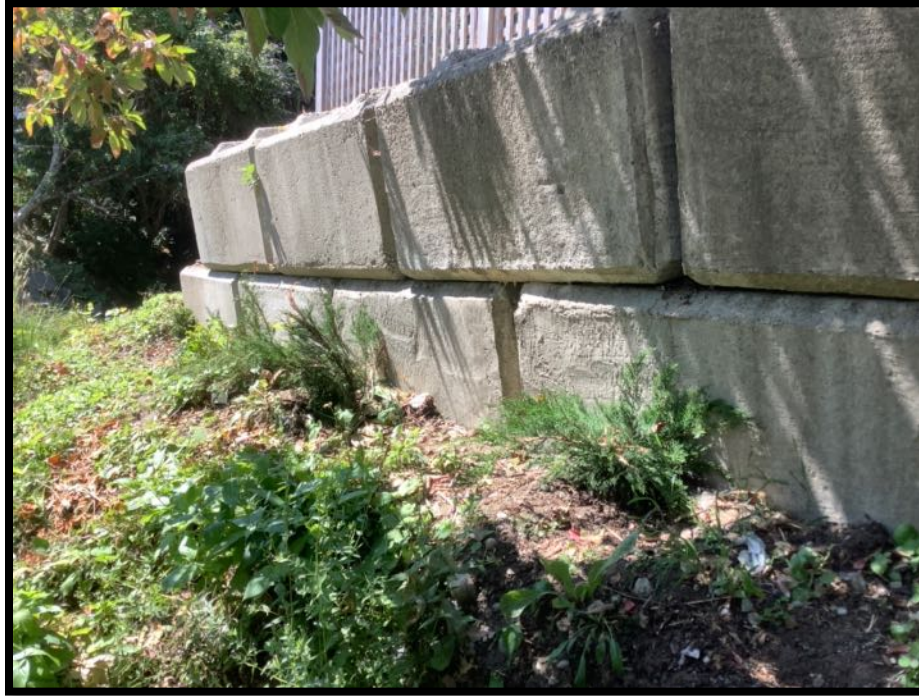
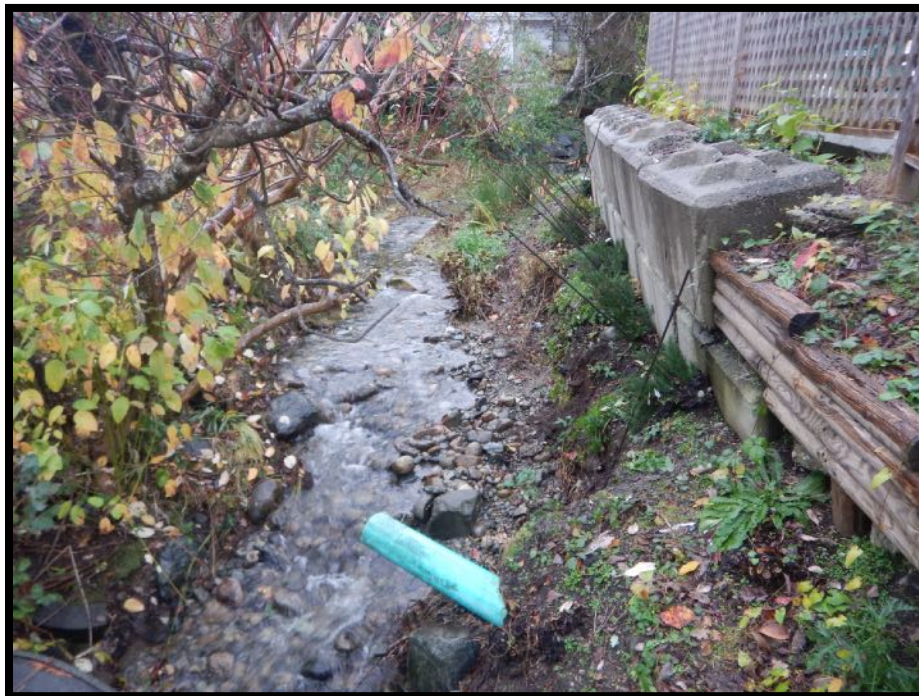
**Figure 8:** Station R1-005, loc-bloc retaining wall located upstream of Dougall Road. The wall is collapsing and at risk of blocking the active stream channel. Channel shows evidence of backwatering from under capacity culvert and erosion near toe of wall.

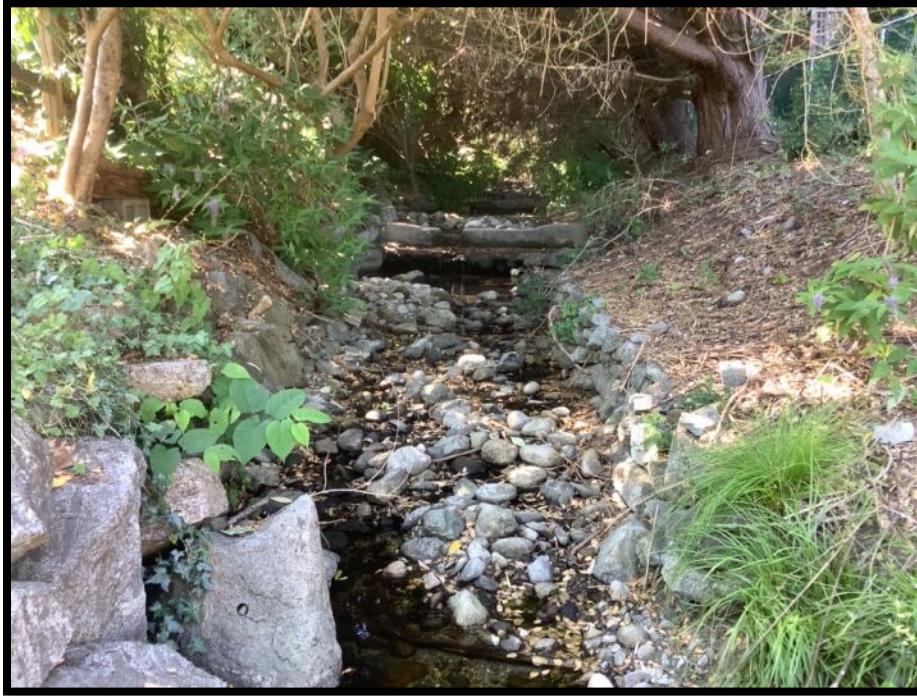
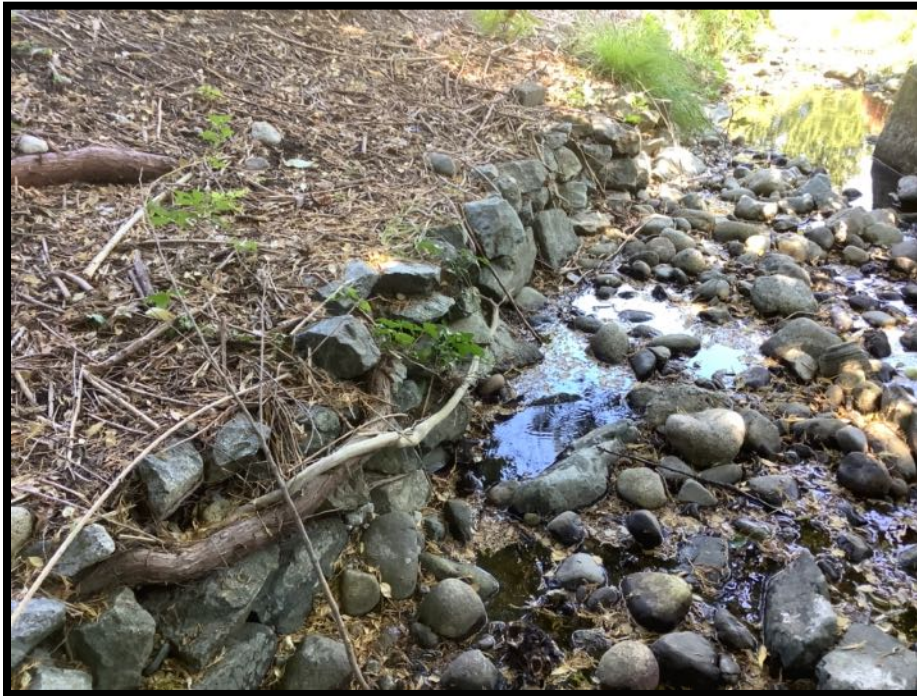
**Figure 9:** Station R1-006, channelization of Charman Creek using rock hardened banks. Channel confined within the hardened channel resulting in degraded habitat.

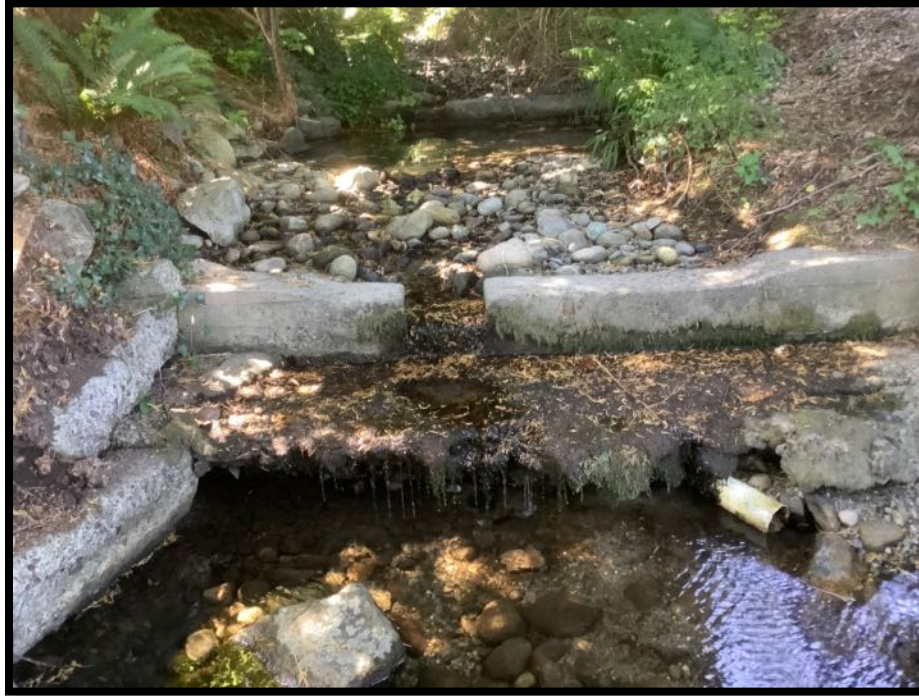
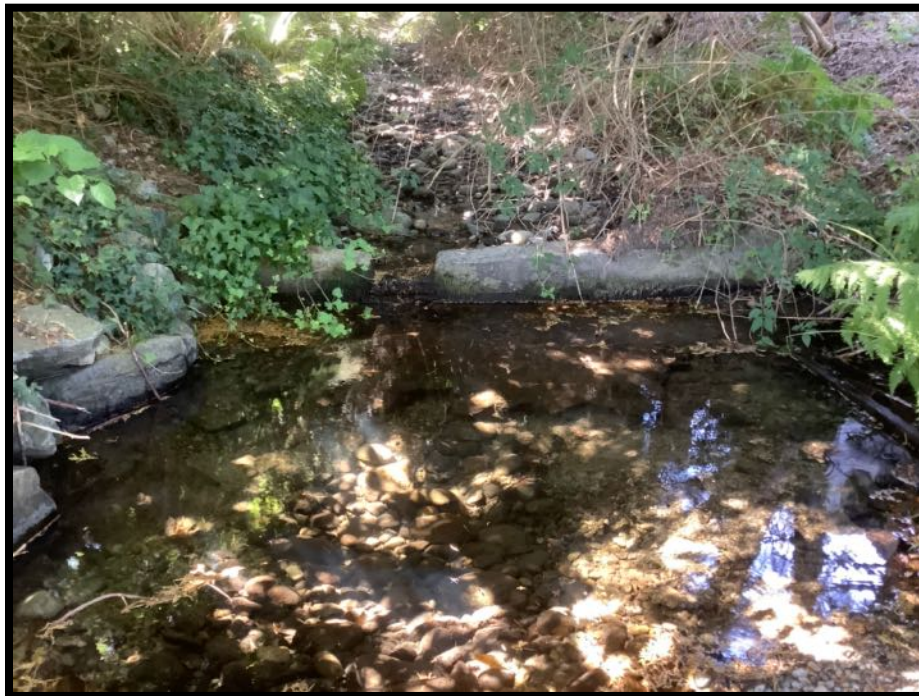
**Figure 10:** Station R1-007 and 008, concrete weirs that “throat” down the channel. Bottom has been hardened with concrete. Weirs prevent natural channel forming functions and have resulted in significant habitat degradation including downcutting of bottom. Structures present passage barriers. Pooled water have provided limited refuge for juvenile salmonids.

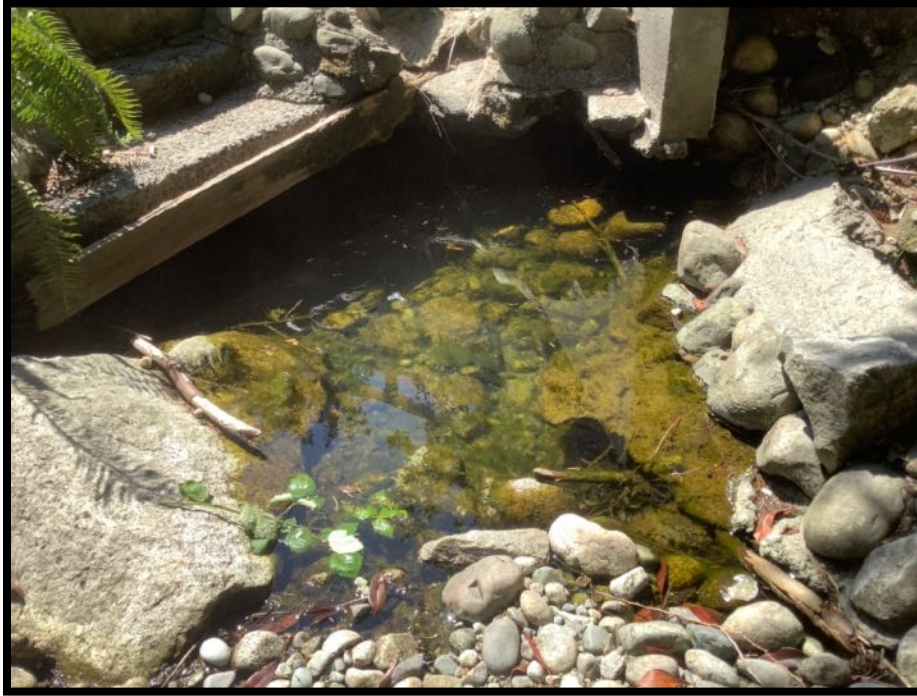
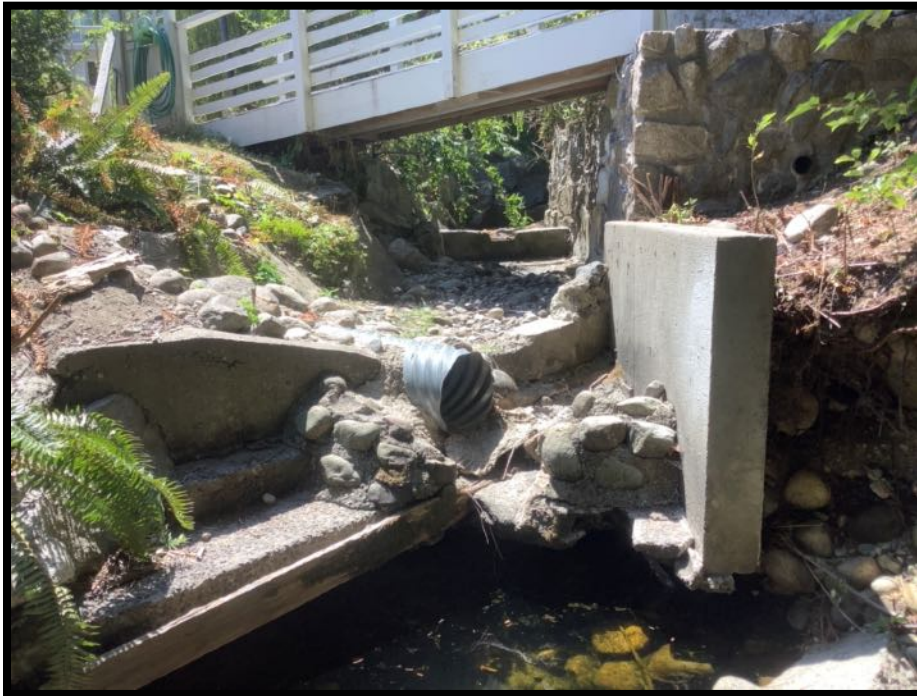
**Figure 12:** Station R1-012, concrete weirs and corrugated metal pipe used to create weirs and hardened bank protection. Stream has undercut structures and habitat significantly degraded. Scour pool created provides refuge for juvenile salmonids with likely high predation risk. Passage barrier to salmonids.

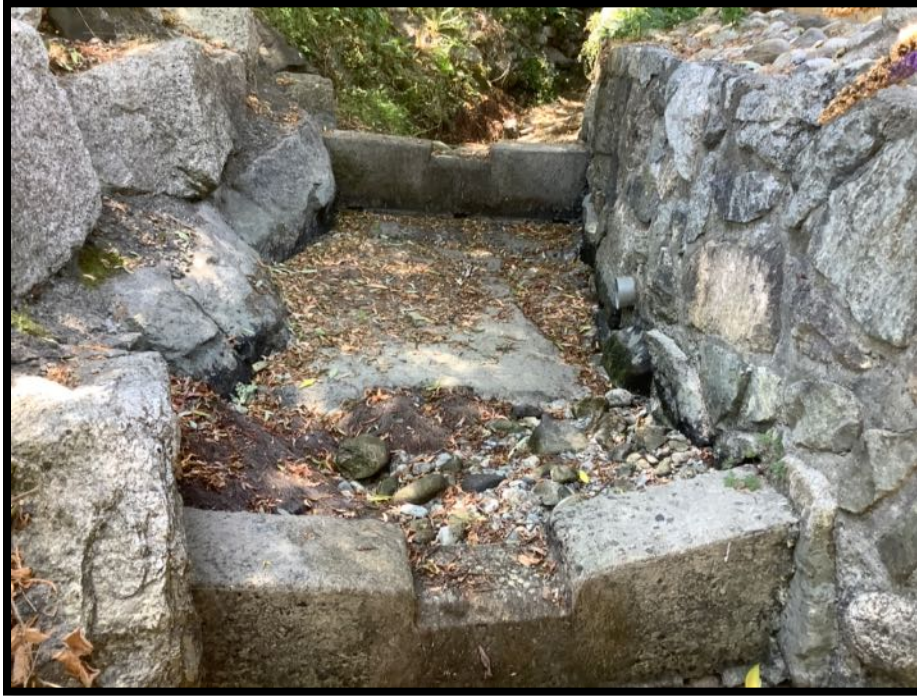
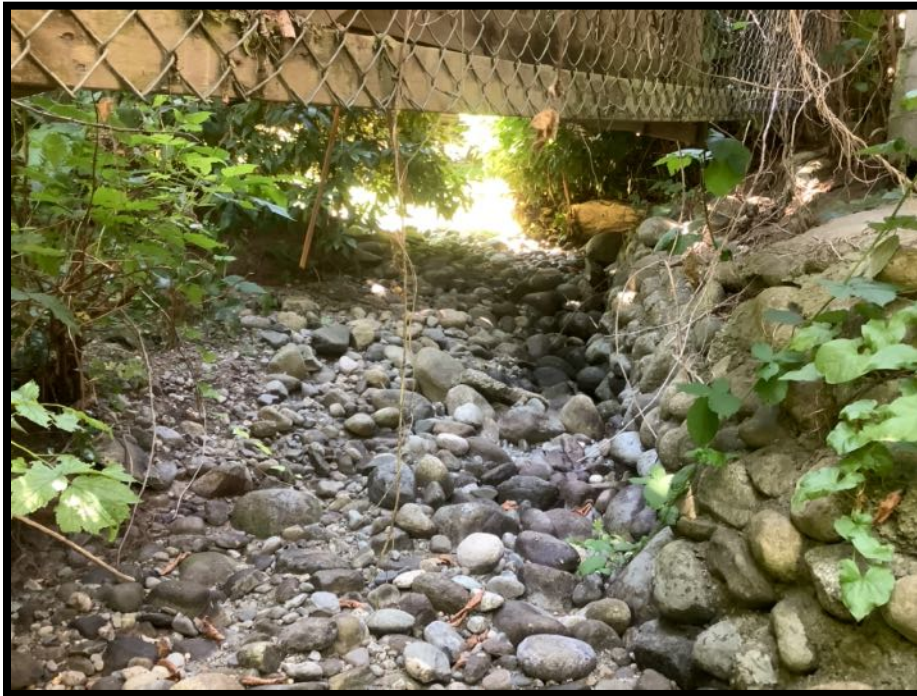
**Figure 13:** Station R1-013 (top) and 014 (bottom) where a numerous weirs, concrete bottom and hardened banks channelizes Charman Creek. Habitat is degraded or non-existent (top) and structures present passage barriers, including potential velocity barriers at high flows. Channel was dry during low summer flow period.

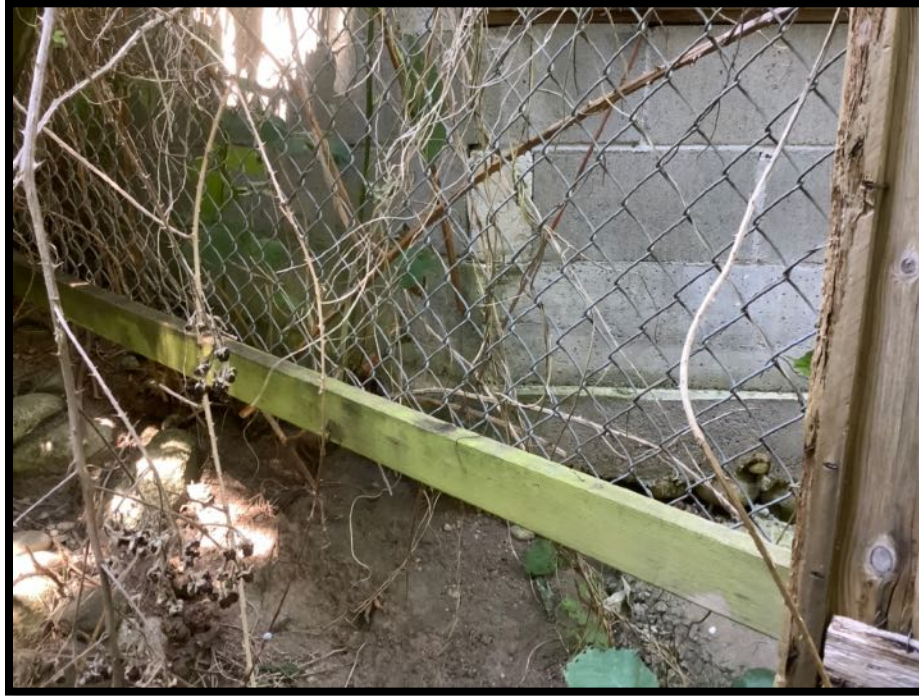
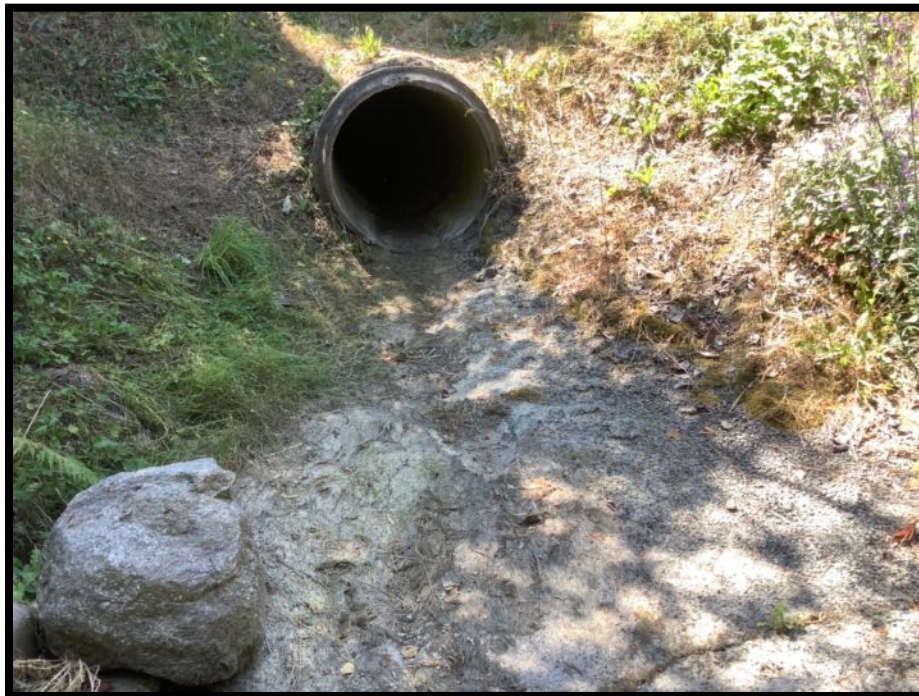
**Figure 14:** Stations R1-0015 (top) and 015 (bottom) where a building appears within or near the active channel bank (top) and the concrete culvert under Glassford Road (bottom). The culvert is not embedded and is dry during the summer months creating a passage barrier. At higher flows this pipe may create a velocity barrier, particularly for juvenile salmonids. Back flooding may be an option.

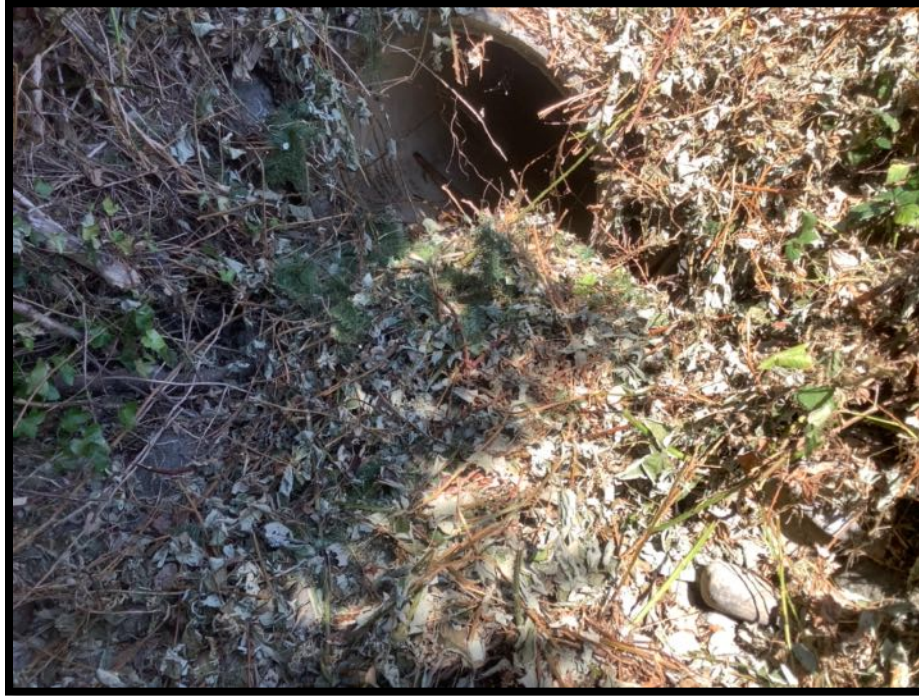
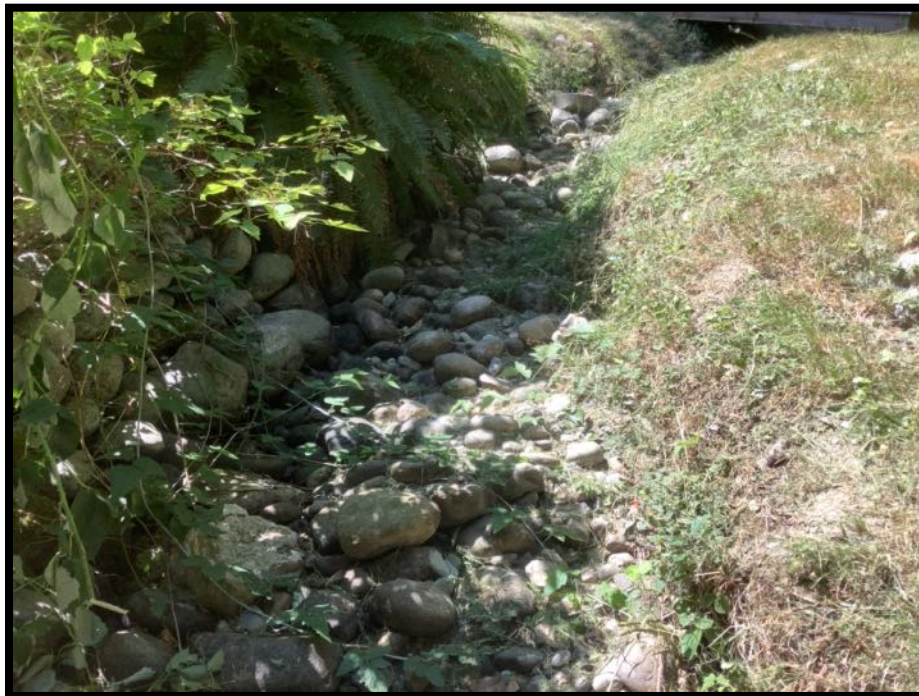
**Figure 15:** Station R2-001, channelized stream channel with invasive plants dominating the riparian vegetation. Evidence of locals dumping organic waste into the ditch that will block the channel. Dumping organics waste into the stream channel is an infraction under the Federal Fisheries Act.

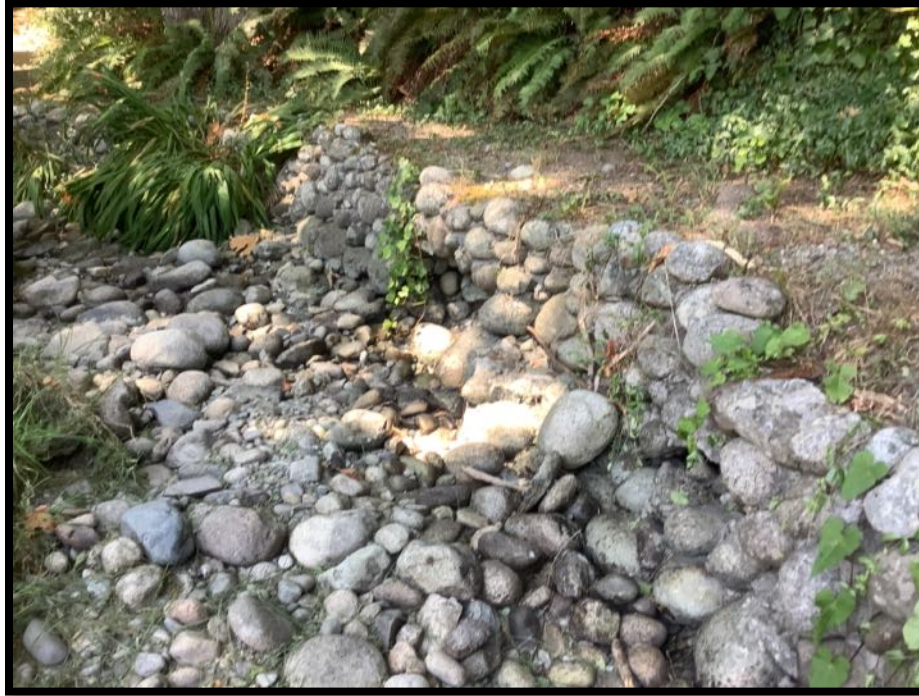
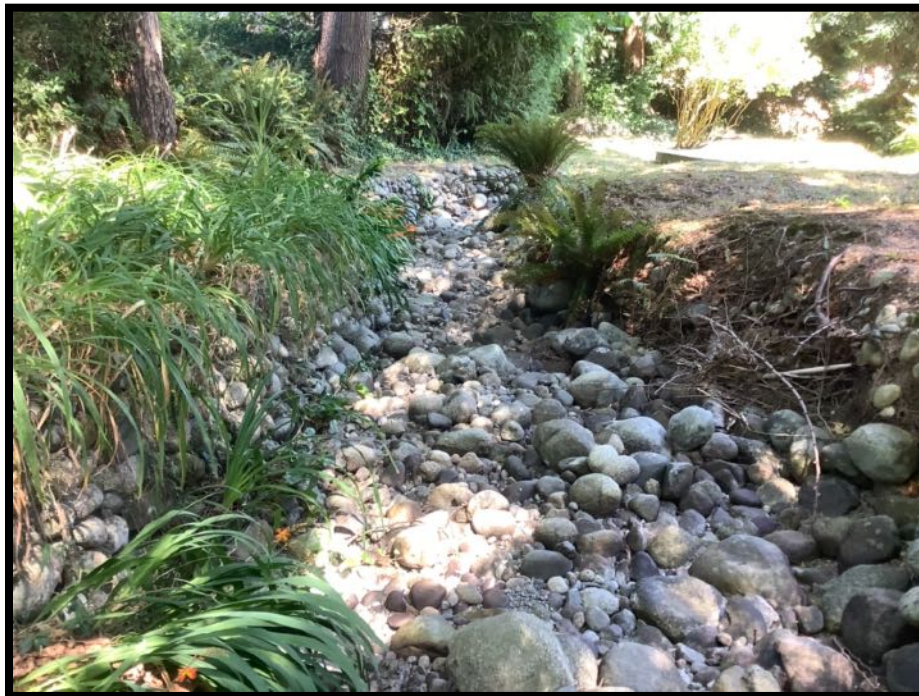
**Figure 16:** Station R2-002, hardened stream bank using stacked boulders. The image illustrates the risk of poorly planned bank protection. The armouring on the wone side has forced the channel to adjust and erode the opposite bank as it adjusts its channel capacity and energy dissipation.

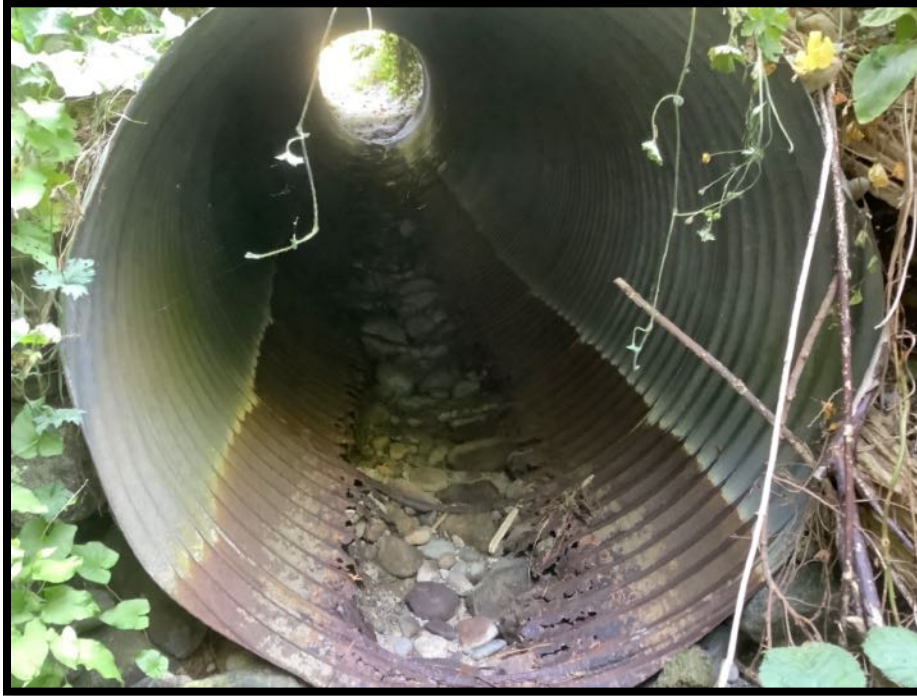
**Figure 17:** Station R2-003, rusted corrugated metal pipe. Culvert should be removed and replaced with an embedded structure that encourages substrate deposition within the pipe.

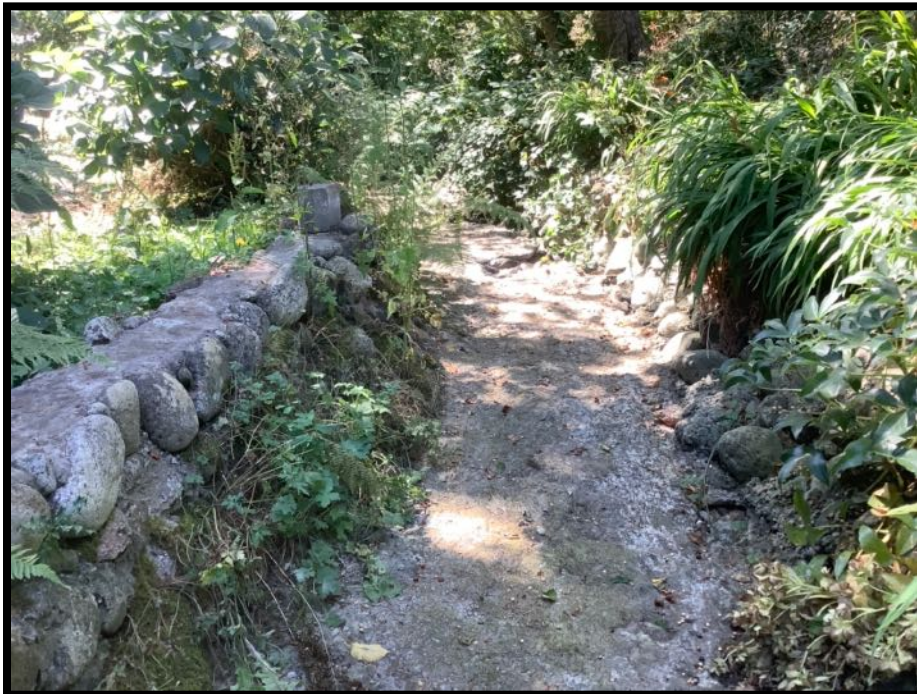
**Figure 18:** Station R2-004, channelized length of creek with non-native plantings within the riparian. Channel is dry and habitat poor.

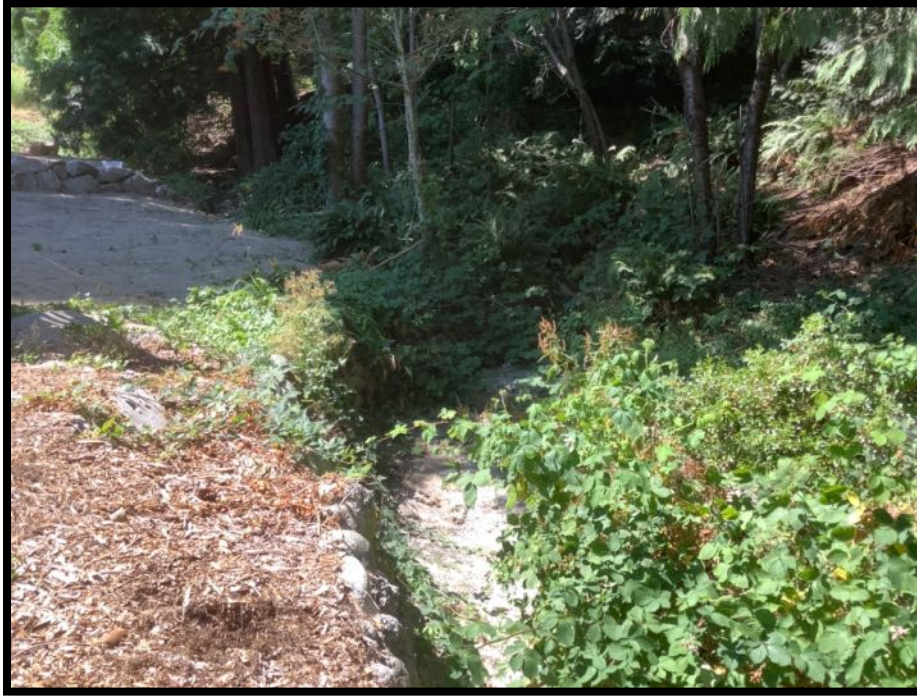
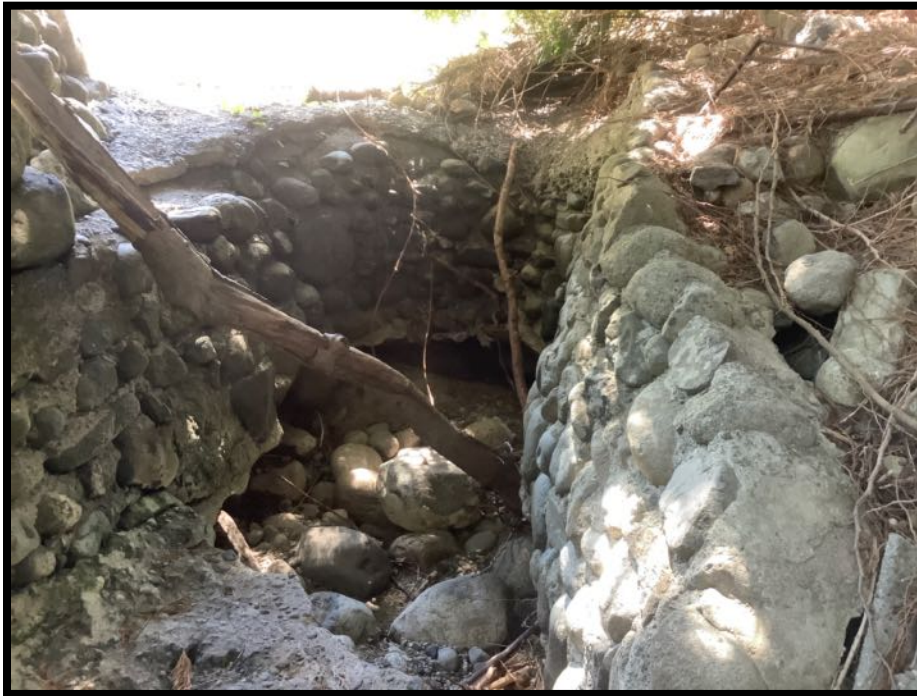
R2-005	462890	5471632	Channelized armoured stream banks presumably constructed by property owners. Channel confined within armoured channel. Poor habitat, dry channel.	19
R2-006	462866	5471620	Concrete and rock retaining (armour) structures that are failing. Downcutting and undermining evident. Channelization of stream resulting in degraded habitats.	19
R2-007	462850	5471620	Culvert under Gower Point Road. Barrier to passage during low flows and potentially high flow by creating a velocity barrier. This is considered the upper extent of fish distribution because of passage issues.	-
R3-001	462796	5471626	"Natural" stream channel begins and Reach 3 and 4 are more indicative of a natural stream channel and processes. This area is steeper than Reaches 1 and 2 so expected habitats differ. No contiguous running surface waters. Expected water in pools or depressions with hyporheic flows would provide contributing flow.	20

**Figure 19:** Stations R2-005 (top) and 006 (bottom) showing channelized stream channel with hardened retaining structures. The structures prevent the channel from developing natural geomorphological processes that would contribute to creation of suitable salmonid habitat.

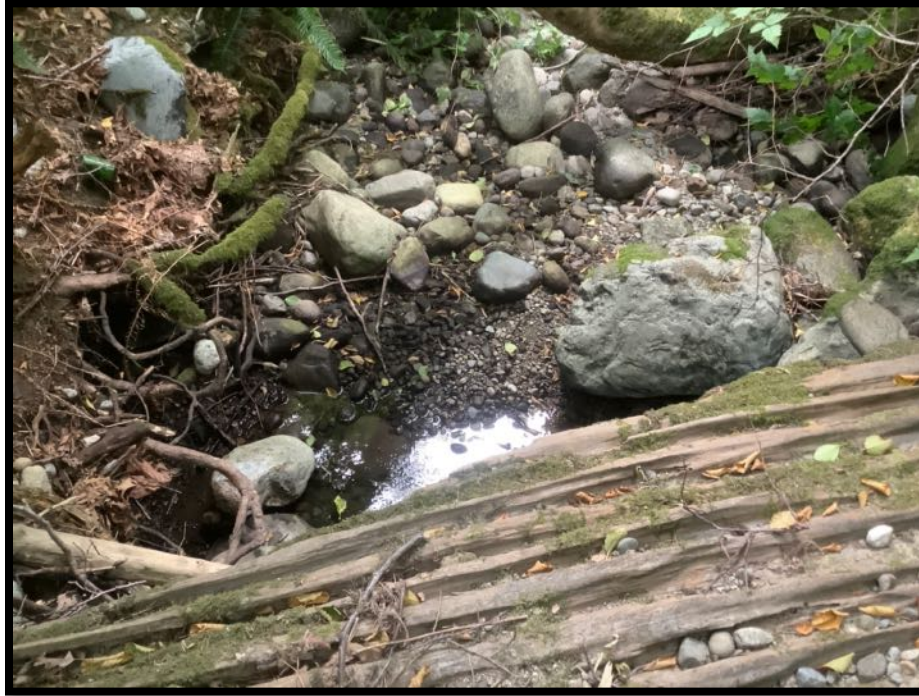
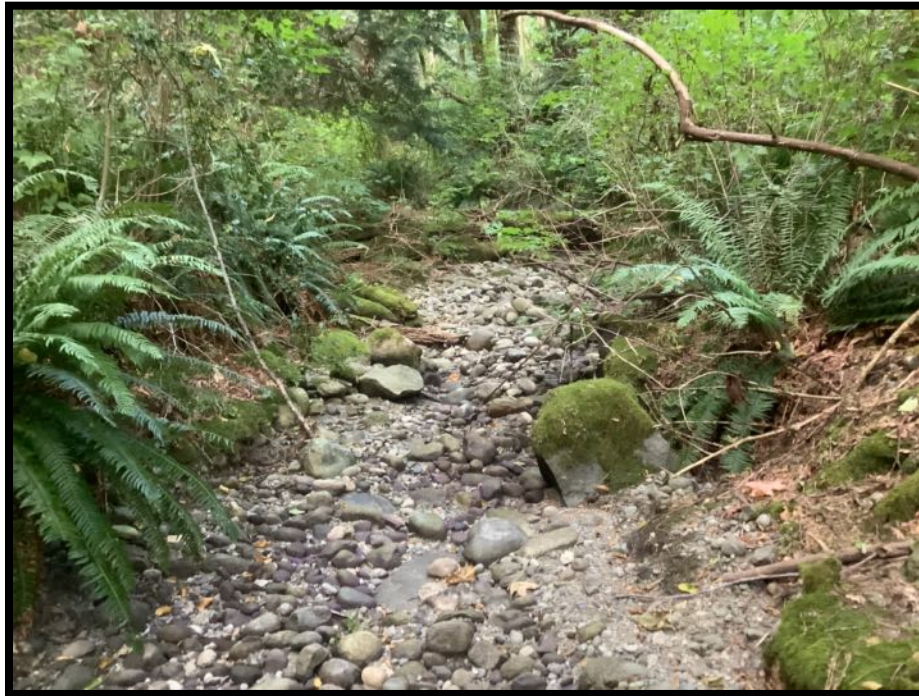
**Figure 20:** Examples Charman Creek stream channel and riparian area above Gower Point Road. The upper reaches , with some exceptions, are in better condition and exhibit “better” quality habitat. The limiting factor in these areas is the lack of summer surface baseflows.
