**Tree Evaluation Report for:
1057 Gibsons Way
Town of Gibsons, BC**

**Mike Fadum and Associates Ltd.
#105, 8277-129 Street
Surrey, BC
Phone 778-593-0300**

**Date: June 16, 2023
Revised: August 14, 2023
Revised: August 23, 2023**

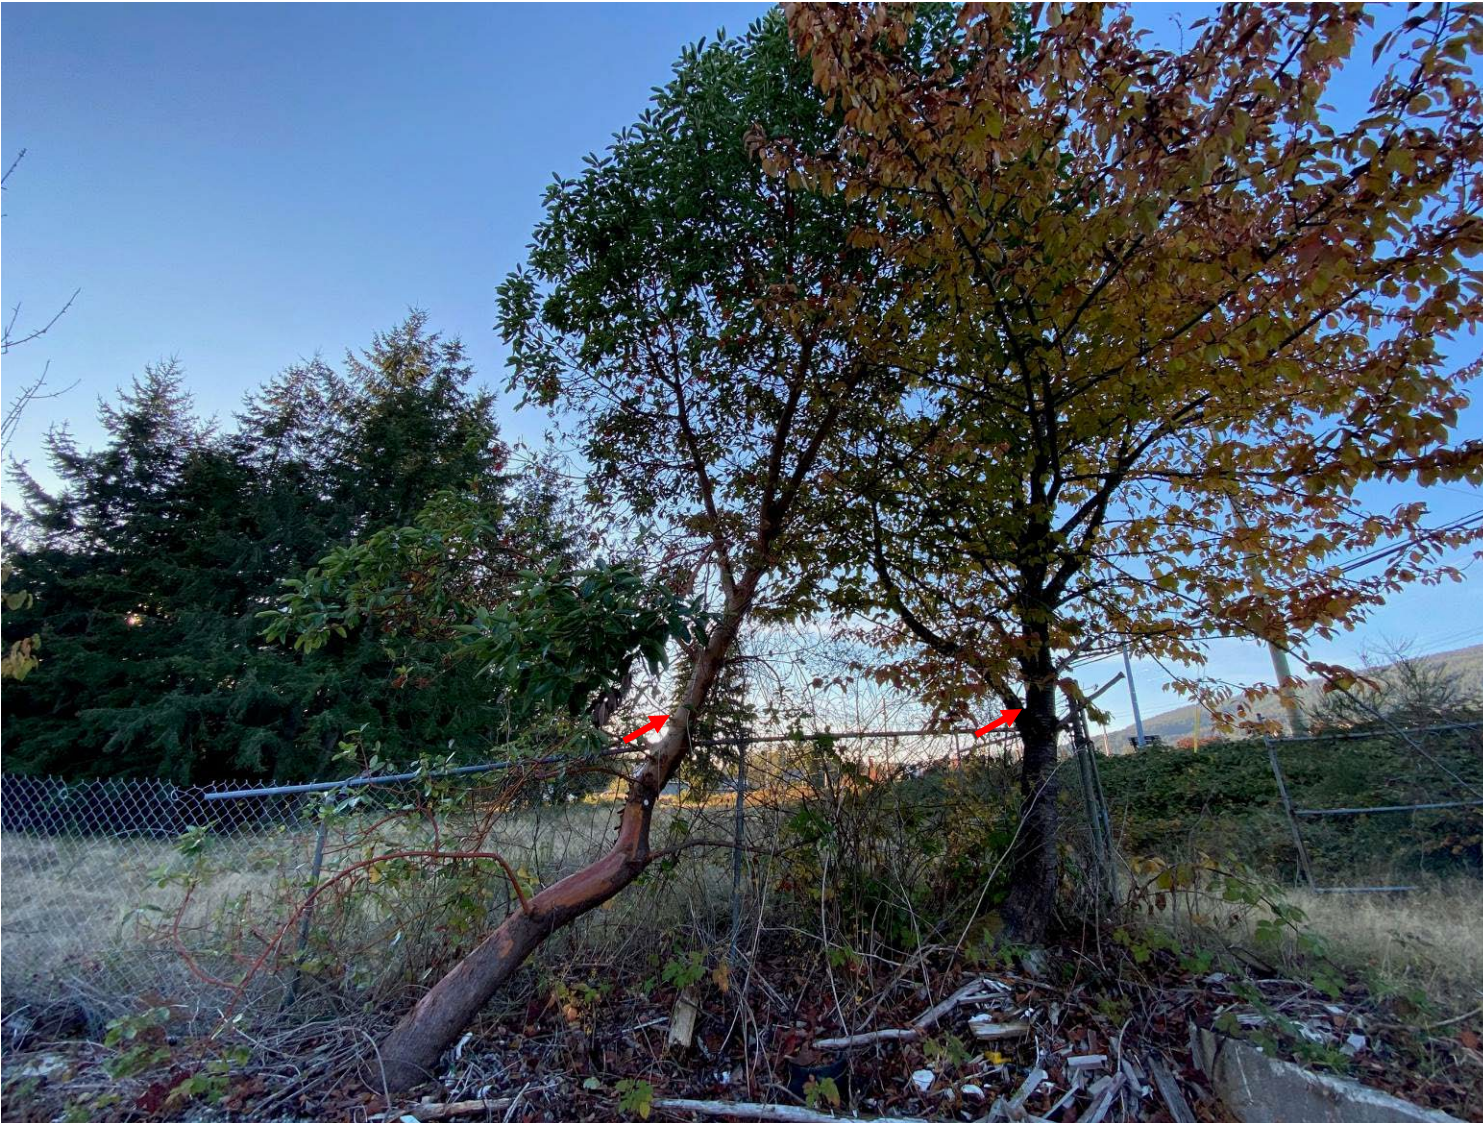
Figure 2: Trees 3446 & 3447 – left to right.

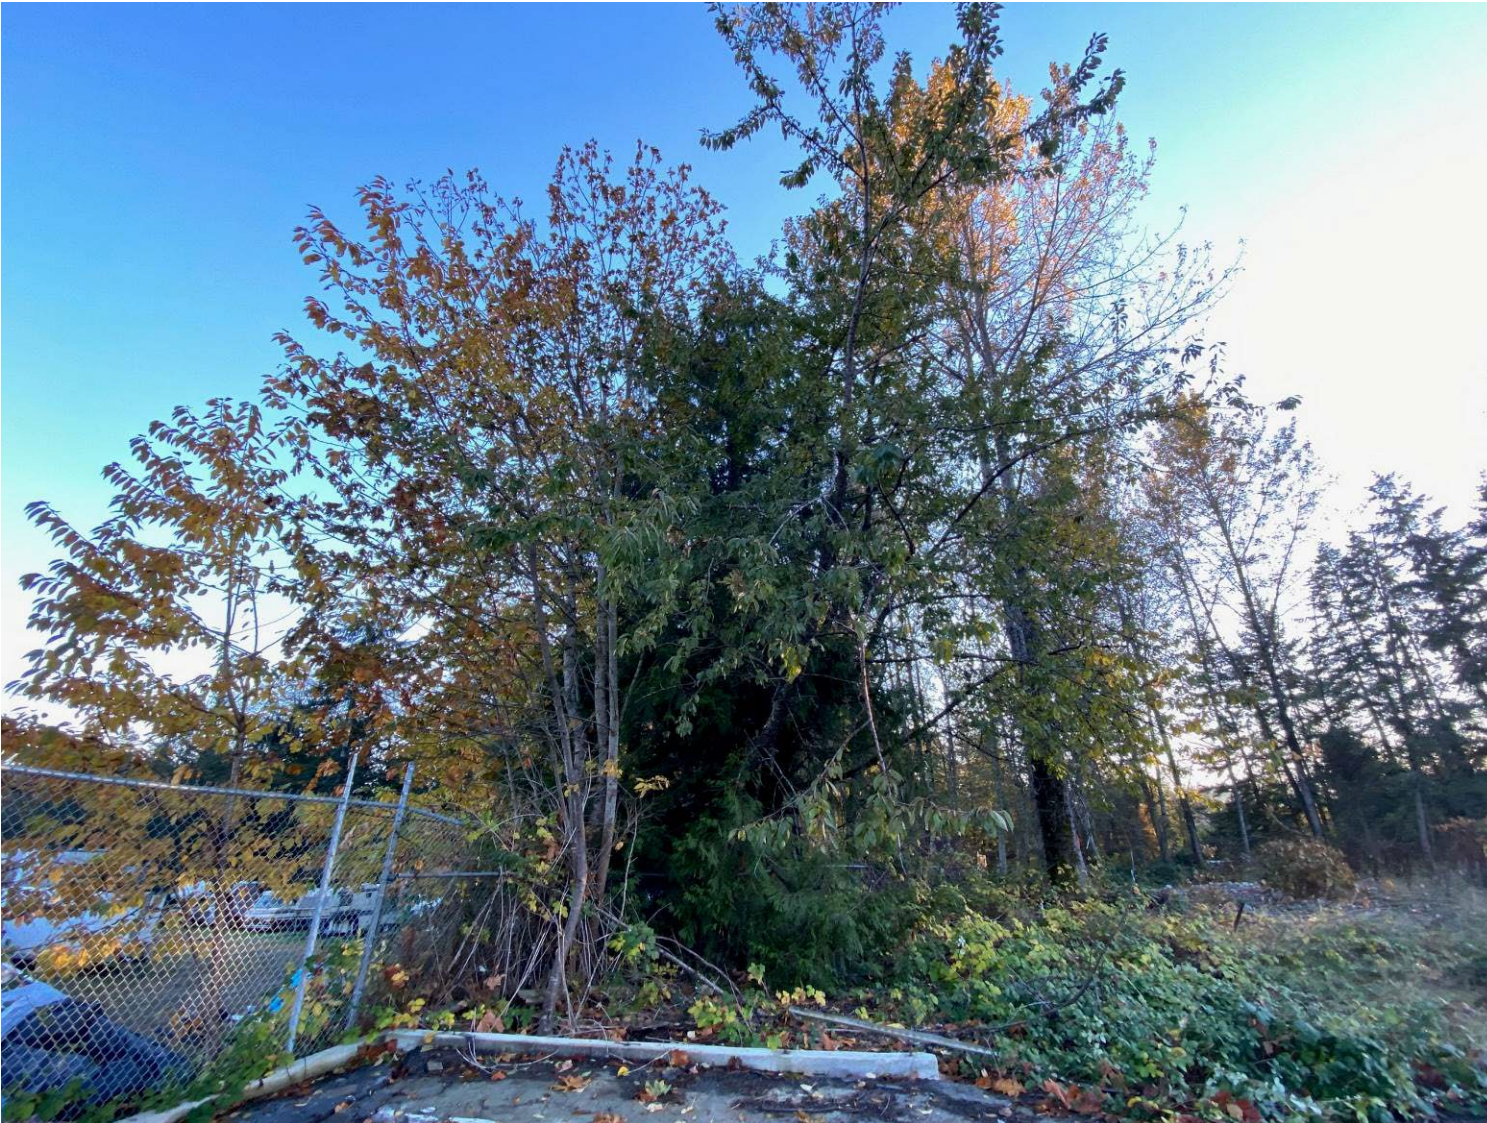
Figure 3: Trees along east property line.

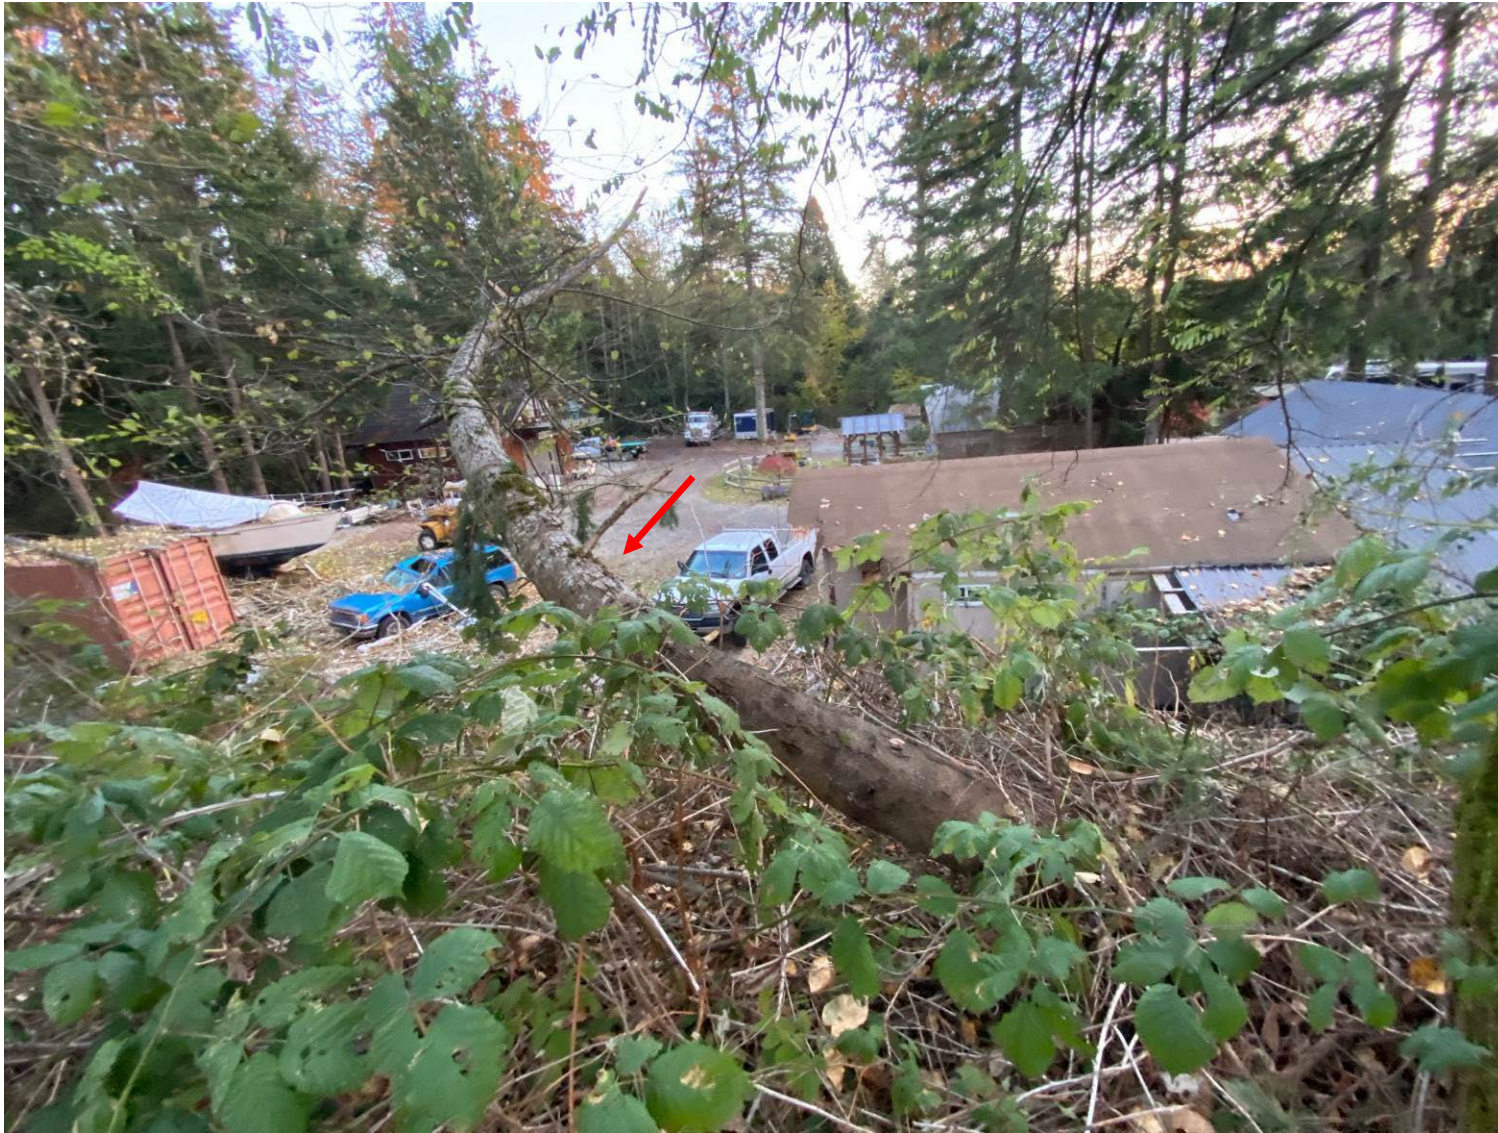
Figure 4: Tree 7114 targeting neighbour's property to the south – remove to mitigate risk.

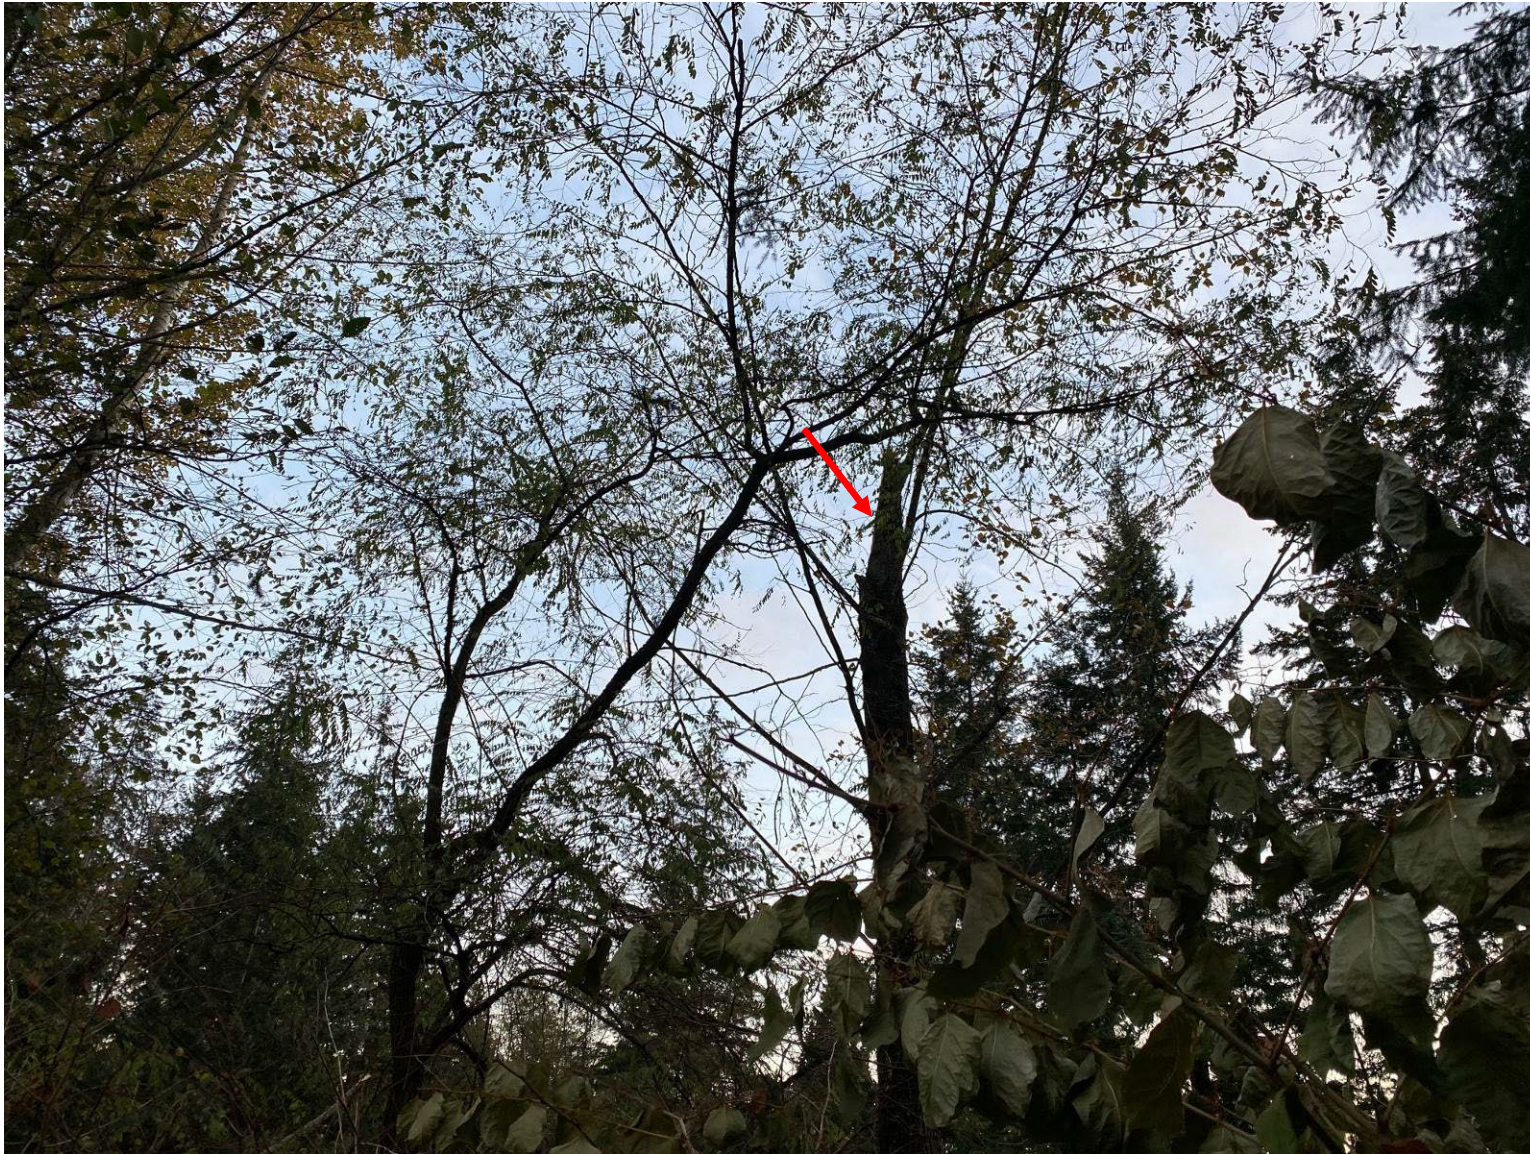
Figure 5: Tree 10290 – note broken top.

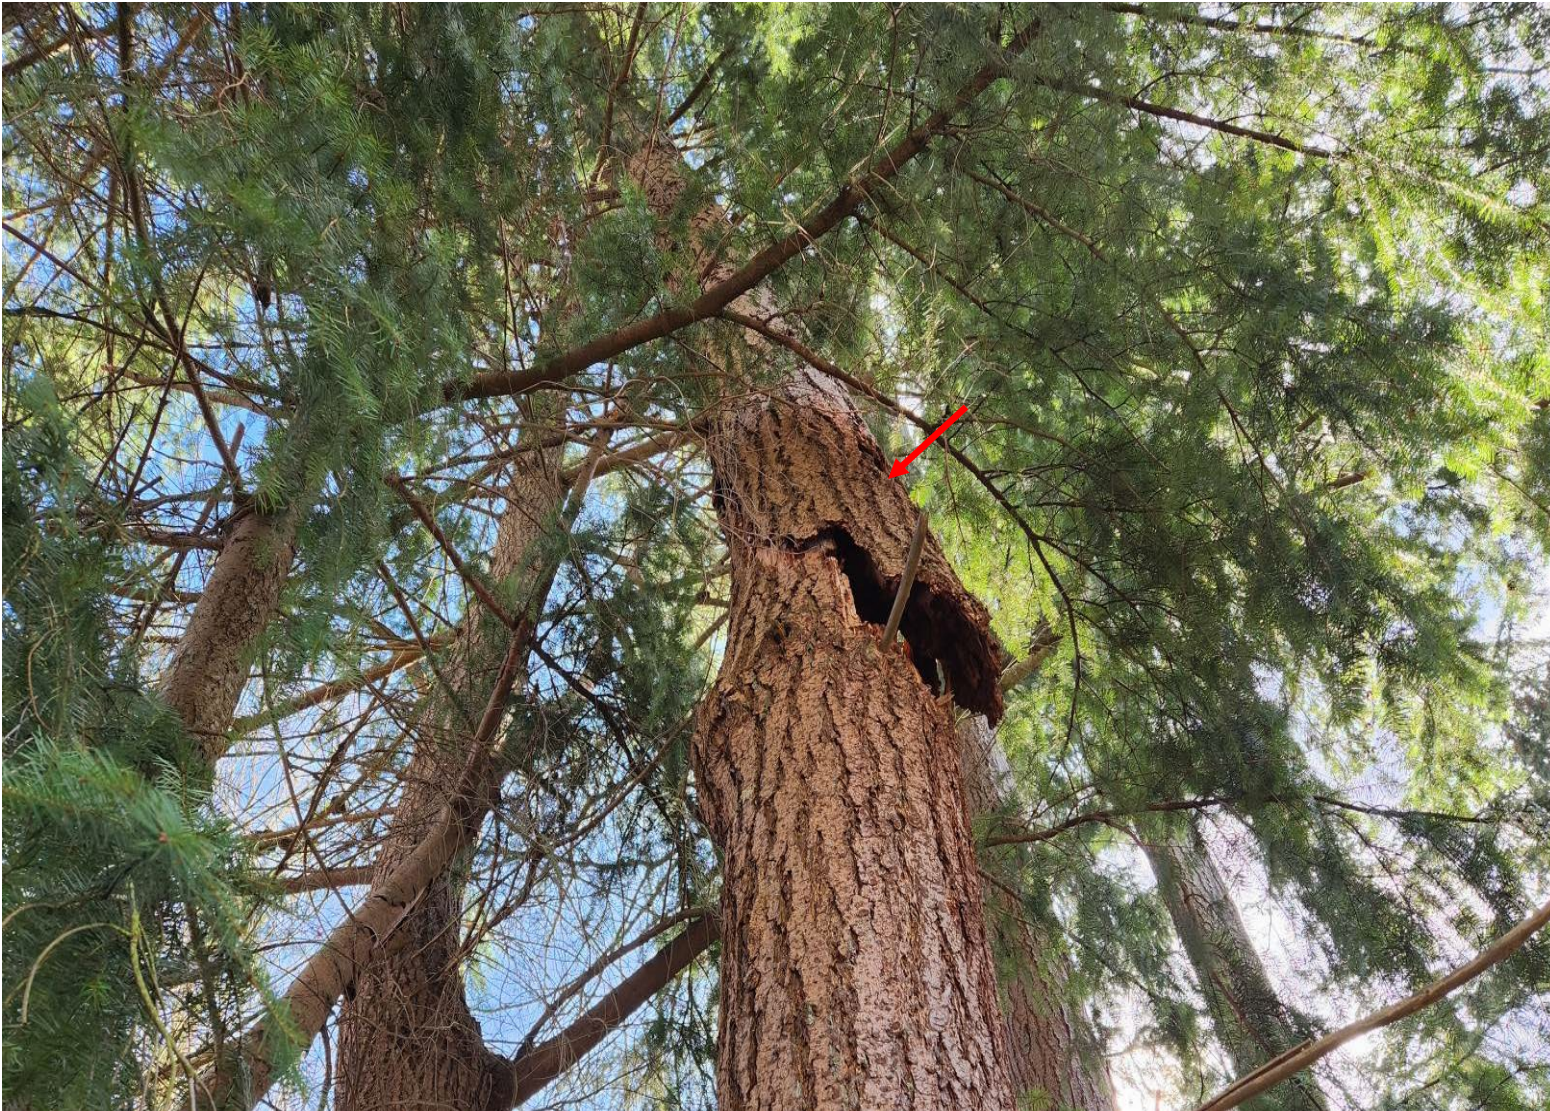
Figure 6: Partially failed Douglas-fir.
