**GEOTECHNICAL HAZARDS REPORT
DPA1 UPDATE – GIBSONS OFFICIAL
COMMUNITY PLAN
TOWN OF GIBSONS, BC**

CLIENT: TOWN OF GIBSONS

PREPARED BY:
RAM ENGINEERING LTD.

NOVEMBER 12, 2025
OUR FILE: 122-5203

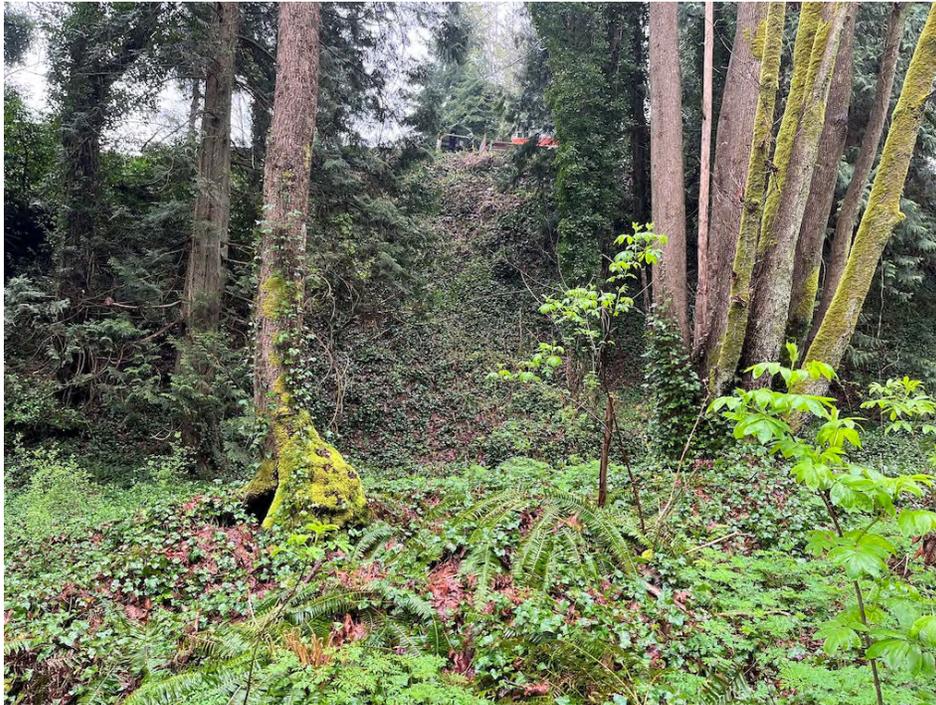
Photo 1: April 26, 2023. Looking south (upslope) at the southwest ravine slope of Gibsons Creek just upstream of Marine Drive. The slope area lacking trees and dominated by English Ivy is identified in the DPA 1 Schedule C as “Adverse Fill Area”.

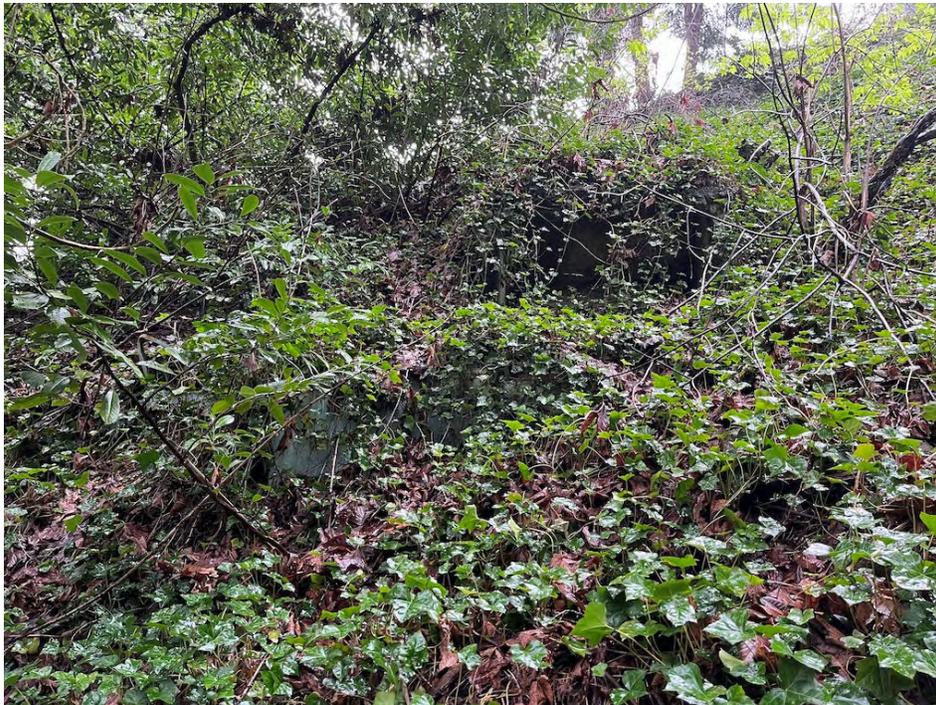
Photo 2: April 26, 2023. Looking south (upslope) at the southwest slope of the Gibsons Creek ravine just upslope of Marine Drive at the “Adverse Fill Area”. Garbage was observed under the English Ivy.

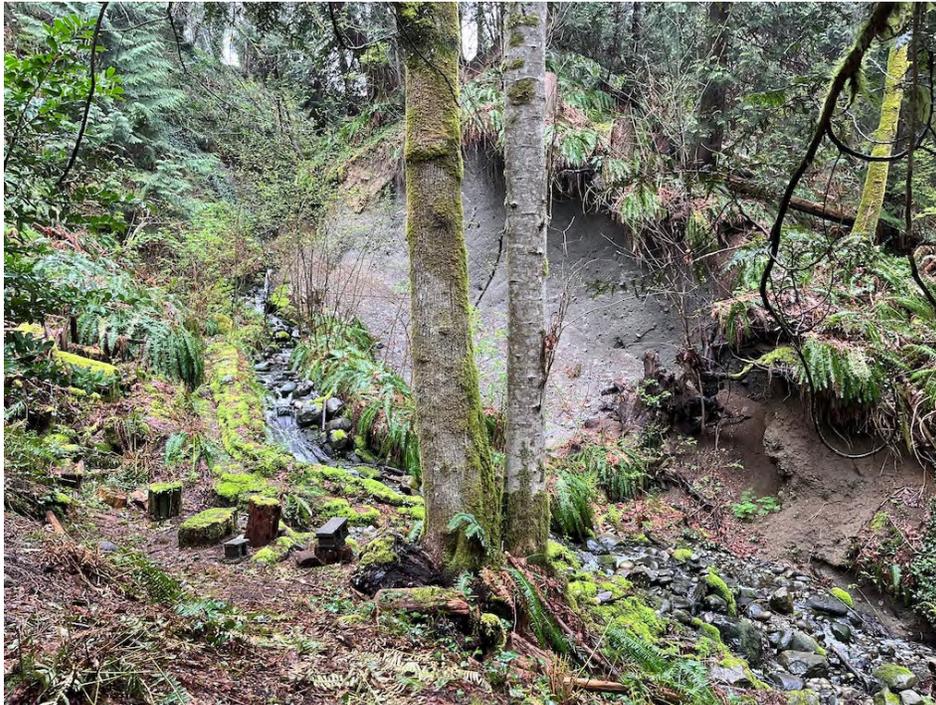
Photo 3: April 26, 2023. Looking upstream on a tributary of Gibsons Creek located near Gibsons Way. A slope failure occurred on the left (north) bank slope of the tributary. The failure is 44 m long and 8 m high.

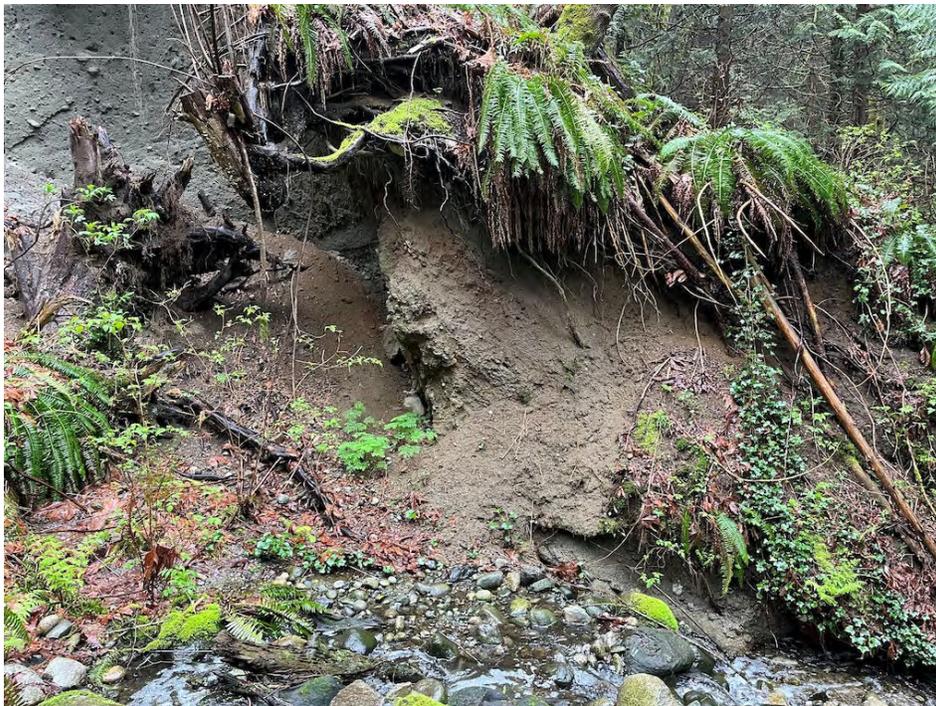
Photo 4: April 26, 2023. Looking north at the slope failure on the left (north) bank of the Gibsons Creek tributary near Gibsons Way showing a recently uprooted tree from the crest of the failure.

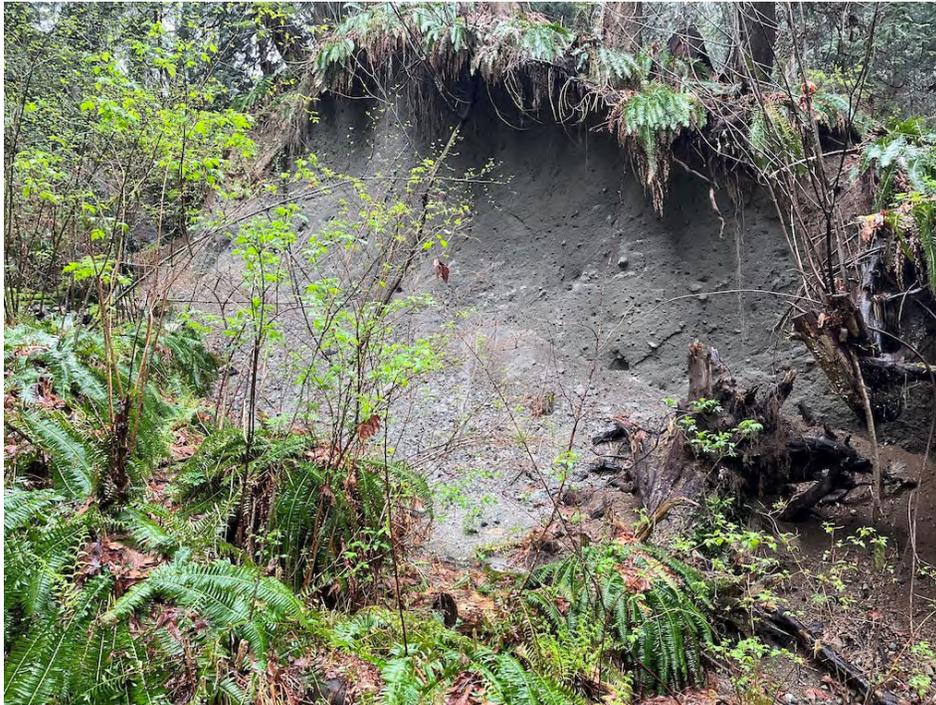
Photo 5: April 26, 2023. Looking north at the slope failure on the left (north) bank of the tributary on Gibsons Creek near Gibsons Way.

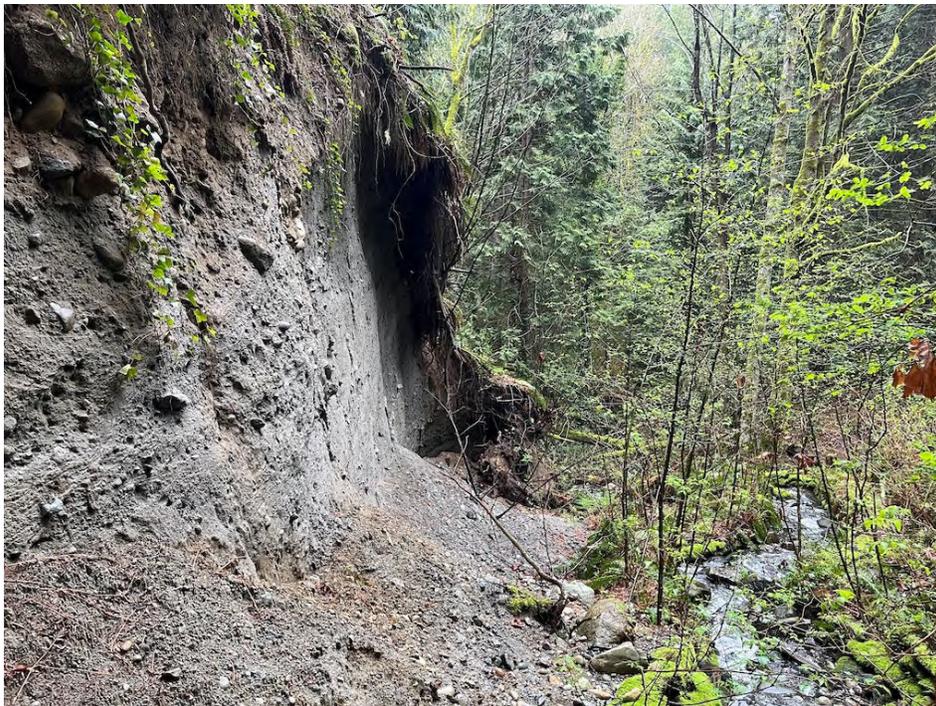
Photo 6: April 26, 2023. Looking downstream at the slope failure on the left (north) bank slope of the Gibsons Creek tributary near Gibsons Way.

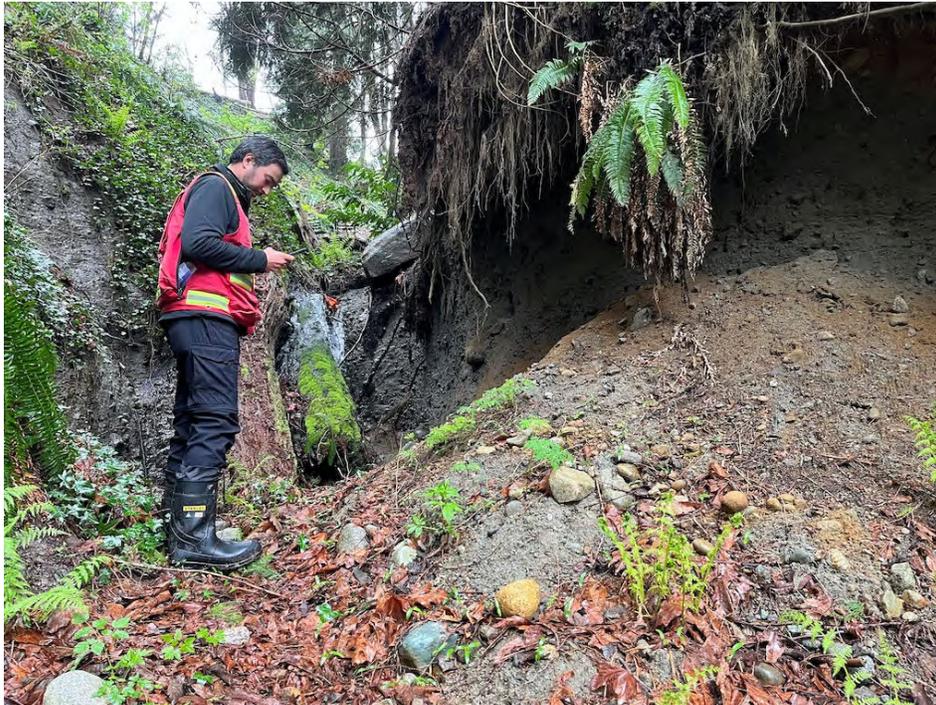
Photo 7: April 26, 2023. Looking upstream on the Gibsons Creek tributary near Gibsons Way at the upstream end of the slope failure on the left (north) bank slope.

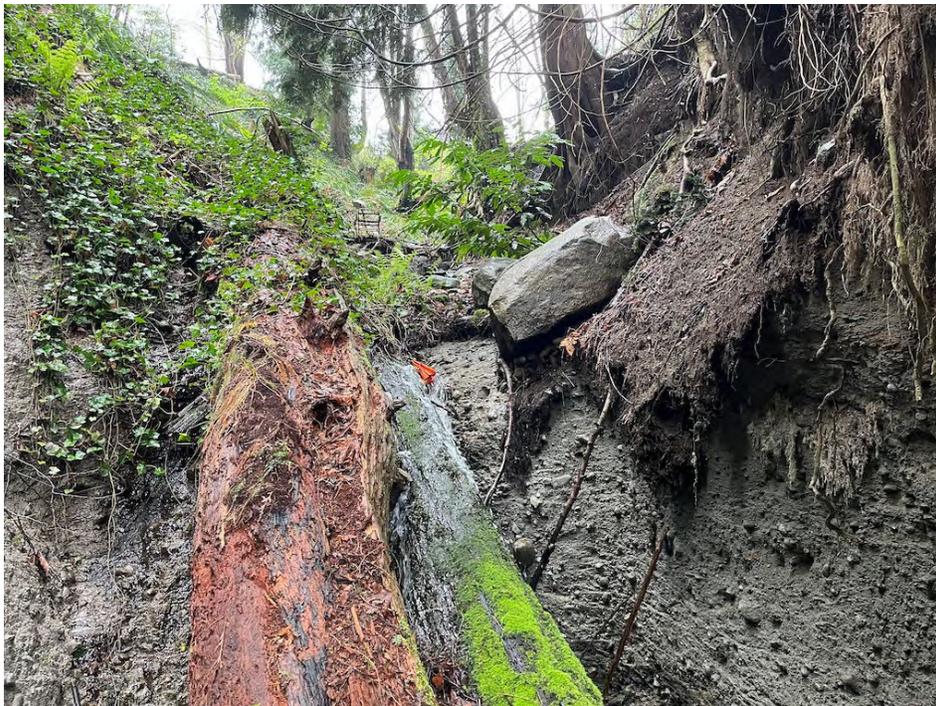
Photo 8: April 26, 2023. Looking upstream on the Gibsons Creek tributary near Gibsons Way at the upstream end of the slope failure on the left (north) bank slope.

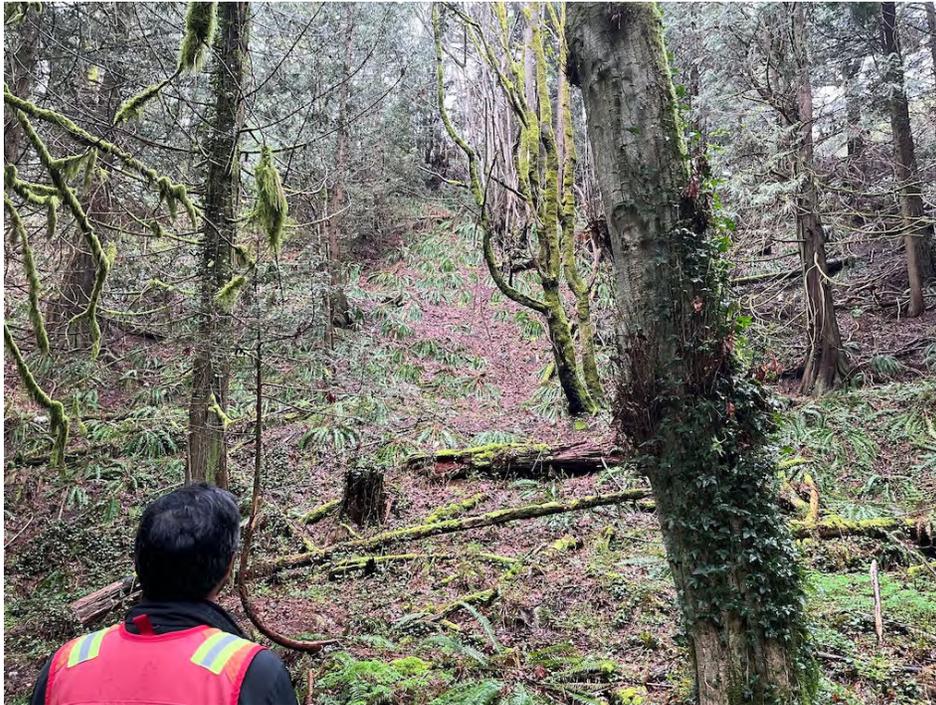
Photo 9: April 26, 2023. Looking south (upslope) at the southwest ravine slope of Gibsons Creek adjacent to the Hillcrest Road area. The area on the slope void of trees suggests an old, disturbed area either by intentional clearing or a slope failure.

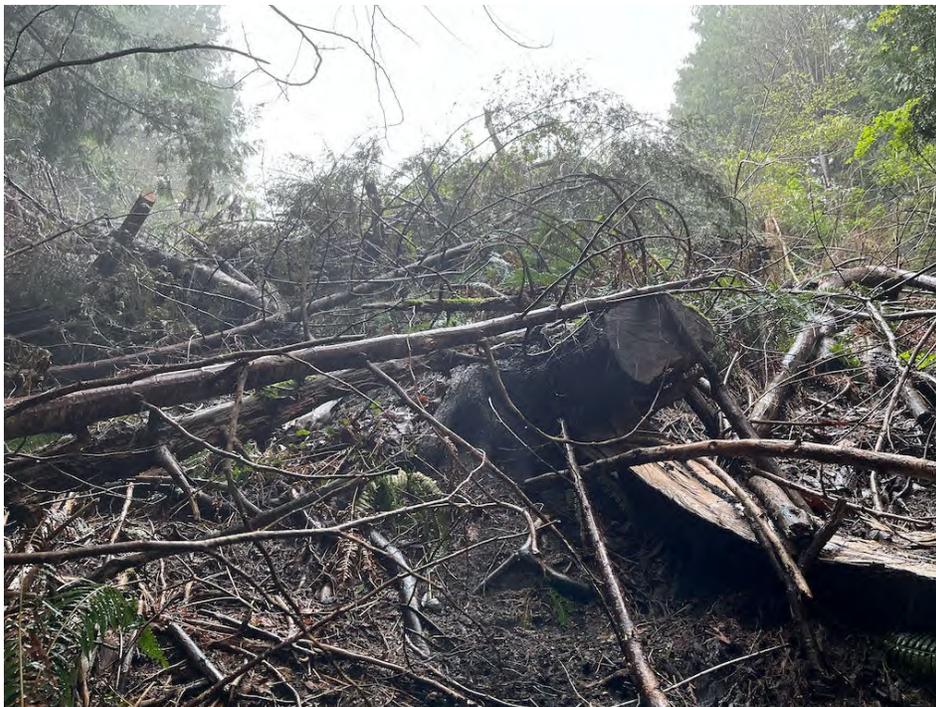
Photo 10: April 26, 2023. Looking west (upslope) on the southwest slope of the Gibsons Creek ravine where clearing of ravine slope crest has occurred in the Tricklebrook Way area. Fallen trees have been left on slope.

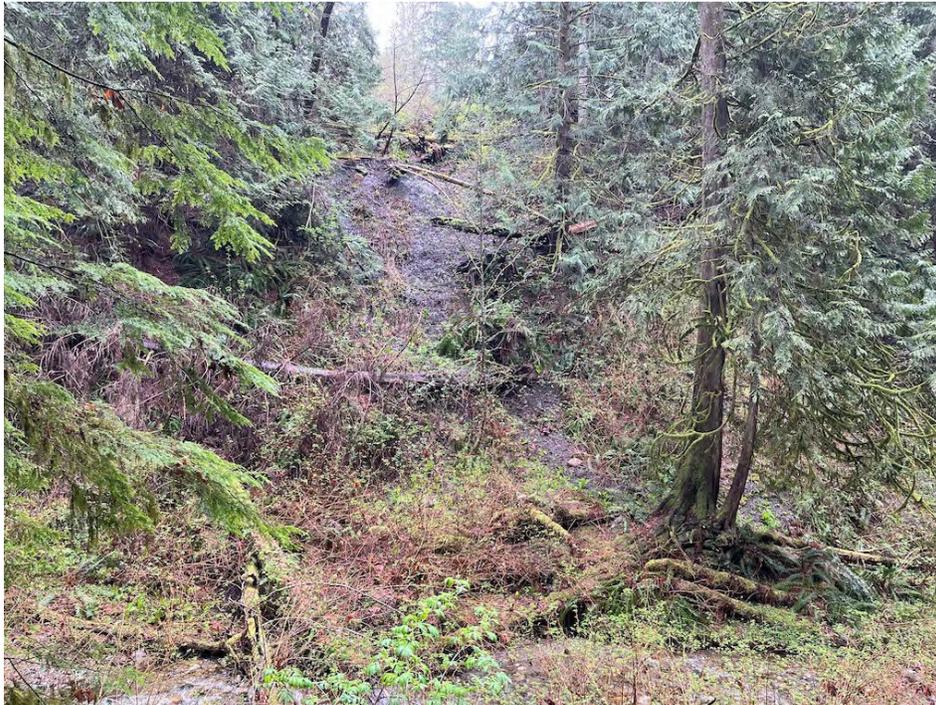
Photo 11: April 26, 2023. Looking west (upslope) at the west ravine slope of Gibsons Creek in the Creekside Crescent area showing a disturbed portion of the slope.

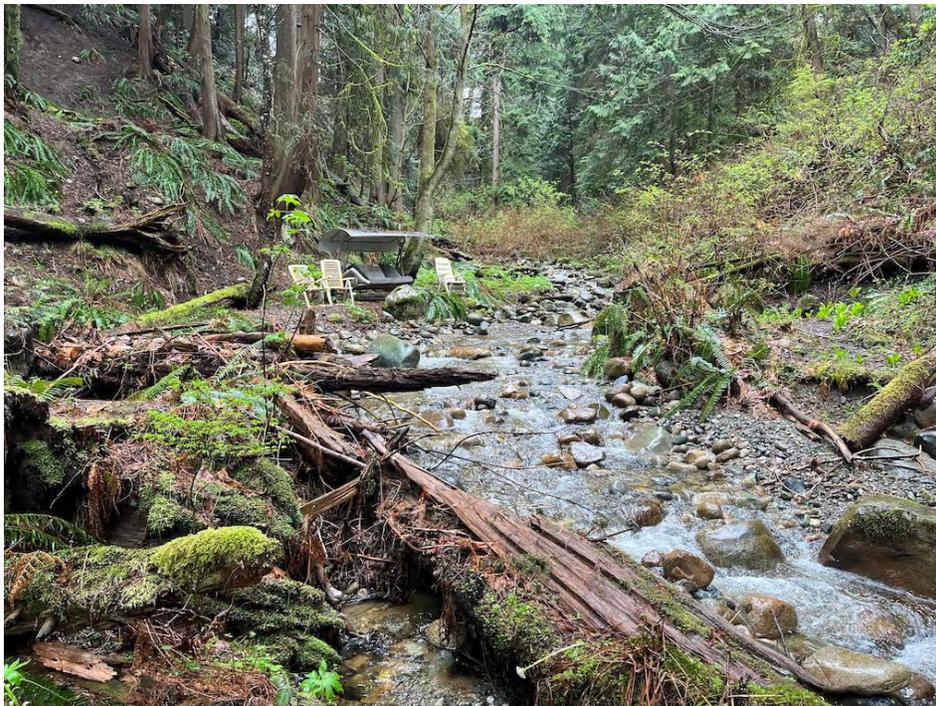
Photo 12: April 26, 2023. Looking upstream on Gibsons Creek where lawn chairs have been set up along the creek near Mountainview Drive. Note the oversteepened exposed slope above the chairs.

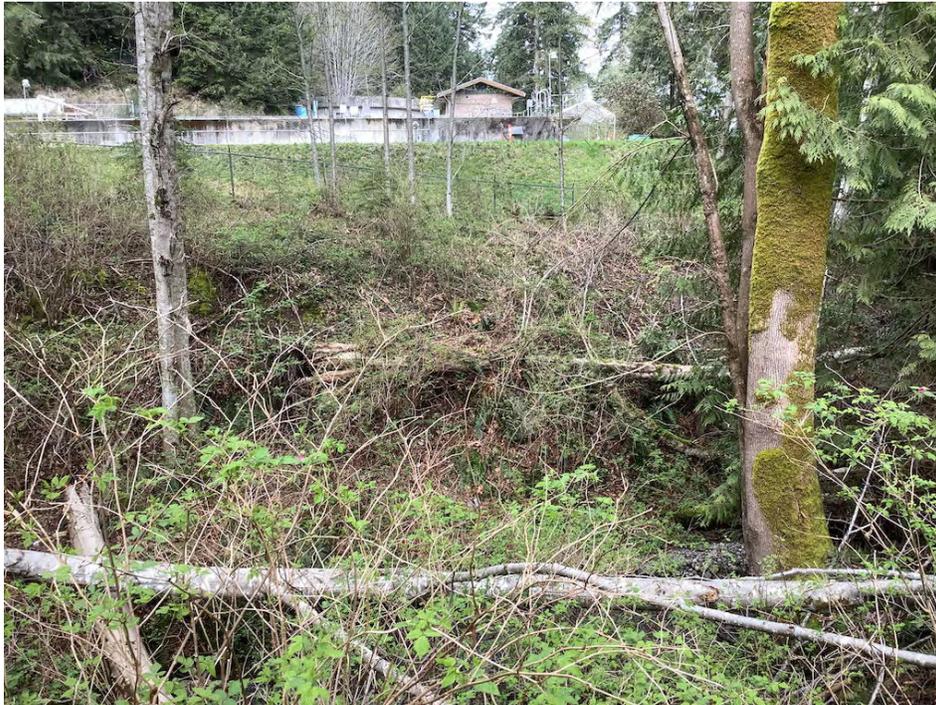
Photo 13: April 26, 2023. Looking north from Charman Creek at the north ravine slope just upstream of Stewart Road at the site of “Adverse Fill Area” as identified in the DPA 1 Schedule C.

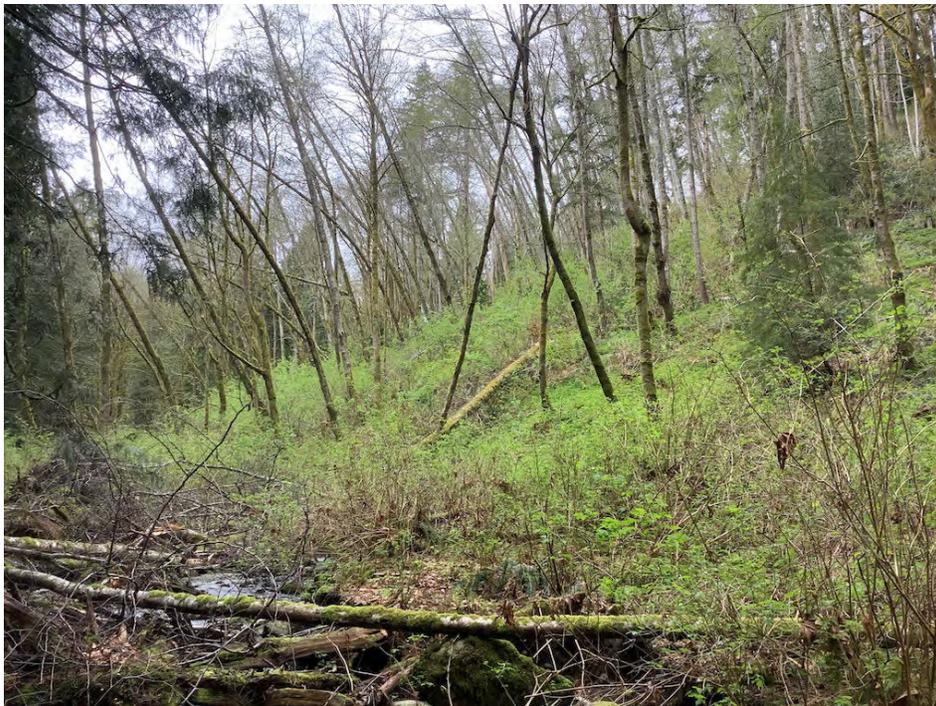
Photo 14: April 26, 2023. Looking upstream on Charman Creek 300 m upstream of Gower Point Road showing the left (north) bank ravine slope dominated by a young deciduous forest with an established understory. This forest area is unique to the rest of the ravine suggesting this slope may have been cleared.

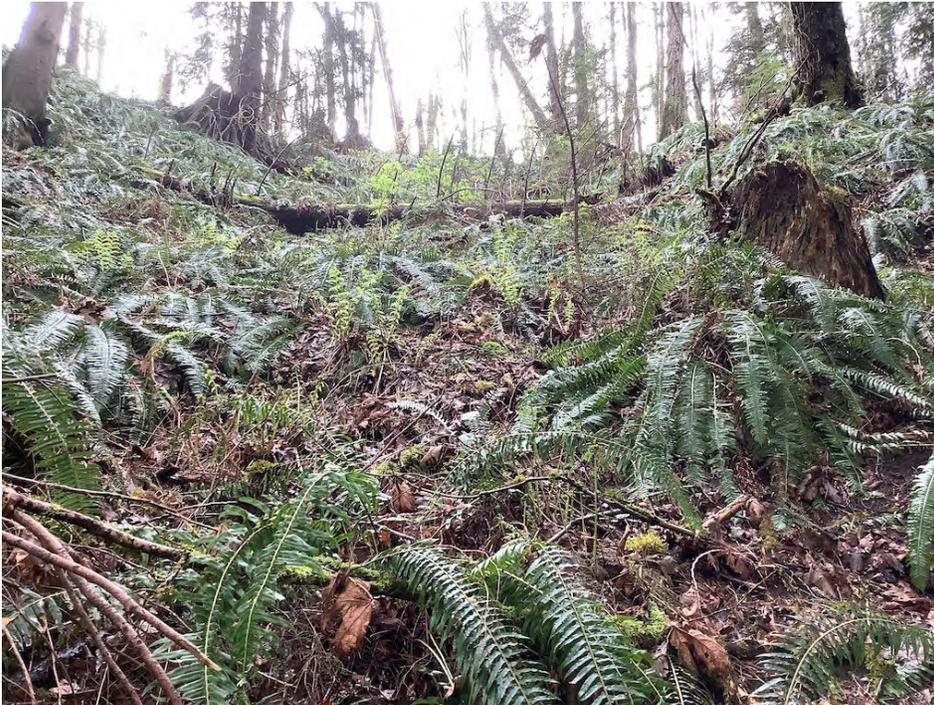
Photo 15: April 26, 2023. Looking upslope (south) on a wide gully on the right bank of Charman Creek north of Shaw Road. The lack of mature forest in this gully suggests it may have been intentionally cleared or it's the location of a slope failure.

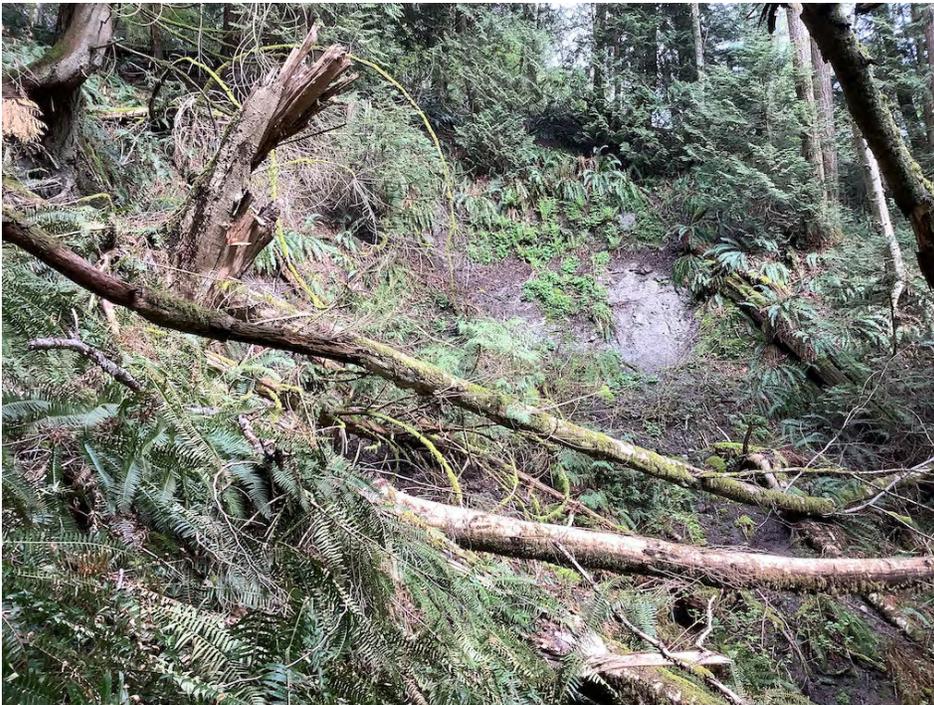
Photo 16: April 26, 2023. Looking upslope (north) at a slope failure near the crest of the north ravine slope south of Shaw Road adjacent to Inglis Trail.

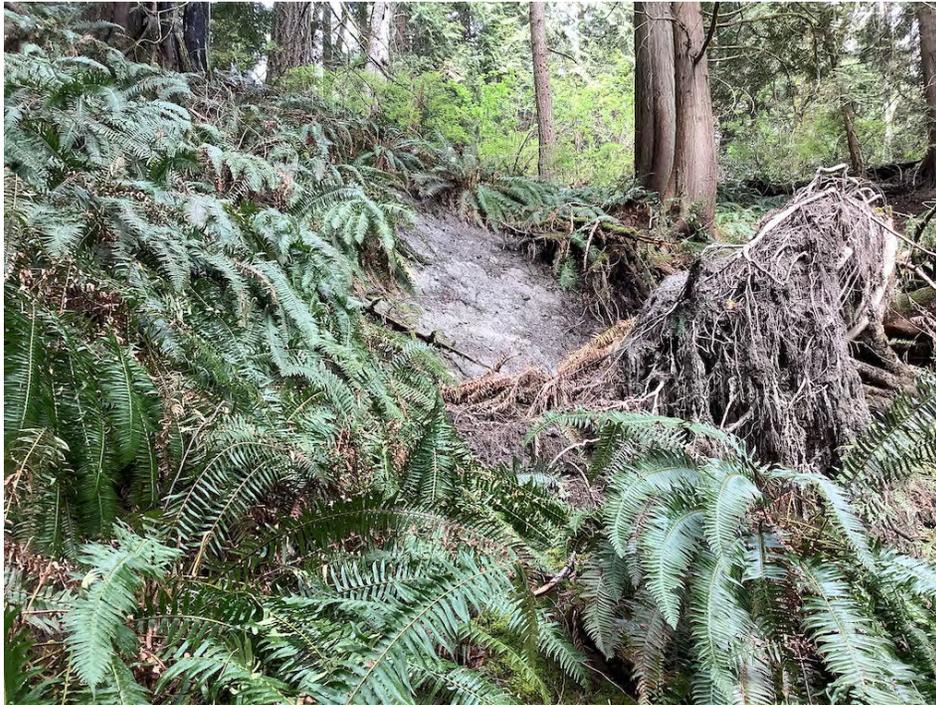
Photo 17: April 26, 2023. Looking upslope (north) at a slope failure near the crest of the north ravine slope south of Shaw Road adjacent to Inglis Trail. Note the large root bulb that has been mobilized.

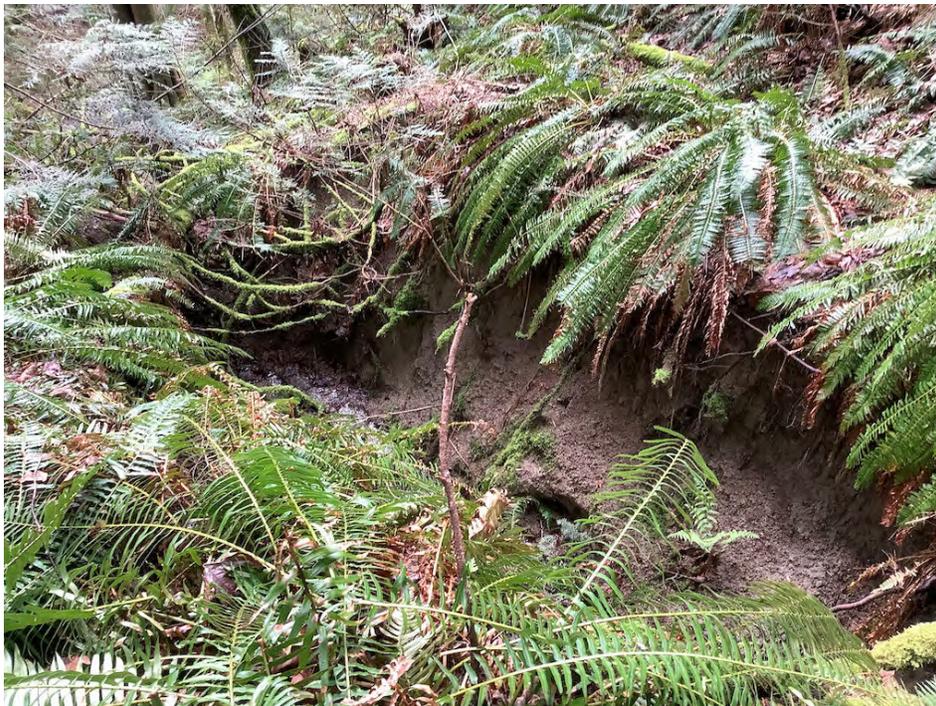
Photo 18: April 26, 2023. Looking west across a deep and narrow eroded gully on the north ravine slope south of Shaw Road adjacent to Inglis Trail.

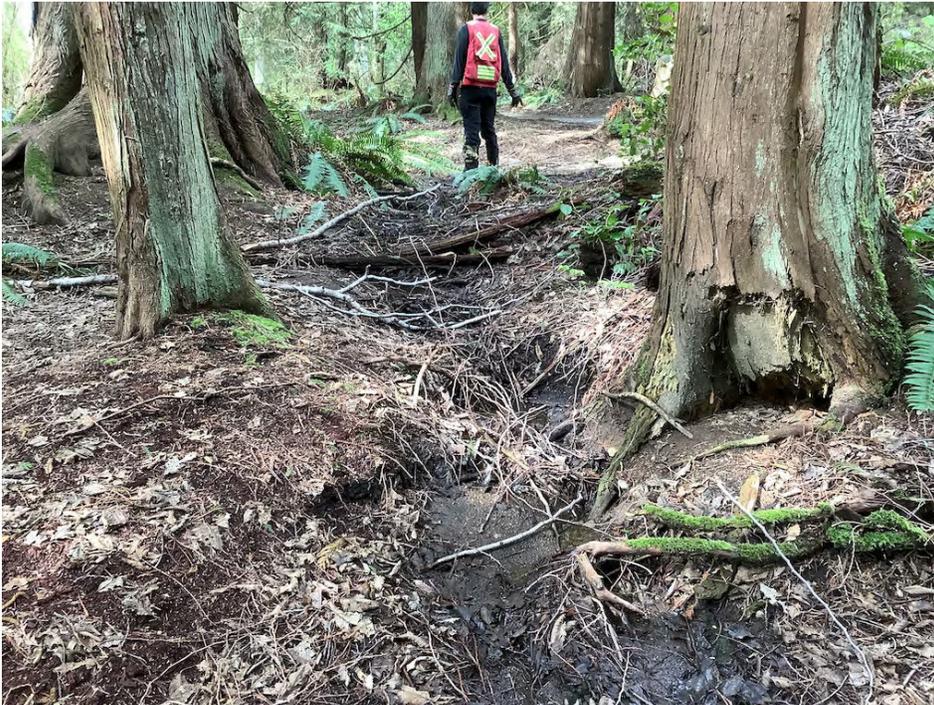
Photo 19: April 26, 2023. Looking upslope (north) at the crest of the north ravine slope adjacent to Inglis Trail at a channel draining ditches for the trail. Flow from this channel caused the eroded gully in the previous photo.

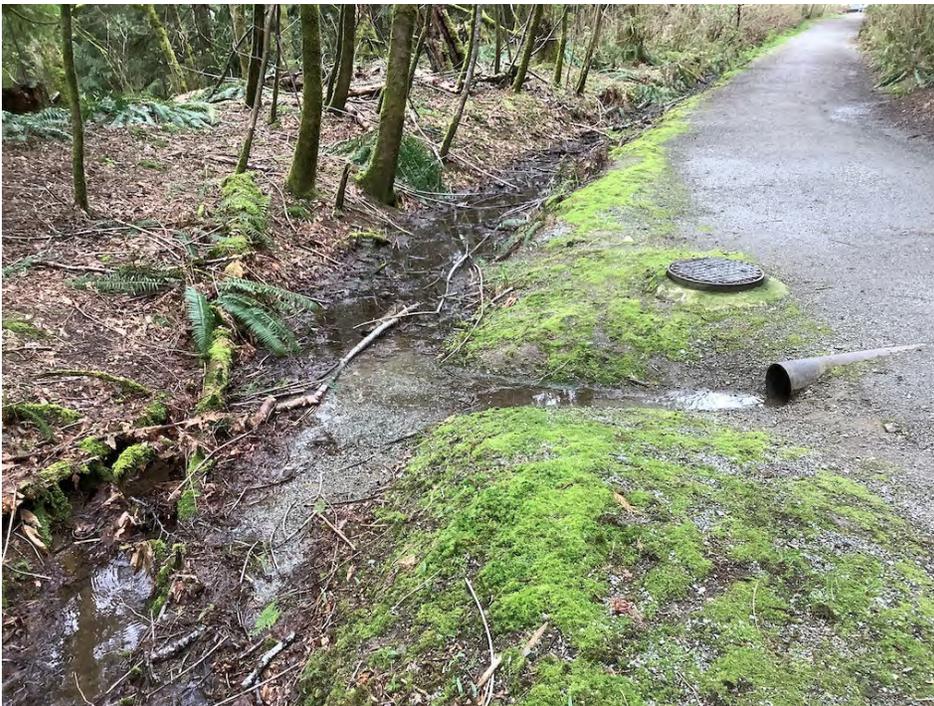
Photo 20: April 26, 2023. Looking north along the Inglis Trail south of Shaw Road showing the culvert and ditch runoff from the trail that drains to the channel down the slope shown in the previous photo. The ditch extends north to Shaw Road.

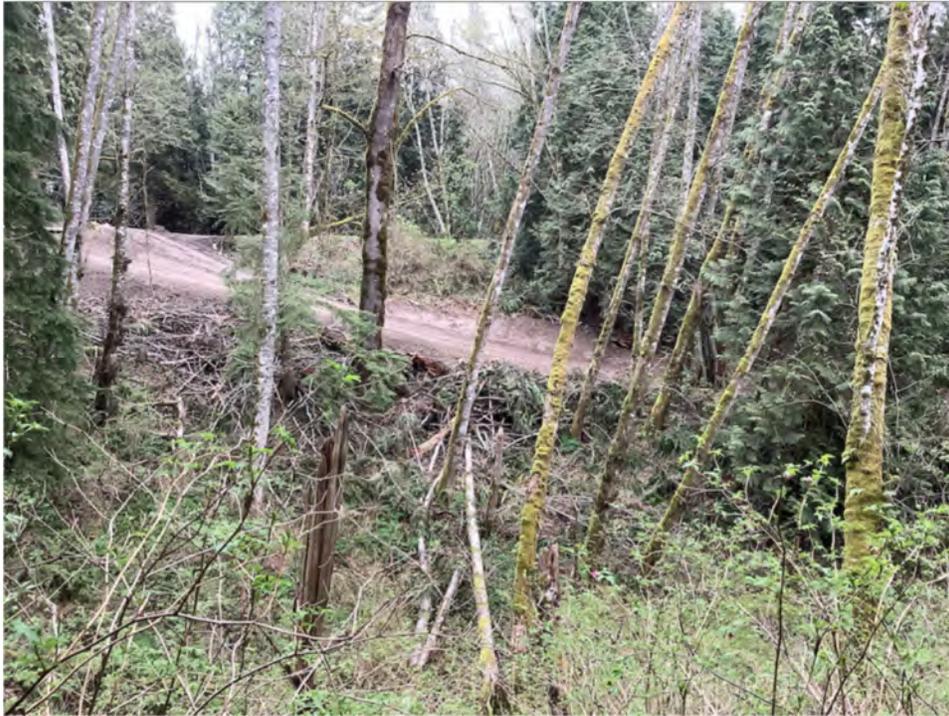
Photo 21: April 26, 2023. Looking east (upslope) at a newly constructed road on the east ravine slope on Charman Creek between the confluence with the East Tributary and Inglis Road.
