# DEVELOPMENT PERMIT

No. **DP- 2021-09**

May 10, 2021

## **Condition and Impact Assessment Report – 575 Gower Point Rd**

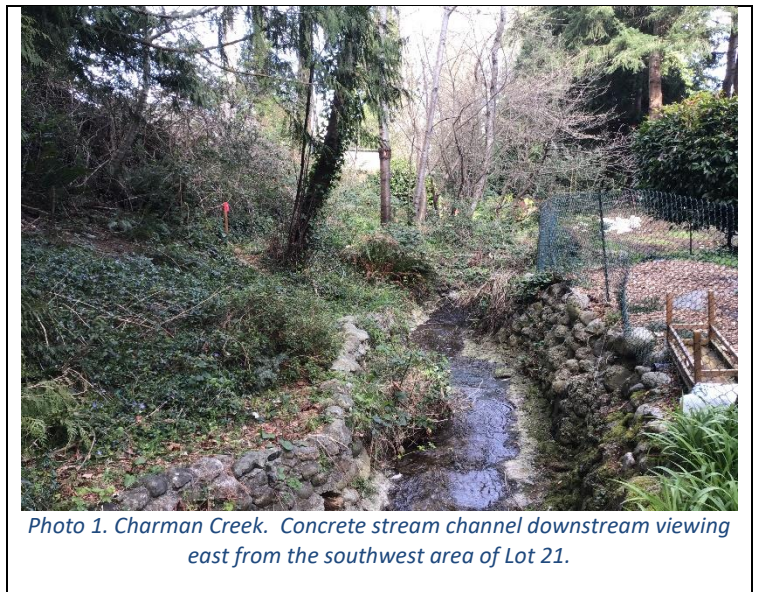
Previous owners have concreted the channel throughout the lot, which has the effect of accelerating flow, covering natural channel substrates, and confining the channel (Photo 1).

Photo 1. Charman Creek. Concrete stream channel downstream viewing east from the southwest area of Lot 21.

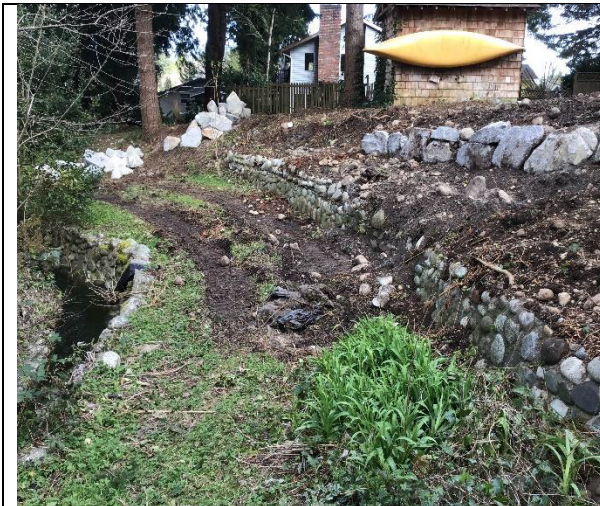
The riparian zone on the southern bank has been landscaped into several tiered benches defined by several low rock walls (Photos 2 & 3). Most of this work pre-dates the current owners. The south riparian area has recently been disturbed during construction activities as part of works to install a rock retaining wall and level bench areas. In the disturbed area, streamside vegetation is mainly an open mix of landscape cover species

*Photo 2. Viewing east at south bank. Pre-existing lower tier landscaping wall is visible.*

The riparian area adjacent to Charman Creek on the south side was levelled and contoured adjacent to the concreted stream channel sometime in the 1990's. A lower tier 2-3' mortared river rock retaining wall has also been in place dating back to that timeframe and a previous owner (Photo 2).

Current conditions are that riparian soils below the pre-existing retaining wall and adjacent to the south bank have been partially disturbed by heavy equipment (Photos 2, 3 & 6), resulting in moderate rutting and tracking. A pre-existing margin or buffer of ornamental vegetation has been retained at the high-water mark (edge of concrete channel, which is helpful for filtering any sediment that might migrate though the disturbed area).

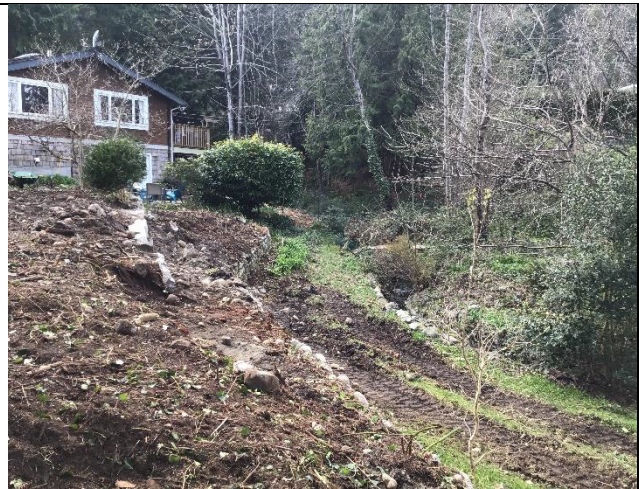
*Photo 3. Viewing west at south bank. Pre-existing lower tier landscaping and current disturbance is visible.*

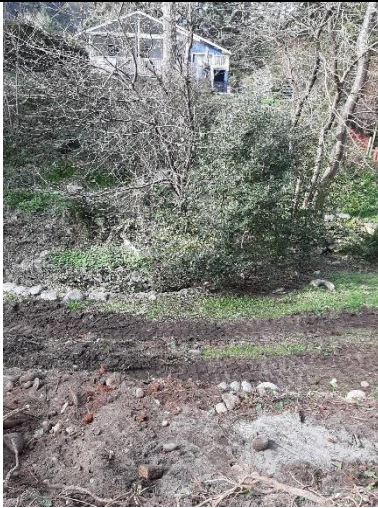
The northern riparian area has not been affected by this recent disturbance but has previously been subject to some manipulation of native vegetation to an open mix of native and non-native species (Photos 4 & 5).

Photo 4. North streambank.

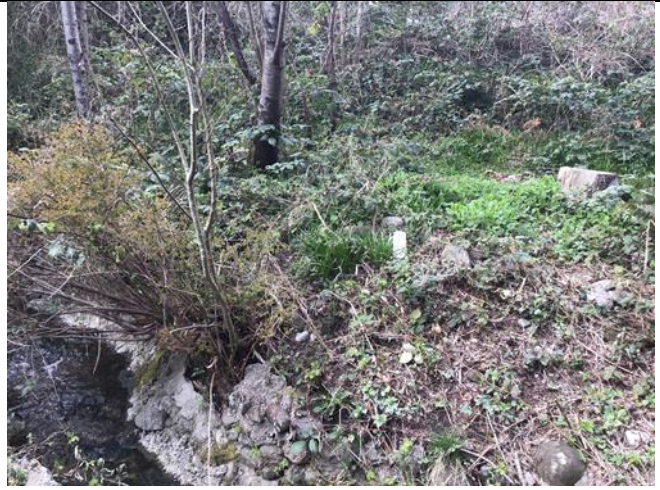
Photo 5. North streambank.

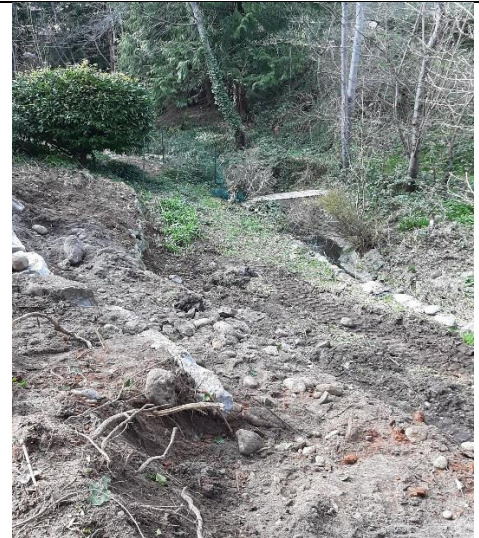
Photo 6. Overview of disturbed area, viewing northwest.

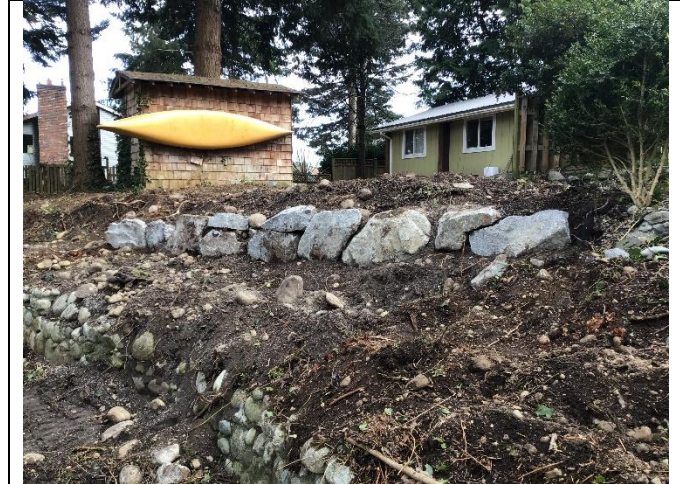
Further back from the high watermark on the south side, the riparian area has been cleared, grubbed, and stripped. A few preliminary coarse angular rocks have been placed as part of the current landscaping prior to works being halted (Photo 7).

*Photo 7. Current landscaping rock walls, partially installed.*

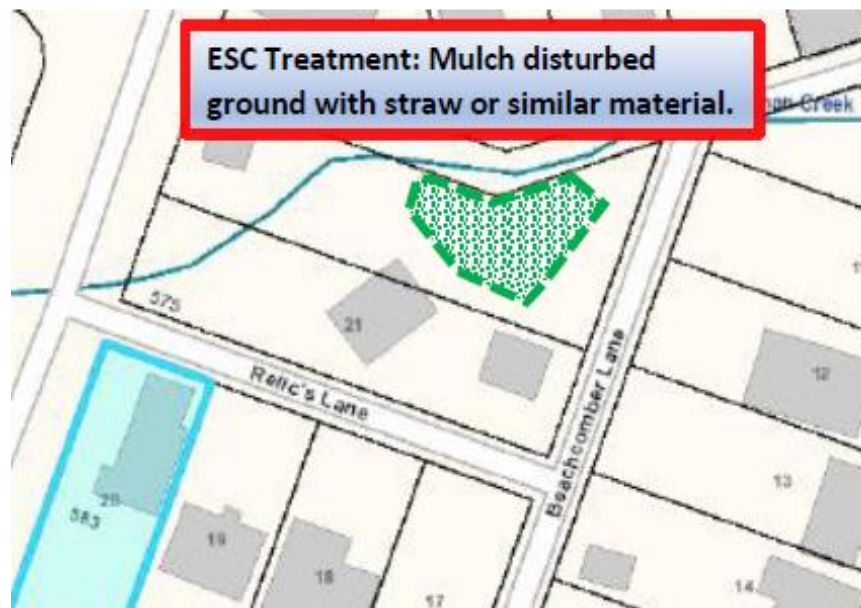
Figure 2. Erosion & Sediment Control Treatment Area

- The main potential hazard would be sediment delivery into the Charman Creek channel. The disturbed ground has a high silt/sand content, some areas of sloped ground and which potentially could erode and travel towards the

- watercourse in a heavy rainfall event. The catchment area is exceedingly small however, and there are no run-off sources directed at the disturbed slope. A simple, and the main ESC treatment, is to protect the ground surface from rainfall drop and rilling erosion.
  - Maintain vegetated margins at the edge of the stream bank to serve as sediment filters in the event sediment does move down slope and settles on the lower bench;
  - Cover disturbed ground with straw or comparable mulch or blanket;
  - Layer the mulch heaviest on the lower bench nearest to the watercourse; and,
  - For the long term, establish native species with a functioning root mat adjacent to the watercourse.
  - See Figure 2 – ESC Recommendations.
