# **ARBORIST REPORT**

#### North Rd Development

#### 718 North Rd. Gibsons, BC

November 29, 2023

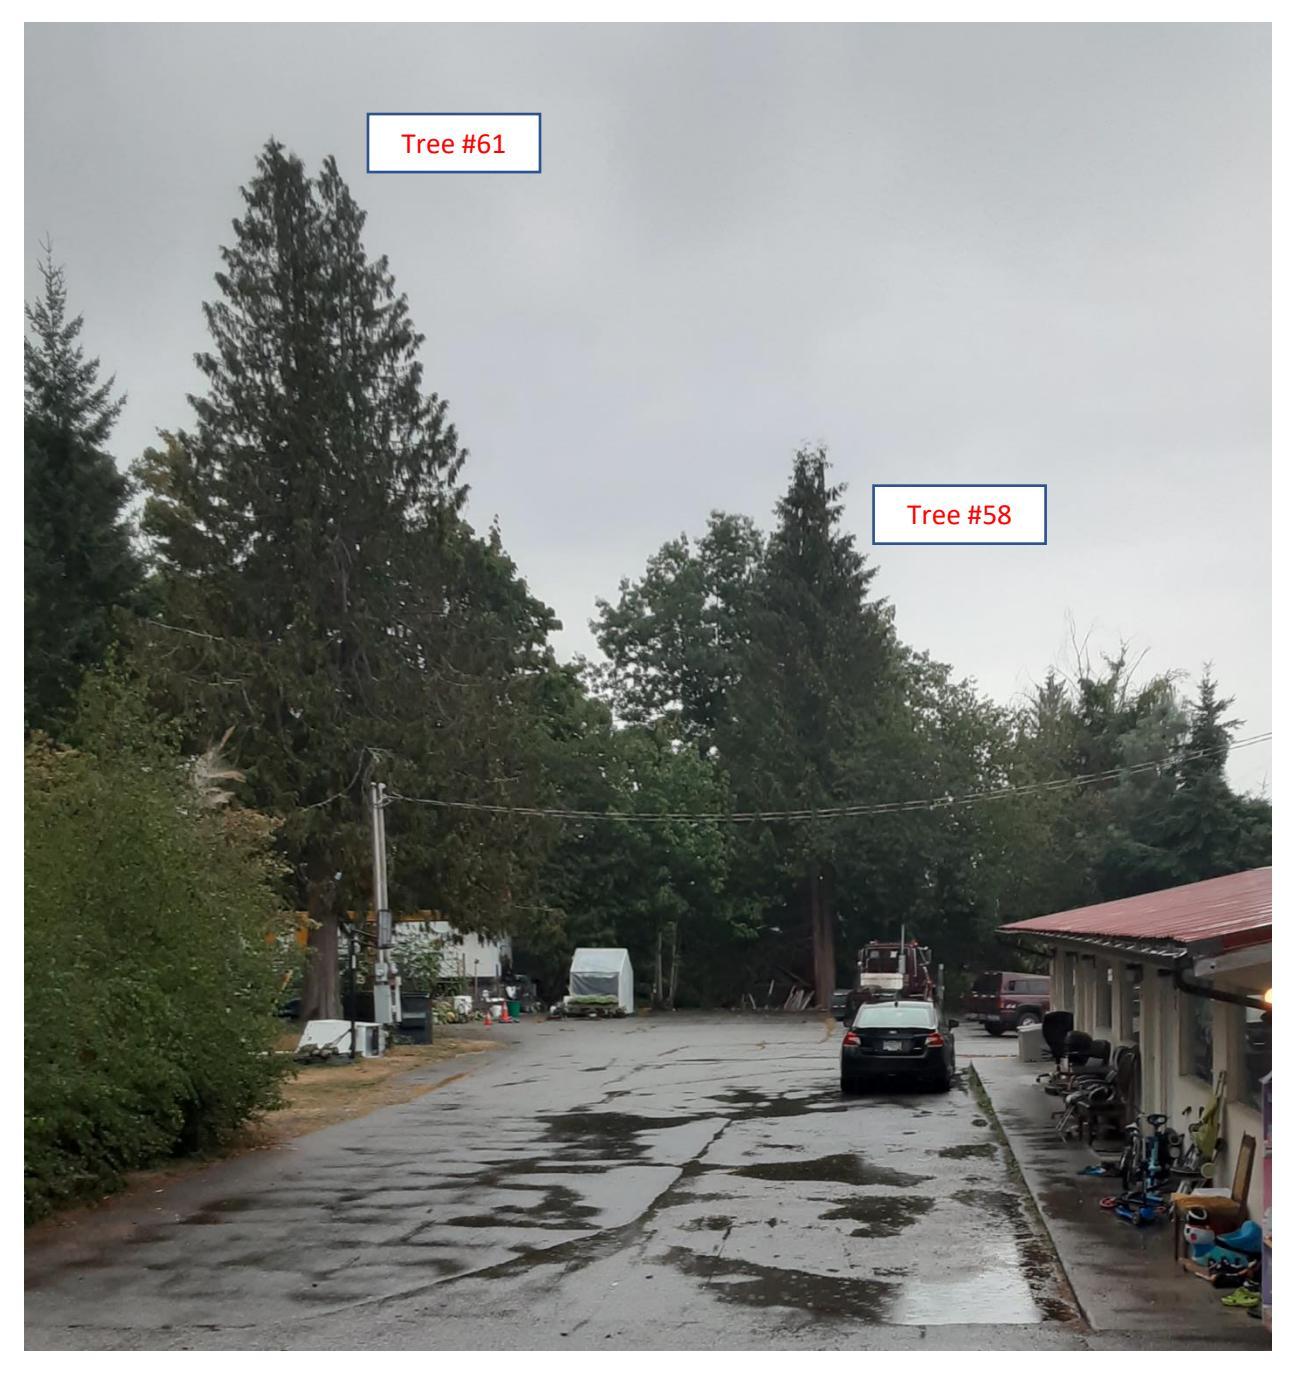
Photo 1 – Large Cedar trees, looking east from entrance to property.

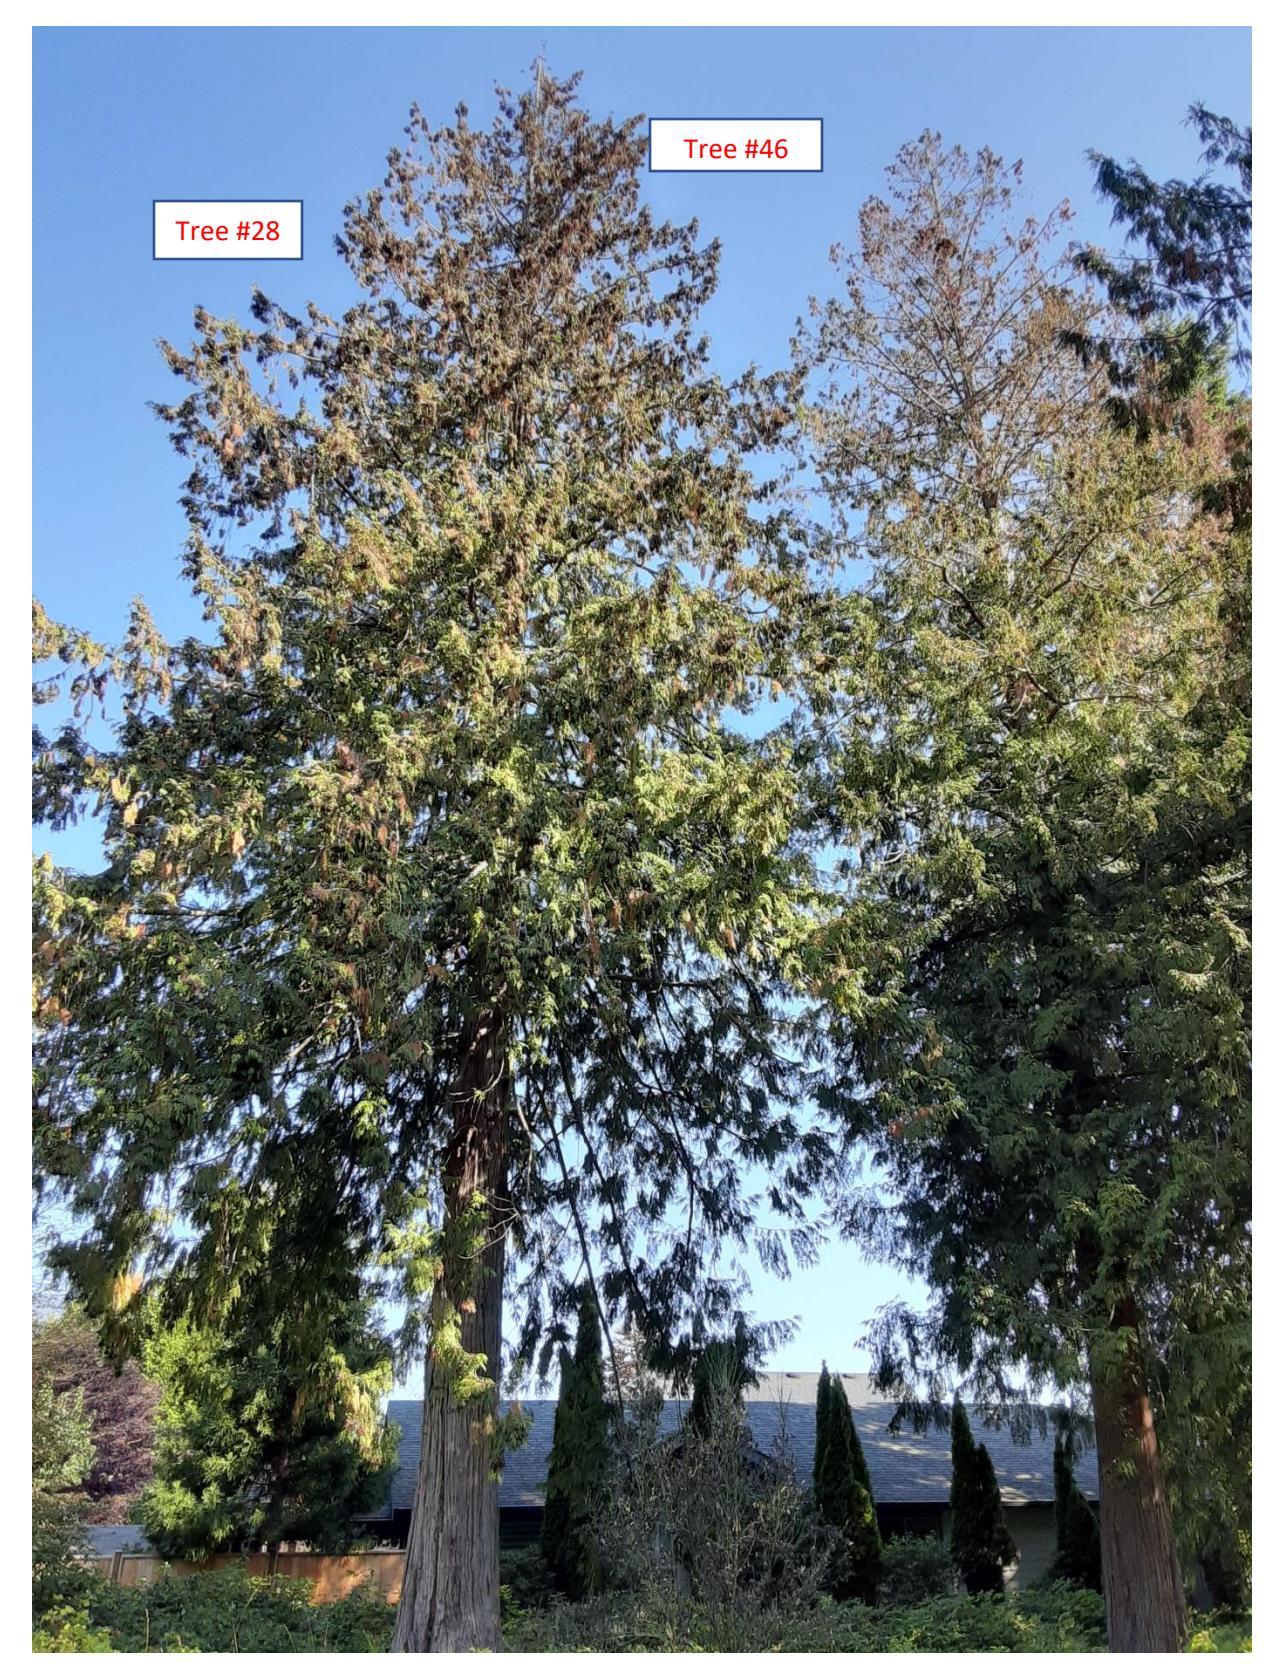
Photo 3 – Trees #28 & #46 with die back in upper crown.

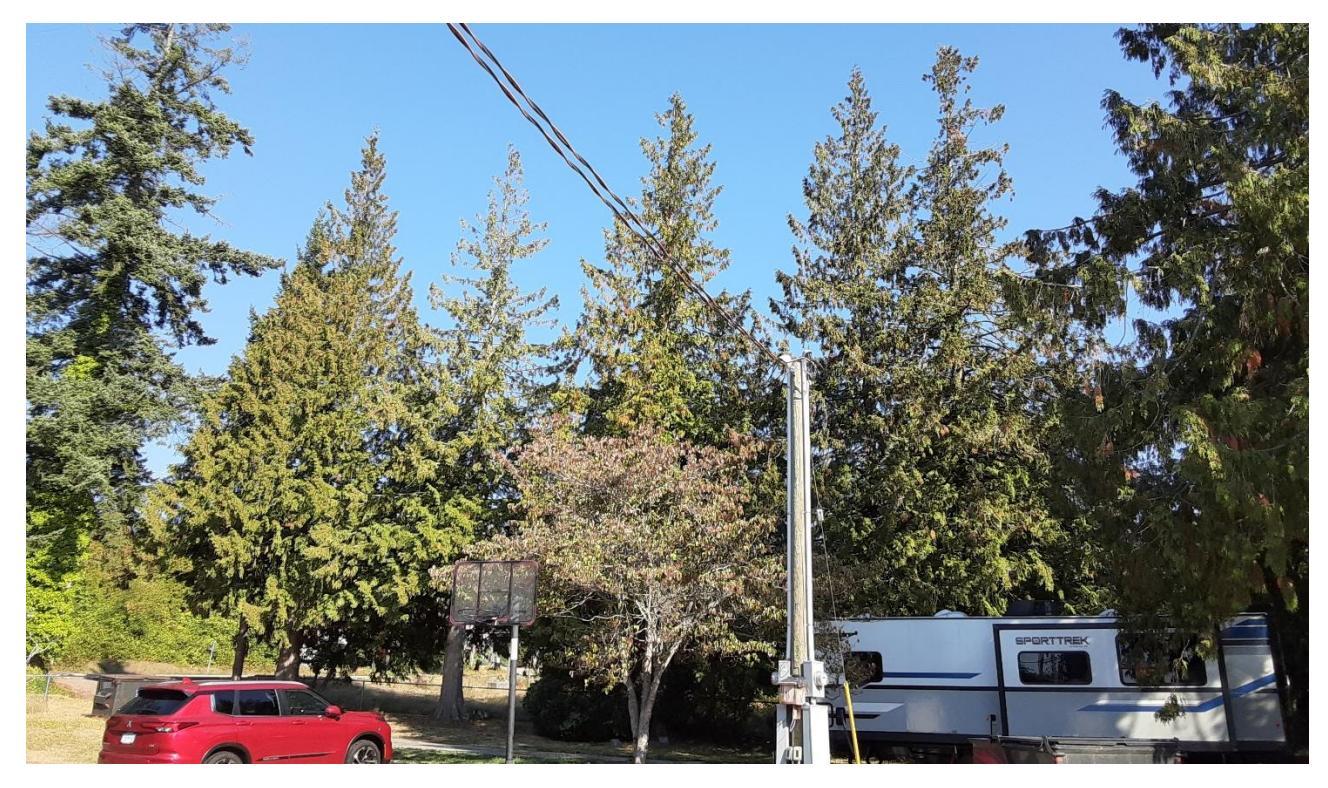
Photo 4 – Cedar trees (Trees #69 to #64) showing signs of upper canopy die back from drought stress.

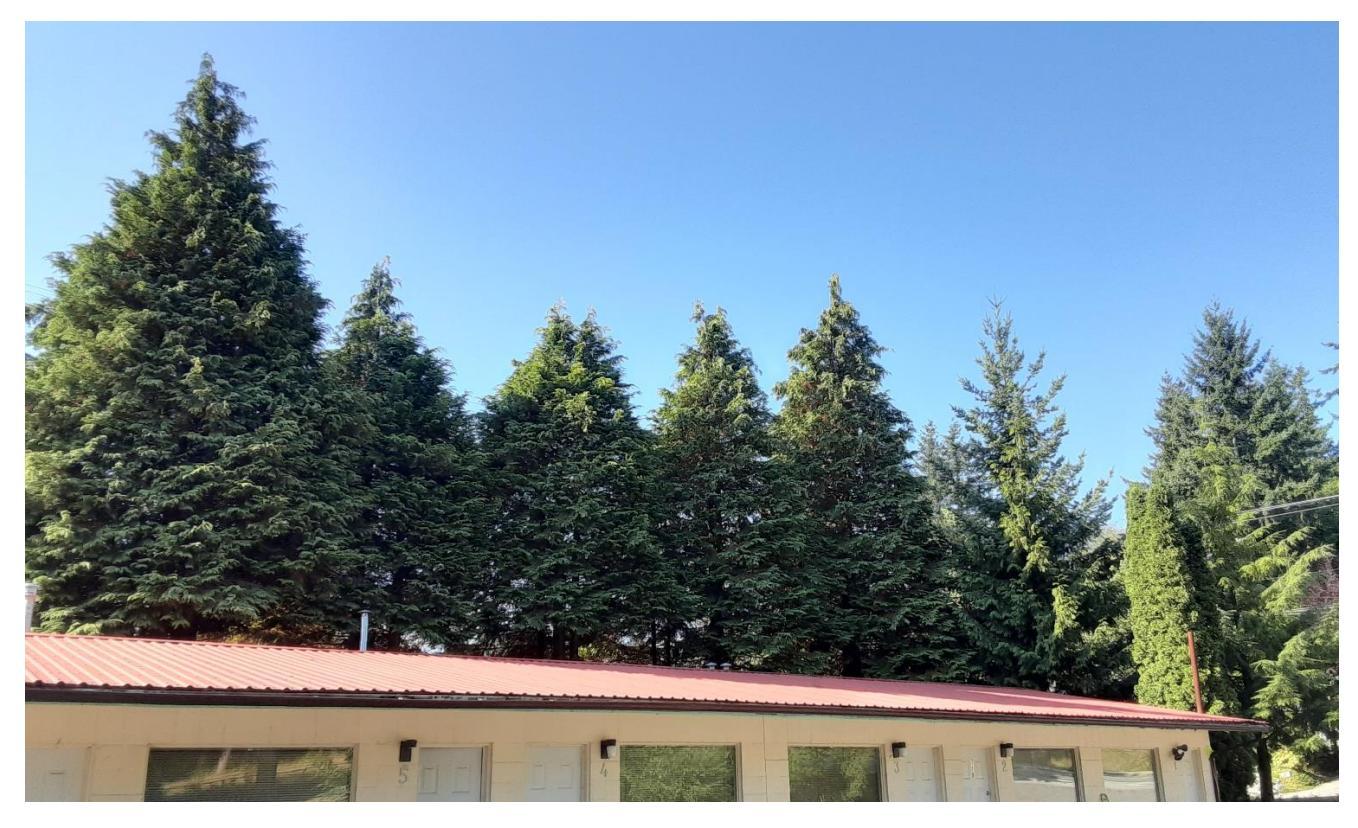
Photo 5 - Row of Zebrina Cedars (Trees #77 - #83) behind existing concrete building
