DEVELOPMENT PERMIT

NO. DP- 2018-12

GEOTECHNICAL ASSESSMENT

623 Gower Point Road, Gibsons, British Columbia

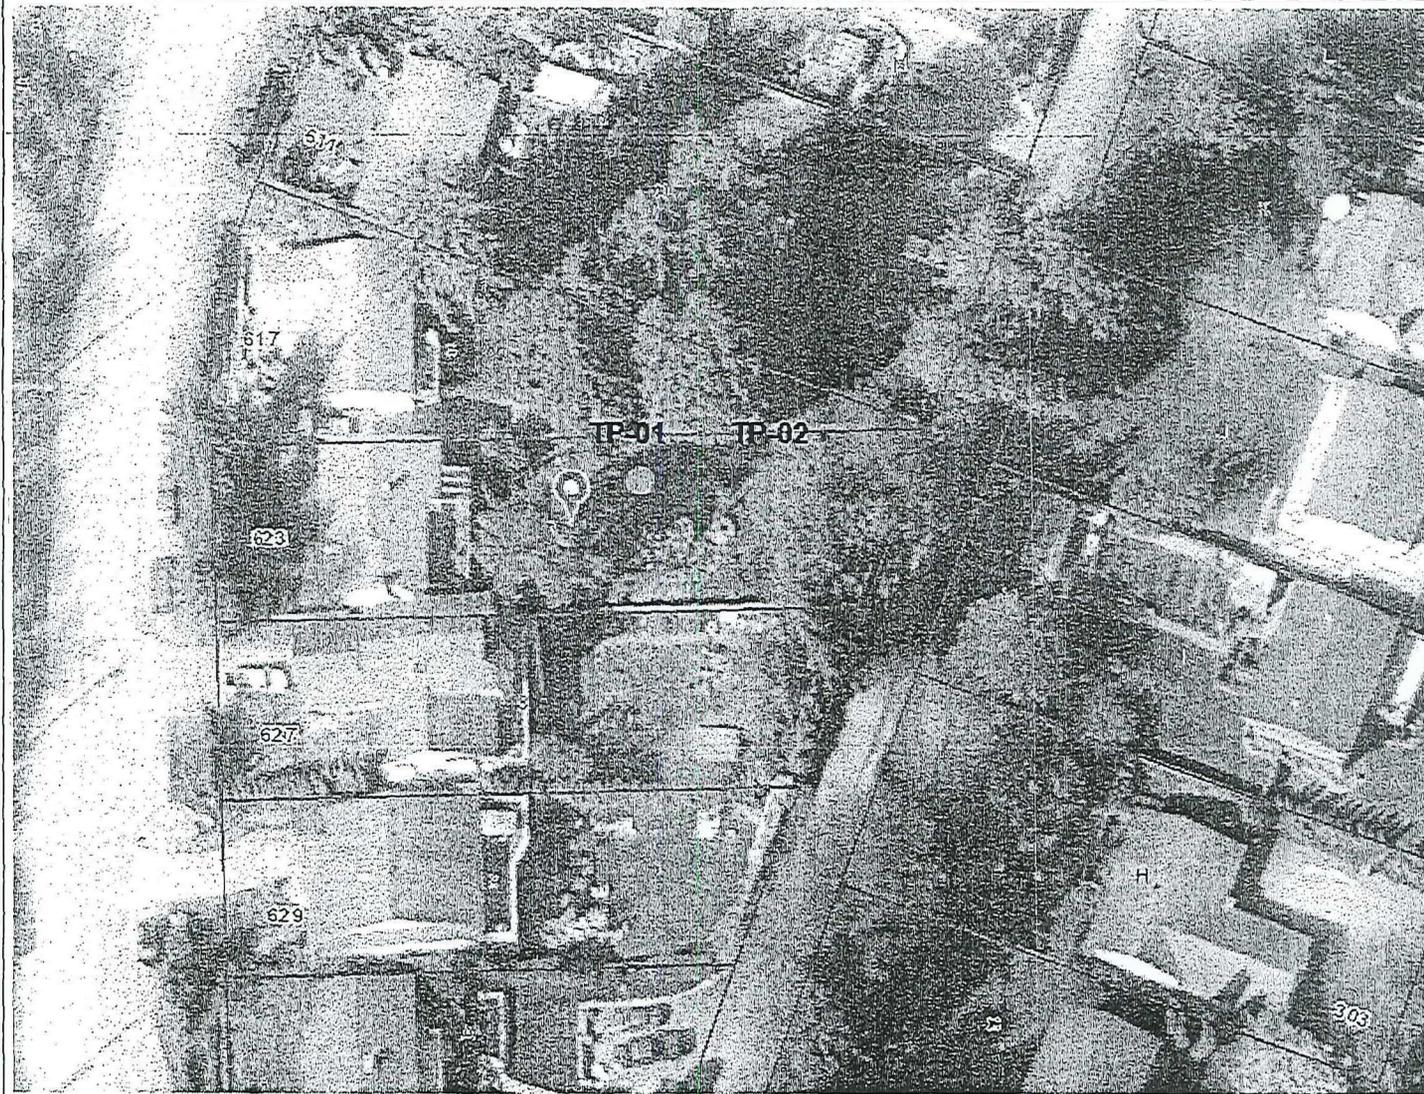
Test Pit Locations

The subsurface conditions on the subject site were investigated with two exploratory test pits. A location map of the test pits can be found within Appendix A of this document. This test pits were advanced with an excavator and extended to a maximum depth of 1.5 m below existing ground surface. Further suggestions of subsurface conditions and variations across the lot were obtained through hand probing and surficial observations conducted on the subject site. Detailed results of the subsurface investigation are presented on the attached Test Pit Log in Appendix B and a summary of the conditions encountered are provided in the following paragraphs.

Test Pit (TP)-01 was advanced approximately 17 m east of the northeast corner of the existing residence. The soils encountered during the excavation of TP-01 consisted of well graded granular fill which had particles sizes ranging from sand to cobble. TP-01 was advanced to a final depth of 1.5 m below ground surface. The fill material had increased moisture content with depth indicating that groundwater may be present beyond the final excavation depth. Although granular soils can wick moisture through capillary action, the client should be aware that saturated ground conditions could be a possibility while developing the lot.

TP-02 was advanced approximately 27 m east of the northeast corner of the existing residence. The subsurface conditions encountered while excavating TP-02 exposed similar granular fill as TP-01

As the design of the structure was in its preliminary stages during the assessment, it was unknown whether the test pits were advanced within the building envelope. Should the test pit fall within the building envelope, the material should be re-excavated and backfilled utilizing vibratory equipment and tested in 0.3 m lift sequences. A Test Pit Location Map can be found within Appendix A. Detailed Test Pit Logs can be found within Appendix C.

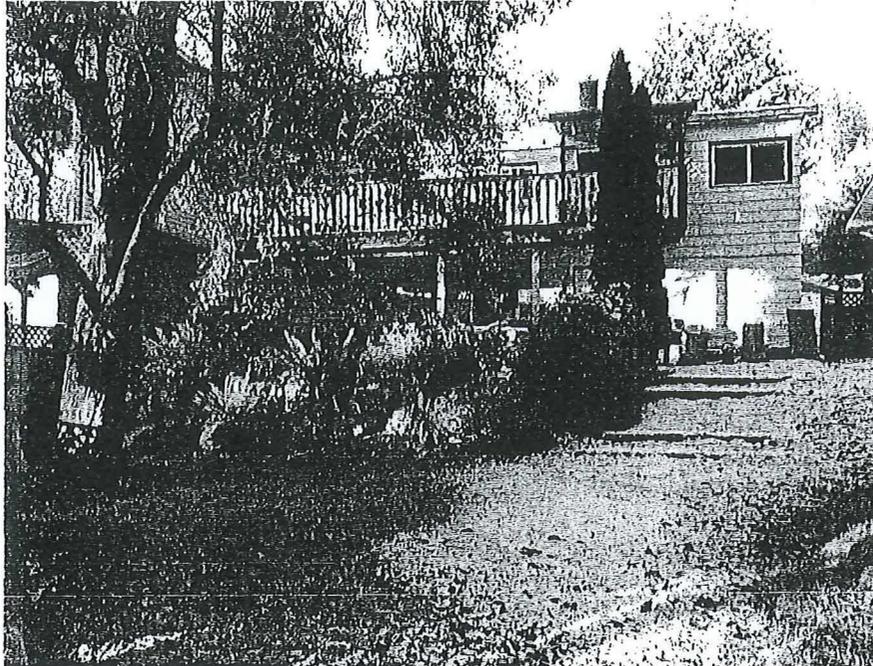
Photograph 1: Area of proposed development.

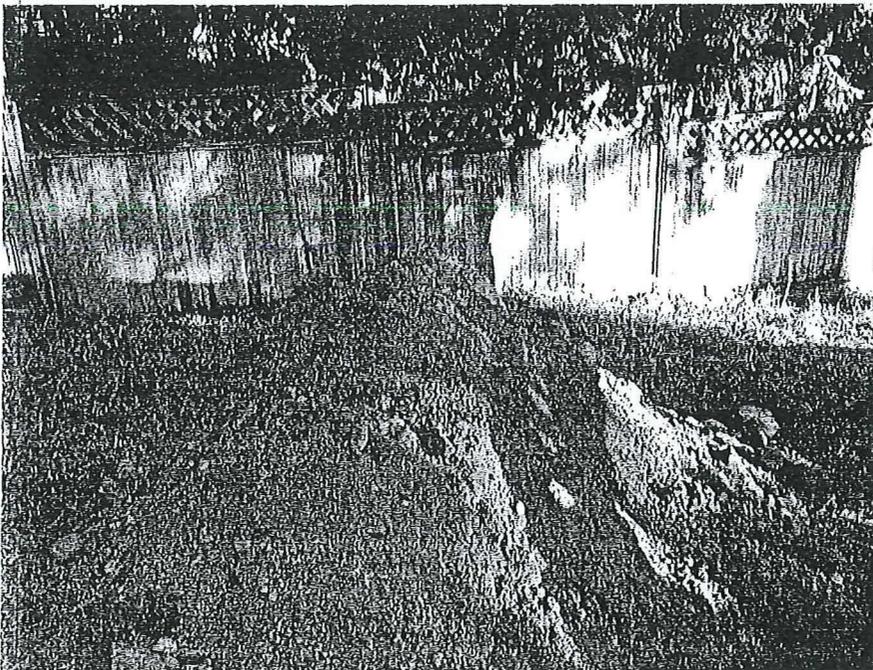
Photograph 2: Relatively clean fill found within the initial 1.0 m of excavating TP-02.

The on-site native fill encountered within the initial 1.0 m of TP-02 could be used as bulk fill or subgrade backfill to reestablish footing grade provided the following recommendations are followed:

- All organics, loose, soft, and deleterious materials are removed from the soil matrix;
- All particles greater than 75 mm are removed from the soil matrix;
- The material is compacted in 0.3 m lift sequences and tested by a WGC representative
