# DEVELOPMENT PERMIT

NO. DP- 2018-29 (Geotech)

Project No.: WG2-0818

**Re: GEOTECHNICAL ASSESSMENT**  
**Deck Renovation at 554 Marine Drive, Gibsons, B.C.**

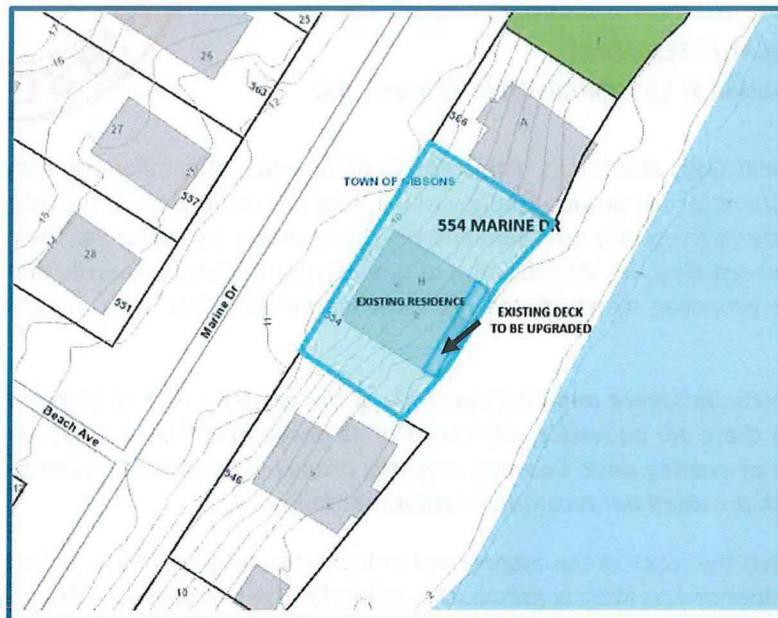
Fig 1: Location of existing residence and proposed deck renovation.

An existing residence is located approximately at the centre of the lot. We understand that our client is planning to replace the wooden structure of the existing deck using the same footprint. No additional building area will be used. The location of the site with existing structures is shown in Figures 1 to 3 below.

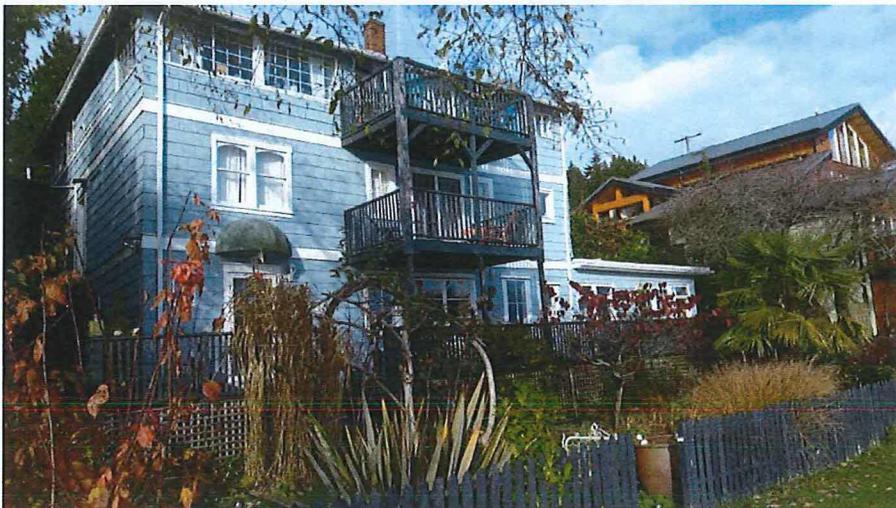
**Fig 3: Southeast elevation of existing residence.**

The site presents a gentle slope from the northwest down to the southeast of about 5% at the entrance of the property at Marine Drive for about 2.5 m. The topography then transitions to a moderately steep slope of about 55% for 10 m and finally a plain slope of about 4% for the last 3.0 m down to the southeastern property line. The vegetation at the site consists of landscaping varieties such as lawn, herbs, and decorative trees.

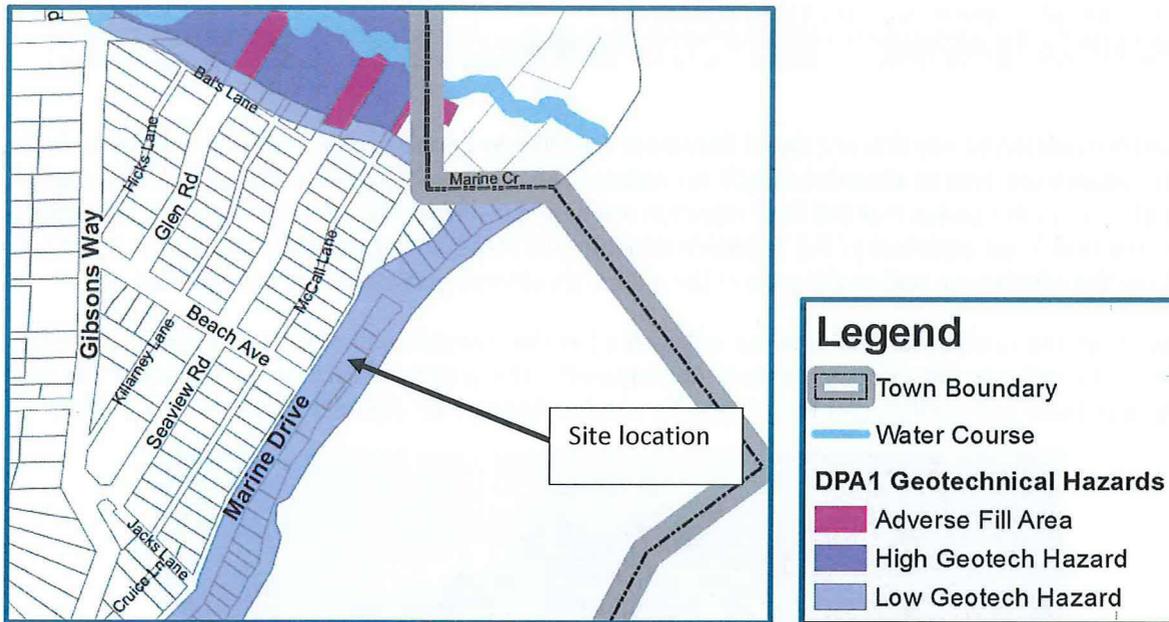
Fig 4: Town of Gibsons' DPA map and site location

In addition, the site falls within the DPA No 1 outlined on the Town of Gibsons' Official Community Plan. It is described as "low geotechnical hazard" (please refer to Fig 4). As such, the site was analyzed for the potential of inundation by oceanic waters.

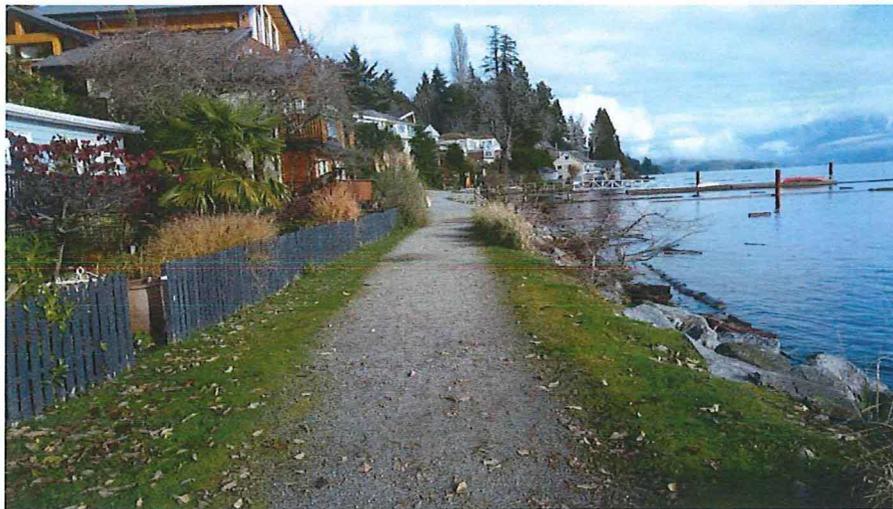
**Fig 5: Existing gravel trail and sea wall.**

In addition, the existing stacked rock sea wall located at the shoreline will provide an additional line of defense to mitigate any oceanic erosion. Consequently, the proposed deck to be upgraded can be considered safe and stable under the 1/100-year oceanic flood event. Figure 5 shows existing sea wall.
