DEVELOPMENT PERMIT

ENVIRONMENTAL ASSESSMENT REPORT

**1000 and 1018 Venture Way,
Gibsons, B.C.**

Project No. 2018.047

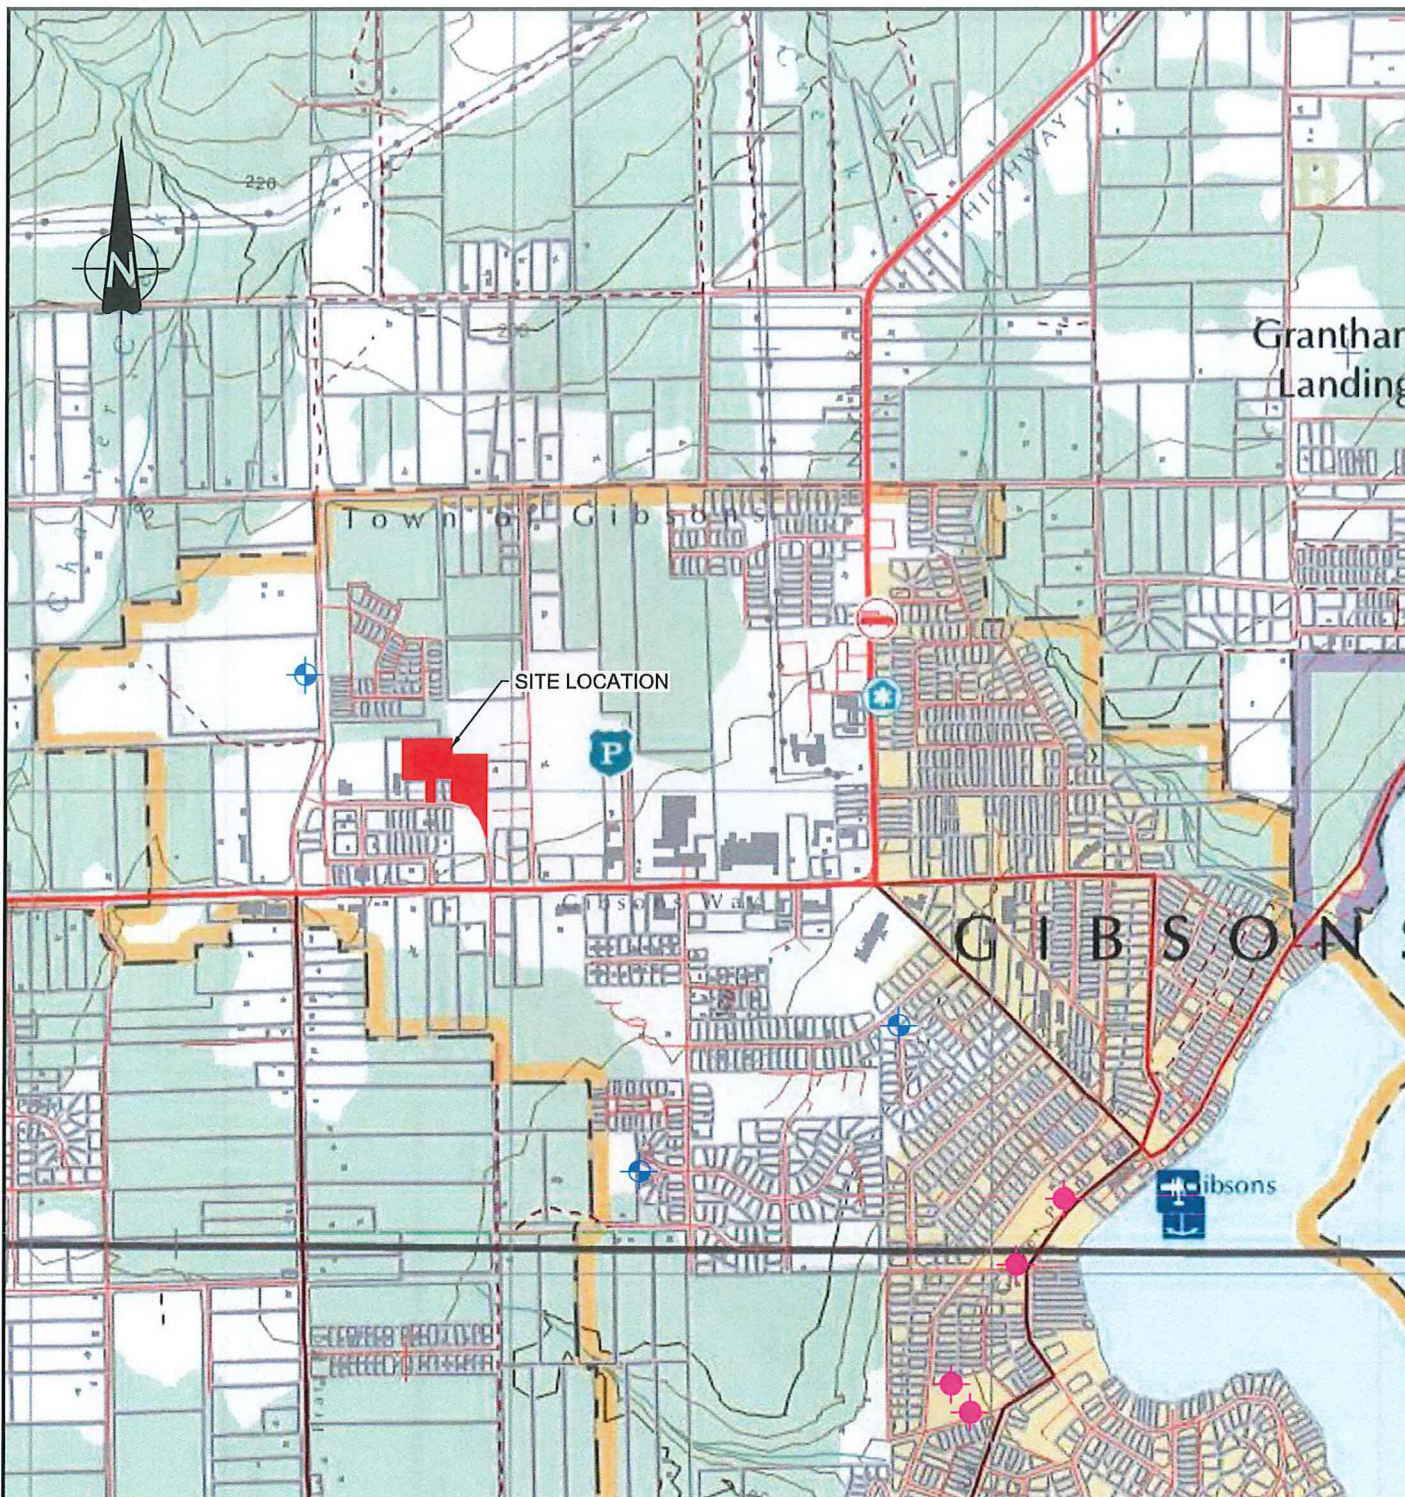
FIGURE 2

The Town has four extraction wells that are located in the Lower and Middle Gibsons (Figure 2). Town well #3 is the primary supply well. Town well #2 is maintained and used as a back up only. Town well #1 is the oldest well (greater than 45 years) and has likely become inefficient. Town wells #1 and #4 are under artesian conditions and when the extraction pumps are not in operation the overflow is diverted to the Towns sewer system. The report indicates that there is significant storage in the Aquifer and it has the capacity to supply the Town in the

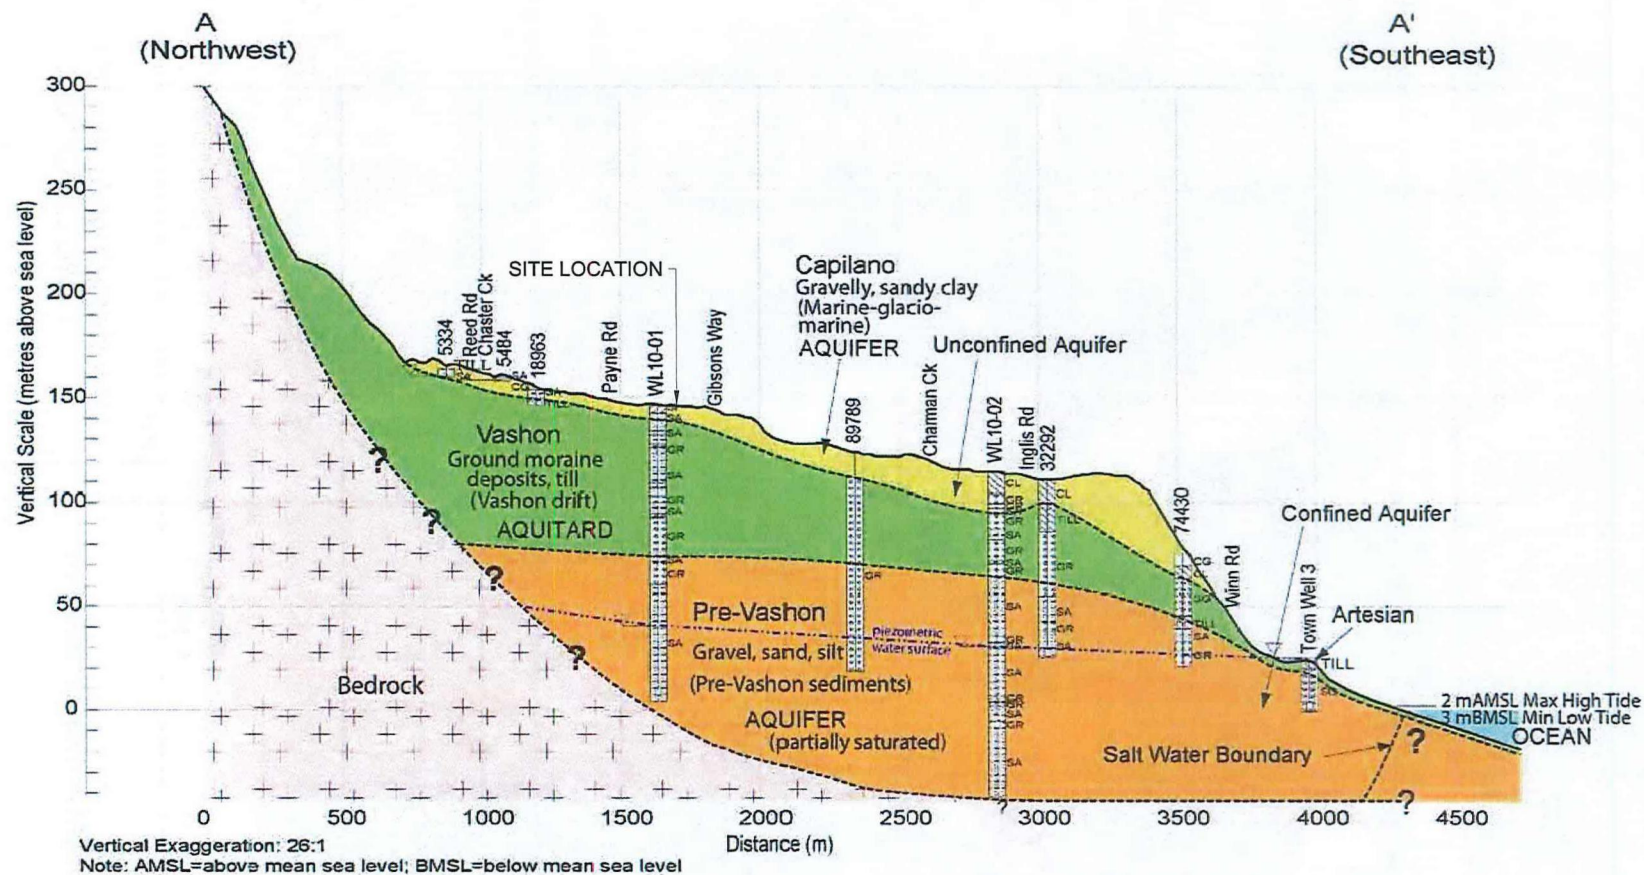
FIGURE 3

The geology of the area consists of Late Jurassic intrusions of quartz diorite and granodiorite. This massif forms the bedrock of Mount Elphinstone. The Bowen Island Bedrock Group overlies the plutonic intrusion near the Town of Gibsons. The northern boundary of this group is located approximately 1 km to the north of the Properties and trends southeast to northwest. The Bowen Island Group is an assemblage of metamorphic, sedimentary and meta volcanic rocks (Figure 3).

Beneath the surficial geology the primary lithology is the Vashon Drift. This unit is subdivided into two, the Upper a glacio fluvial sand and gravel and the Lower a ground moraine which is mainly comprised of a Till. The Till appears to be more extensive and likely covers the Gibsons Aquifer beneath creating an Aquitard layer. An aquitard is defined as less permeable beds in a stratigraphic sequence. These beds may be permeable enough to transmit water in quantities that are significant in the study of regional groundwater flow but their permeability is not sufficient to allow the completion of production wells (Freeze and Cherry). The borehole log for WL10-01 which is located close to the Properties indicates that the Aquitard is approximately 75 m thick in this area. The Aquitard consists of a hard packed silt, clay, sand and gravel. It forms a concrete like mixture of consolidated pebbles in a sandy matrix. In Upper Gibsons this unit impedes the migration of groundwater from surface to the aquifer beneath. In Lower Gibsons it forms a cap over the Aquifer that contains the water pressure resulting in artesian conditions in the lower portion of the Aquifer. The uniformity of this Aquitard across the entire Aquifer is not fully known at this time. The Waterline study indicated that there may be areas where the Till is thinner and may be less of a permeable barrier. It was also reported that there may be vertical recharge from the creeks into the stratigraphy below associated with potential erosion of the streams flowing through the Till horizon.

The Vashon Till is underlain by the Pre-Vashon sediments which are comprised of gravel, sand and silt. This unit is defined as the Gibsons Aquifer. The basal deposits are laminated and composed of stony clays which are believed to rest upon the early Cretaceous Granodioritic bedrock. The Pre-Vashon deposits have only been mapped along the Langdale Creek valley to the east of the Town of Gibsons and otherwise are only recorded in well logs. The Waterline report indicates that beneath Upper Gibsons the Aquifer is partially saturated and beneath Lower Gibsons it is confined. The vertical thickness of the Pre-Vashon sediments was not reported, but the borehole logs from WL10-01 and WL10-02 indicate that it is at least the Aquifer is approximately 40 m thick in Upper Gibsons and is overlain by approximately 75 m thick Aquitard. As the geology progresses towards the south, Borehole (WL10-02) indicates that the surficial sand and gravel increases and the Aquitard Till was identified between 30 to 50 m below surface. Bedrock was not encountered in this borehole, but the Aquifer was proven to a depth of 157 m. Frontier Geoscience Inc. conducted a geophysical survey and produced a bedrock contour map. The data identifies a northwesterly trending bedrock valley that attains depths as much as 50 m below

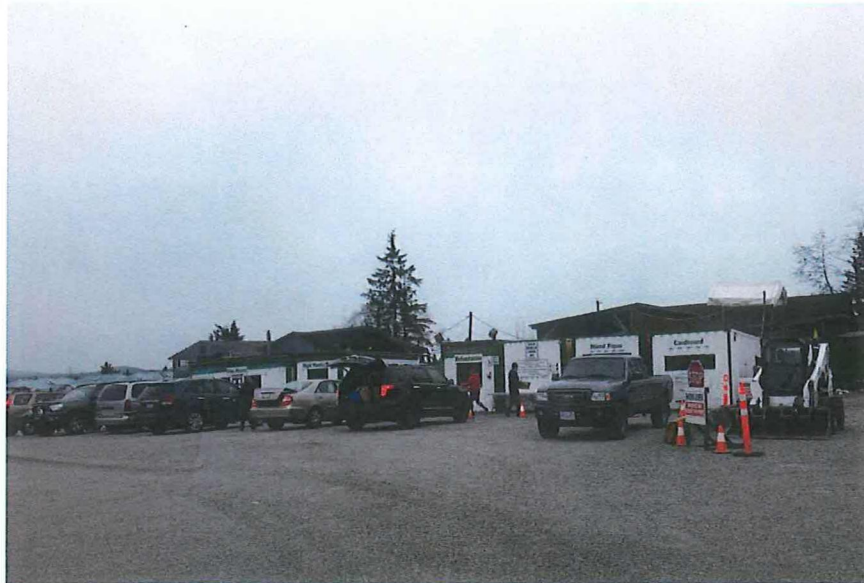
Picture 1 View to the South of the general public dropping off recycling into the sorting areas

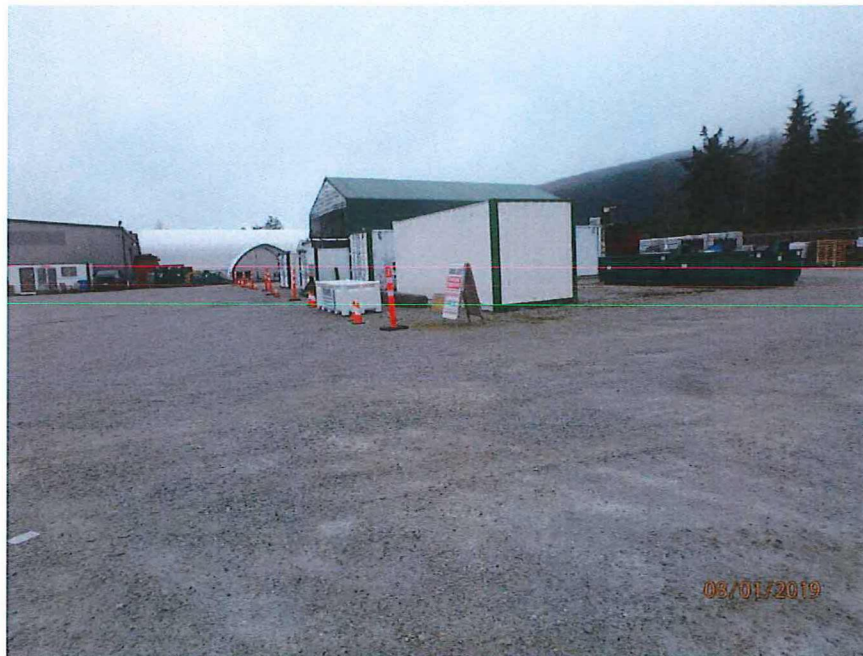
There were no visible AST or underground storage tanks (USTs) located at the Properties during the Site visit. Historically a waste oil AST was located at the Property. It was removed approximately 4 years ago and approximately 0.3 m of soil below the AST was excavated and transported to a licensed facility (according to the facilities operational manager). Given ENTECHs review of the proposed development plans there was no indication of liquid storage in significant volumes that would require an UST.

Picture 2. View to the northwest of the paints and electronic drop off location. Note the former waste oil AST was located to the rear of the shipping container.

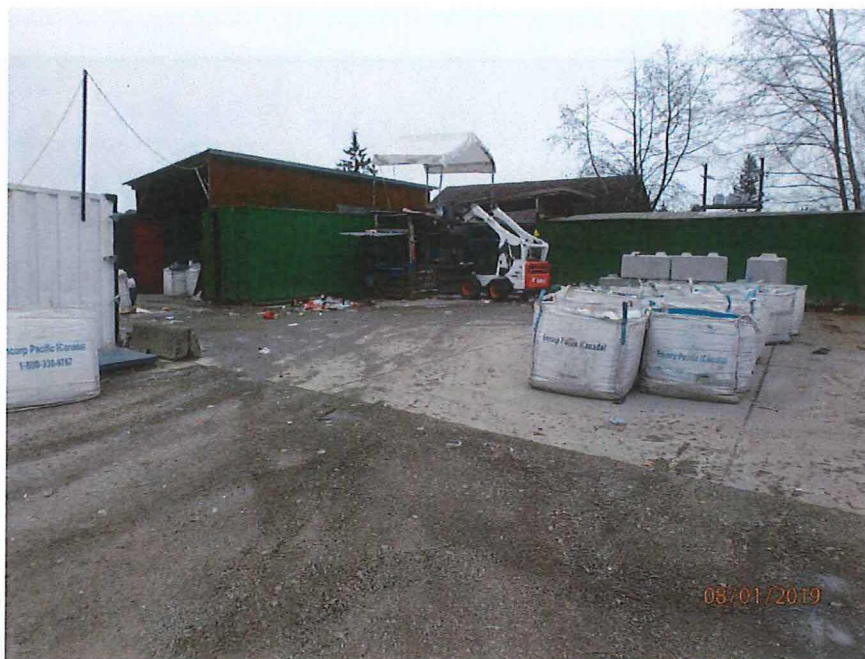
Picture 3 View to south of the paper compacting area

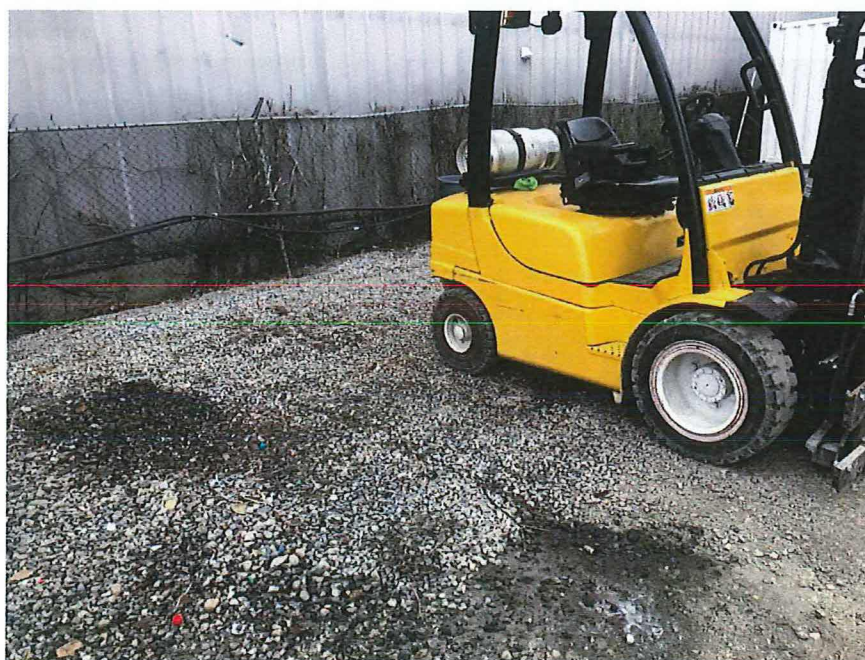
mattresses. A small hydrocarbon surface stain was observed near the Bob Cat parking area and may need further investigation or remediation in conjunction with the development. A drainage ditch along the northwest property boundary adjacent to the equipment storage area may present a risk for the Site and potential offsite migration toward the west, and adjacent lot should there be an accidental fuel spill. A number of storage containers were located along the perimeter of the facility. These did not appear to be potential sources for environmental impact. The only processing on the facility was the waste paper compactor and bailer. The remainder of the operation appeared to be sorting, temporary storage and then disposal off site.

ENTECH has reviewed the physical setting of the Properties and the Historic and Current uses. There was no indication of the land use at 1000 Venture Way posing a potential risk to the underlying Aquifer. The current operation of the Gibsons Recycling Depot appears to be well managed and relatively clean. At present the Recycling Depot does not accept high risk materials such as hazardous wastes or oils. The facility does accept paints stored in totes with lids to prevent precipitation ingress. They are processed in a purpose specific area and volumes encountered did not appear to be high. There was a small spill observed near some of the Bob Cat equipment storage, next to the Office. It was not know if this was maintenance related and it is recommended that this be cleaned up and be included in the spill response of the facility.

Picture 4. View of small stain likely associated with the Bob Cat storage

- a. During the construction phase, Shazach Holdings Inc. will develop a spill response and contingency plan.
 - b. A small spill near the Bob Cat equipment storage, next to the Office shall be cleaned up and included in the spill response of the facility.

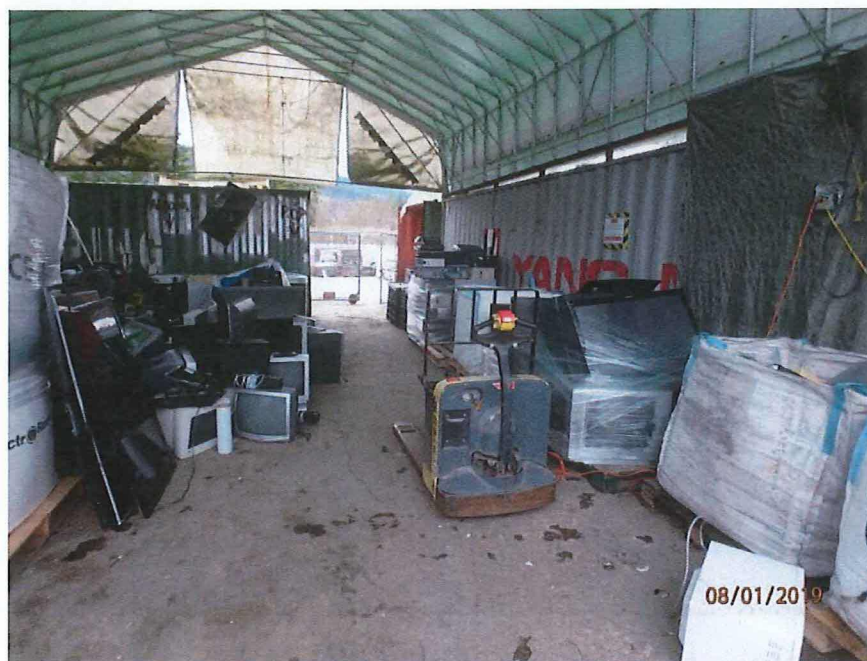
Picture 5 View of the covered electronics and paint receiving area

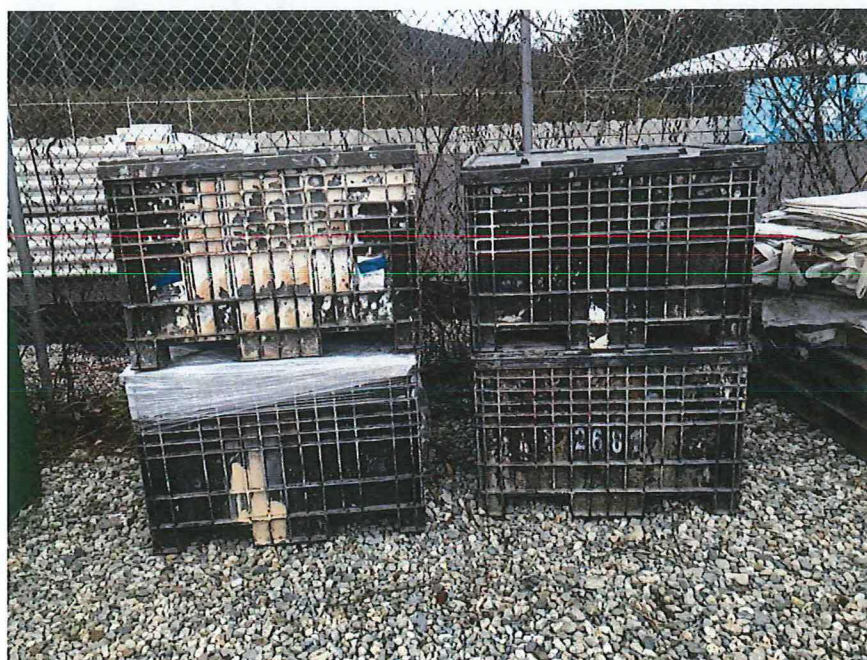
Picture 6 View of the Paint container totes

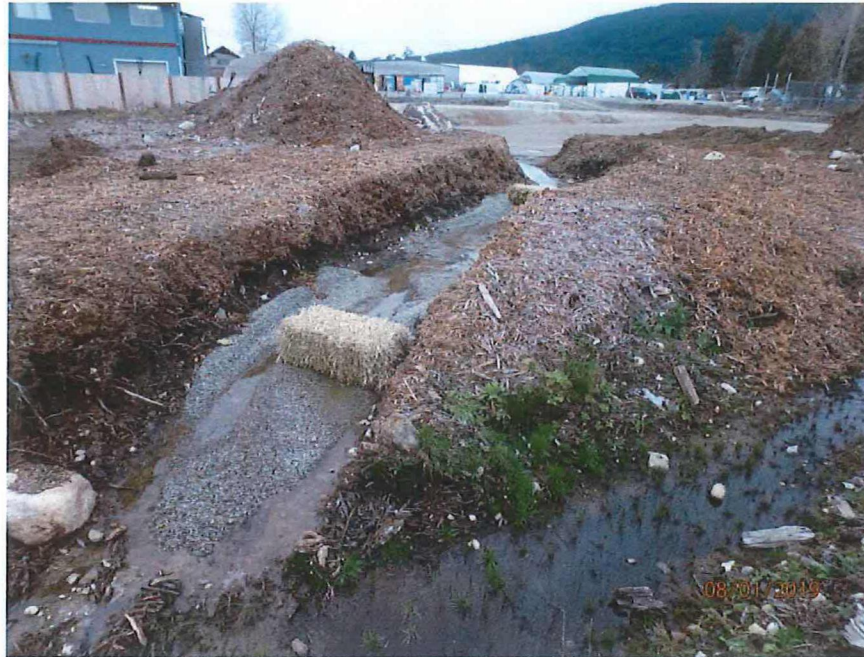
A small drainage channel was located near the centre of the lot with gravel and the occasional hay bale placed intermittently as erosion control to slow any surface water drainage across the lot. Close to the piles of wood chips, decaying plant matter odour was noted and an iridescent sheen was observed in the drainage channel. The iron slick sheen broke into distinctive plates on contact and is typical of biochemical oxidation or the breakdown or decay of organic matter. The lot appeared to contain little of environmental significance.

Picture 7 View to the northwest of the cleared lot at 1000 Venture Way. The recycling depot is in the background. Note some of the engineered drainage and erosion control measures.

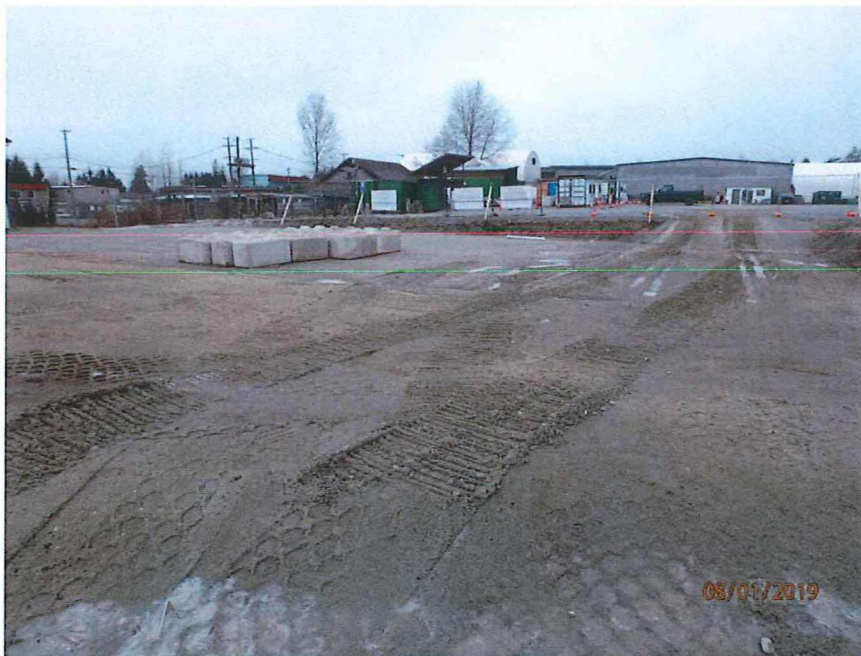
Picture 8 View to the East of the general site preparation.
