# DEVELOPMENT PERMIT

**FILE NO: DP-2019-08**  
**(Environmental)**

- a) Appendix A – Report titled "Environmentally Sensitive Development Permit Area No. 2 – Gospel Rock Subdivision Block 7" prepared by Diamond Head and dated April 29, 2019 updated October 28, 2019

- b) Appendix B – Report titled "Environmentally Sensitive Development Permit Area No. 2 – 6-Lot Subdivision" prepared by Diamond Head and dated February 27, 2019 updated October 25, 2019

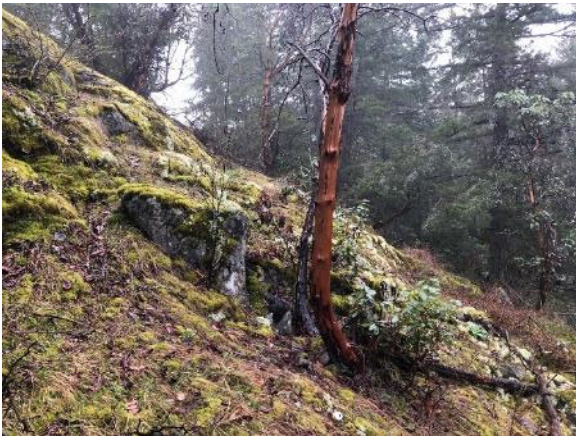
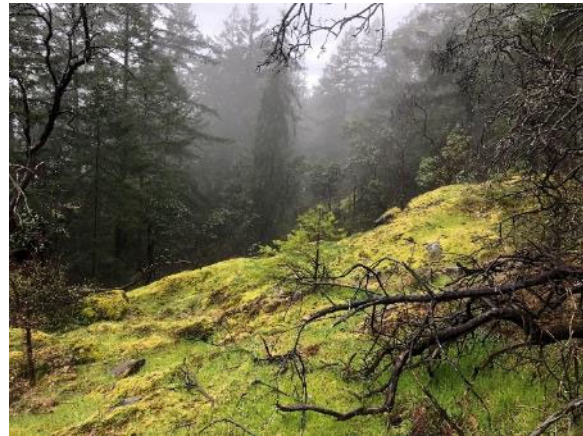
Views of bedrock outcrop areas

There are bedrock outcrop areas and bluffs found throughout the ESA area that are dominated by moss, lichens and grasses with little tree or shrub cover.

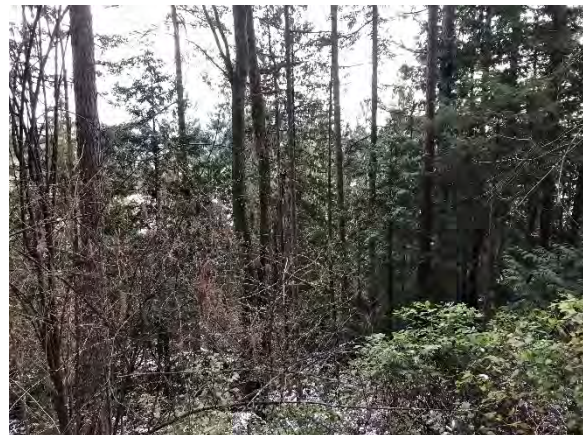
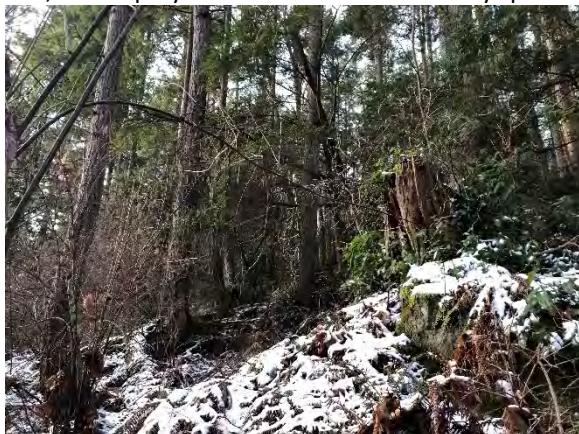
There are steep slopes along the western half of the proposed lots.
