# DEVELOPMENT PERMIT

NO. DP- 2020-20  
DP- 2020-21

Re: Geotechnical Assessment Report for Proposed Landscape Retaining Walls  
Location: 466 Marine Drive, Gibsons BC  
Legal: Lot 1, Block J, DL 686, Plan 6401  
PID: 010-897-321

## Site Photos & Preliminary Retaining Wall Sketches

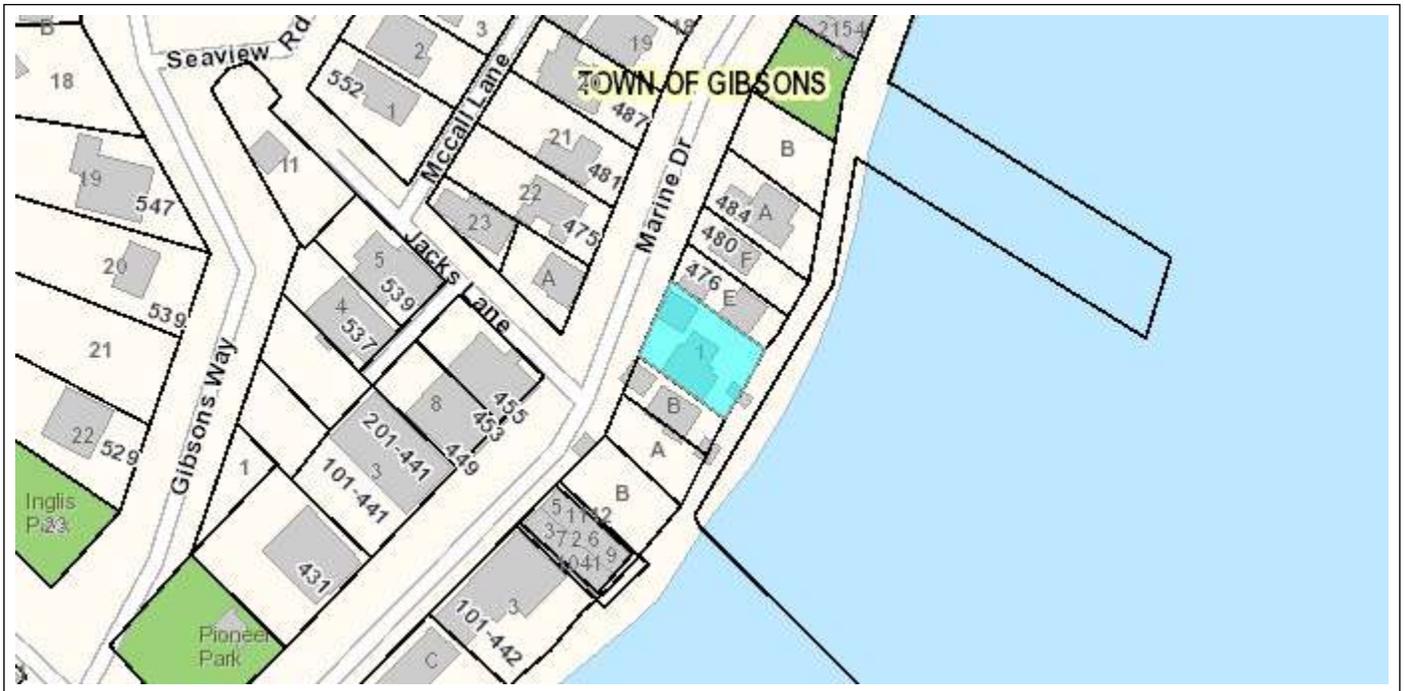
**SITE PLAN OF PART OF LOT 1 BLOCK J DISTRICT LOT 686  
PLAN 6401**

As shown on the attached 'Site Plan' prepared by Strait Land Surveying Inc., the subject property lies along the marine shoreline Shoal Channel, immediately north of Gibsons Landing. The property is situated upon a steep slope stretching from Marine Drive down to a wide waterfront pathway and the marine shoreline of Shoal Channel. This same slope stretches across neighboring properties to the north and south, many of which also have tiered retaining walls. Upon the subject property, the slope is broken into two main segments with a bench in between where an existing home is situated. A detached garage was also present, built into the slope at the northernmost corner of the lot. Total vertical relief between Marine Drive and the waterfront pathway (bottom of slope) is approximately 11m.

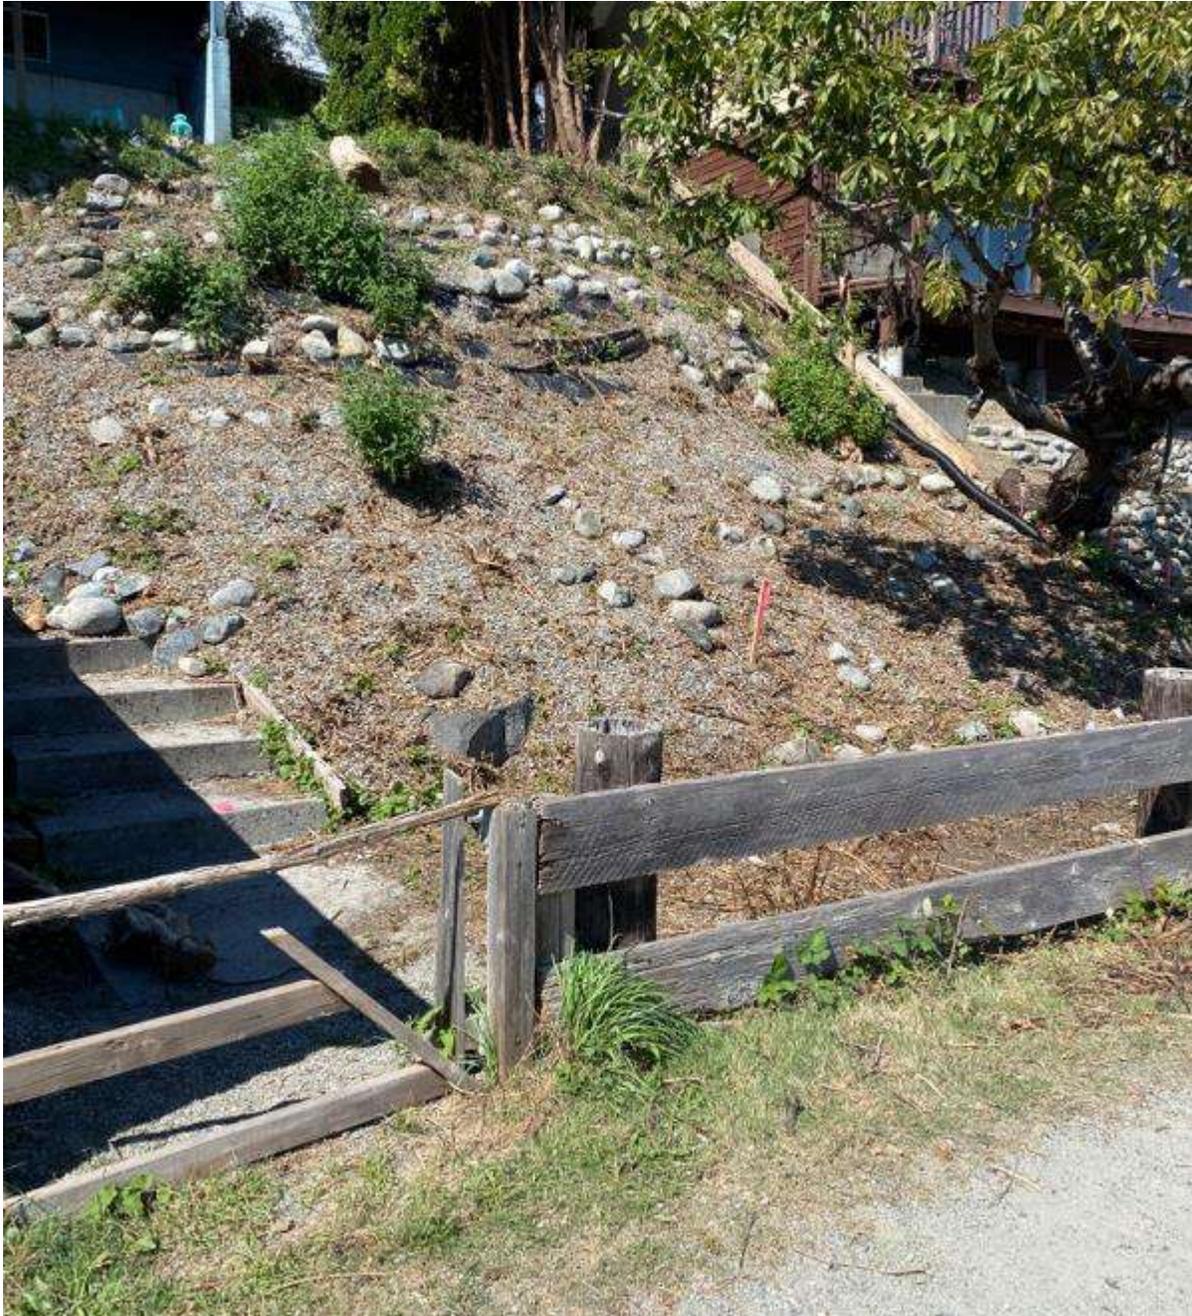
Figure 1: Current state of rear yard slope, looking west from waterfront path. Wood stakes with orange flagging delineate property boundary.

The focus of our assessment was the lower segment of slope, extending up from the waterfront pathway to the existing home. This slope is approximately 6m high and has an angle of between 30 and 40 degrees (see Figures 1, 2 & 3 on the attached 'Site Photos & Preliminary Retaining Wall Sketches'). The slope has several rows of rudimentary stacked rock walls which appear to be slumping down the slope. The slope is mostly bare of vegetation except for several small shrubs and a severely leaning and heavily pruned deciduous tree situated right on the northern property line near the toe of the slope. Areas with black landscape fabric were also visible across much of the slope. No signs of instability were observed on or around the slope. No groundwater seepage, or vegetation indicating recurring groundwater seepage (wet soil indicator plant species), were observed on or around the slope. No subsurface investigation was completed as part of our assessment.

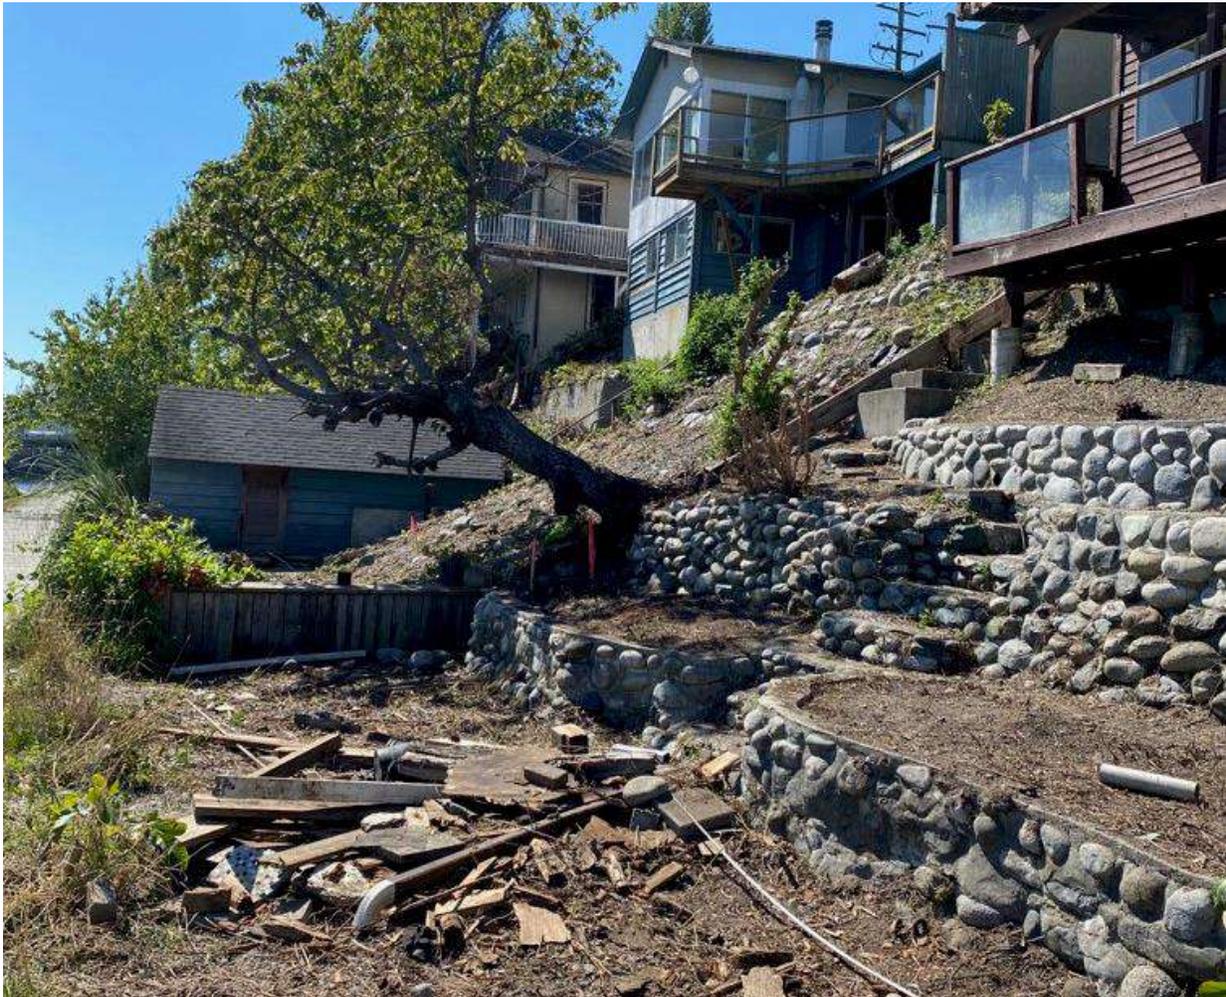
Figure 2: Looking south across neighbors' property towards subject slope. Note neighbor's tiered retaining walls.

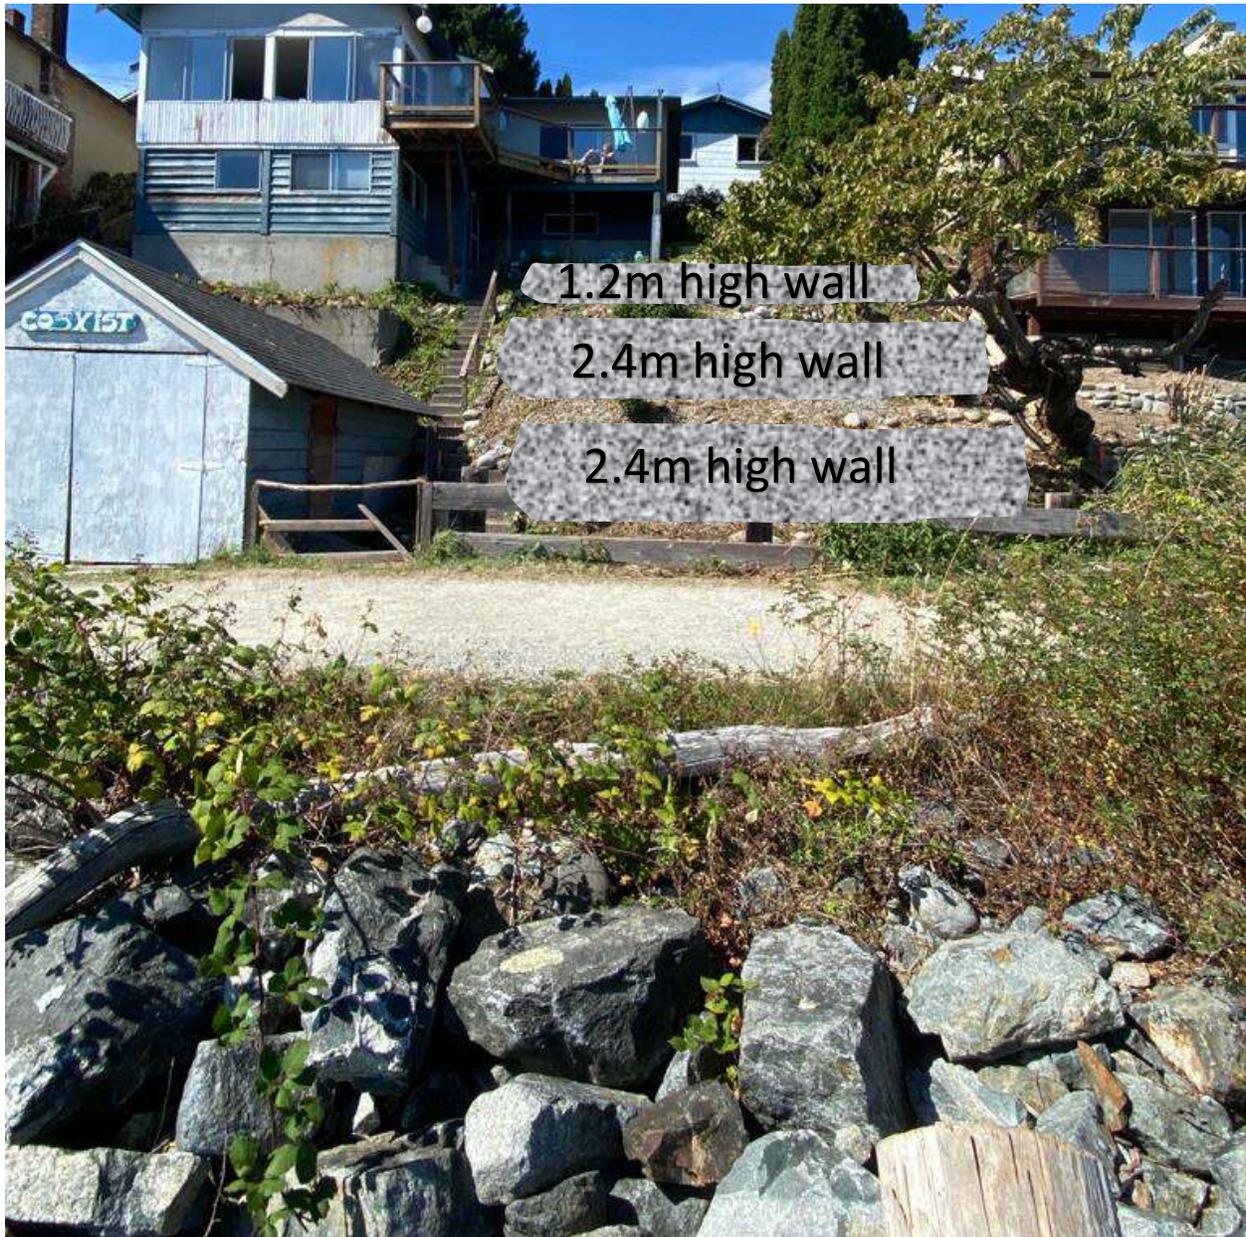
Figure 3: Rear yard slope and proposed retaining walls (looking west from marine shoreline)

Based on our observations, we believe the slope could accommodate the proposed construction of three tiers of professionally designed and constructed stacked boulder retaining walls. Geosynthetic reinforcement of the proposed wall's backfill zones will certainly be required, and such may increase the stability of the existing slope.

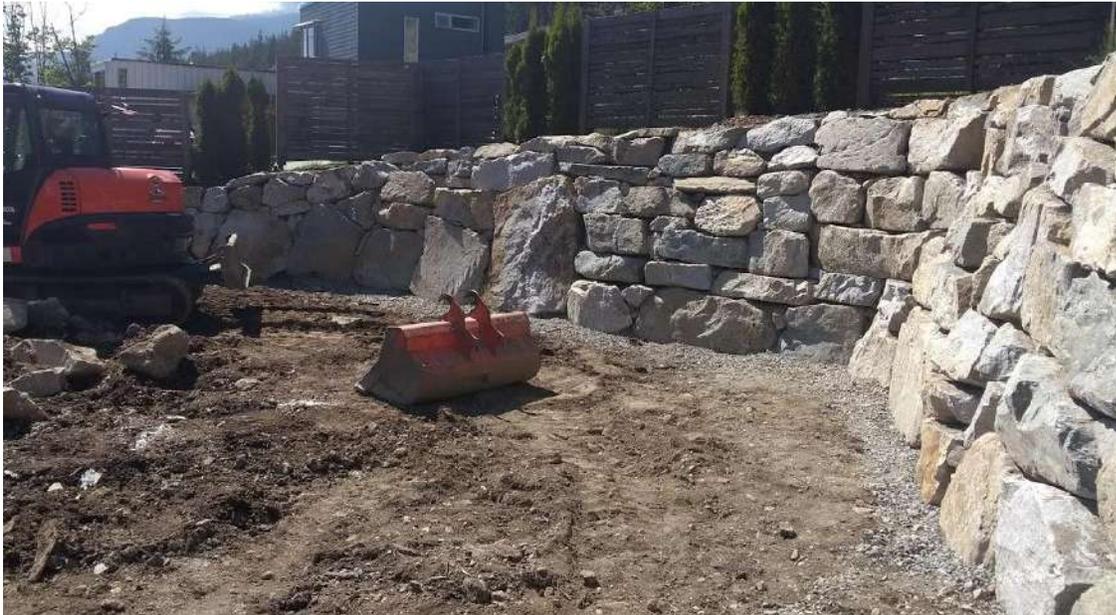
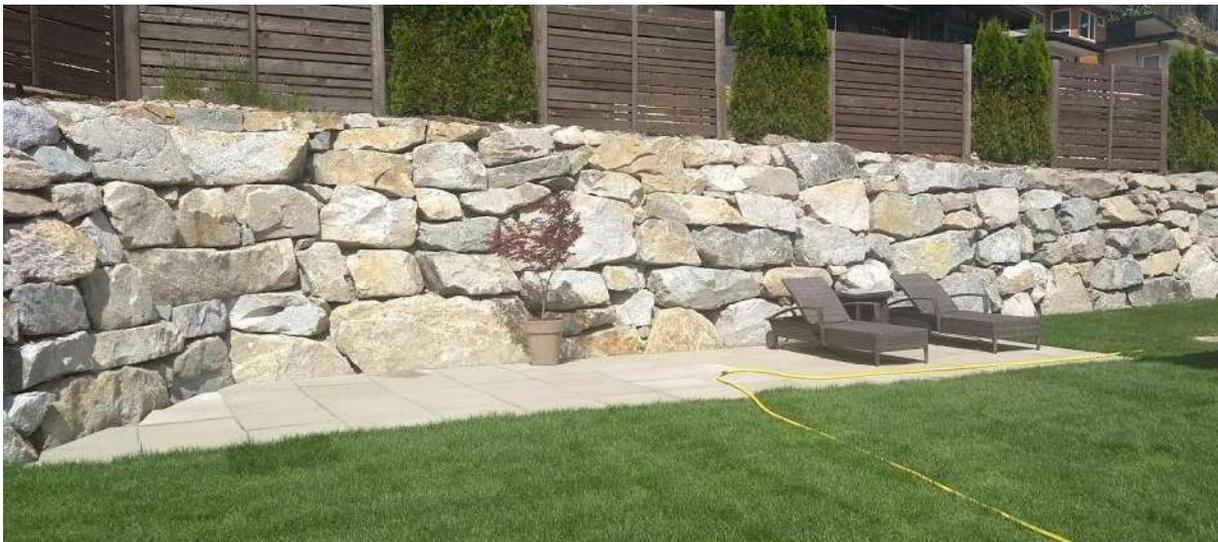
Figures 6 & 7: Example of 2.5m high stacked boulder retaining wall recently built in Squamish BC

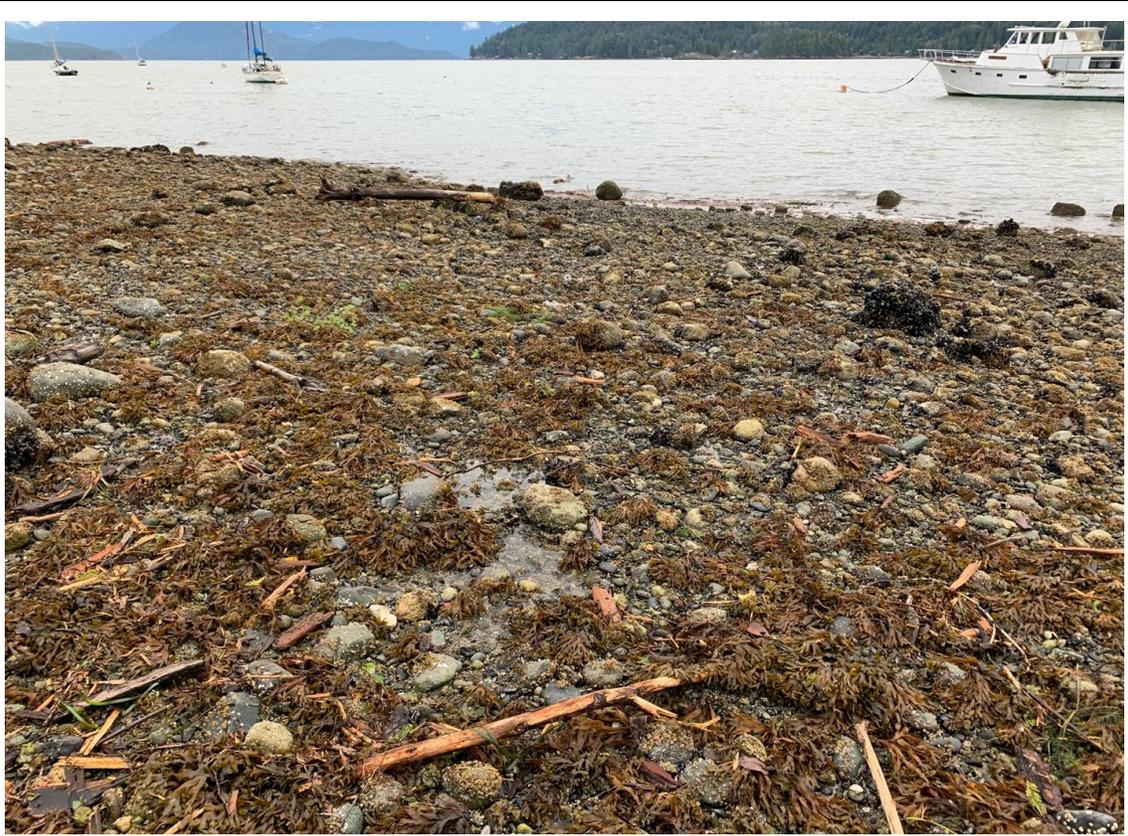
Algae - Macroalgae are important in both a biochemical sense as well as a physical sense. Macroalgae found in the Lot 1 foreshore include many of the beneficial macroalgae which removes excess nutrients and pollutants from sea water (Photo 1). *Fucus gardneri*, or more commonly known as rockweed, is the dominant species found on site. *F. gardneri* consists of multiple branches each with an air bulb at their tip. The bulbs allow the plant to stay orientated towards the sunlight when the tide rises. When the tide is high, rockweed provide shelter from sunlight and predators for juvenile fish and shoreline crabs (*Hemigrapsus oregonensis*). At

**Photo 1 – Rockweed, *Fucus gardneri*, dominating in the intertidal zone.**

Mitigation – Although rockweed is a common species found along the coastline of BC, the importance of macroalgae cannot be overlooked. Because they are anchored to the rocky shore, rockweed can continue to provide these valuable ecosystems services even during strong wave action. However, the most sensitive aspect of rockweed is their ability to photosynthesize. If the plant is smothered by sediment or pollutants, they will not be able to reach the sunlight. Therefore, the biggest threats to rockweed are sediment run-off and pollutants from upland construction sites, thermal discharges, oil discharges, and stormwater run-off. Practices should be put into place to prevent the smothering and destruction of this macroalgae.

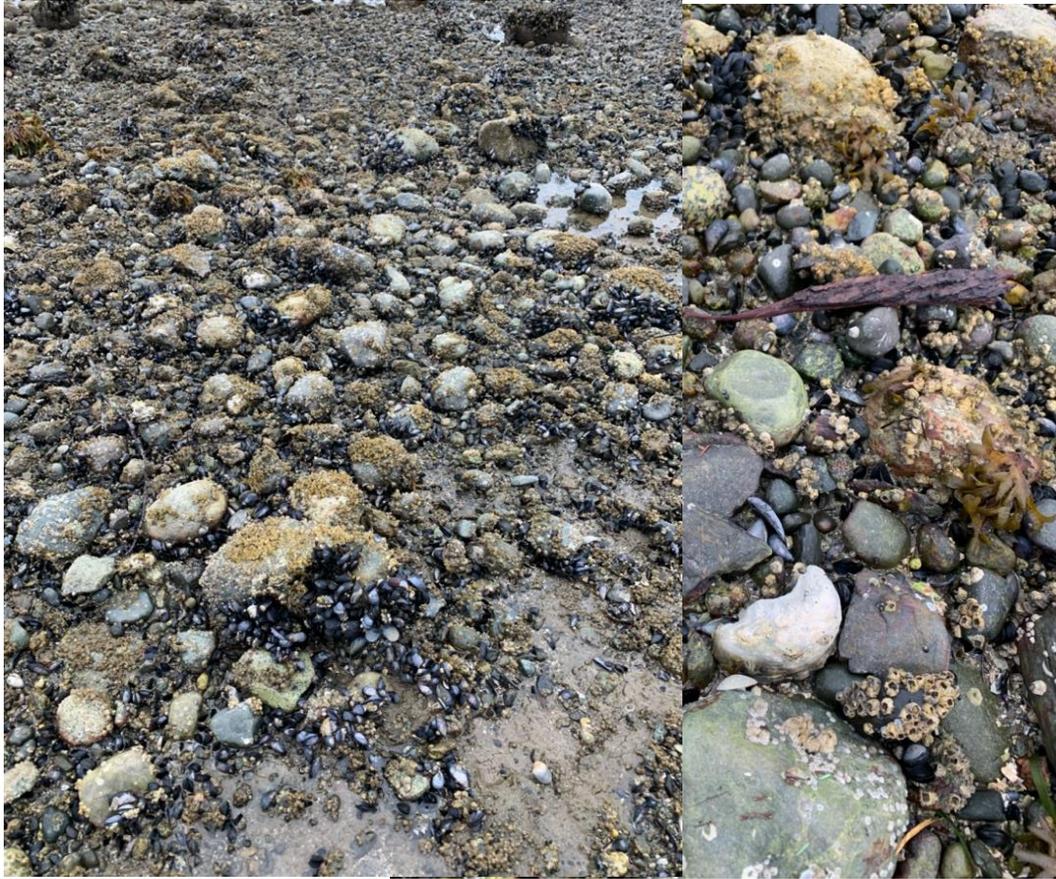
Filter feeders – Similar to the algal species that inhabit the rocky intertidal zone, filter feeders like oysters and mussels help in maintaining water quality. They remove phytoplankton from sea water and help to reduce the impact of harmful algae blooms (HAB's). Two species of interest found at Lot 1 include *Crassostrea gigas*, or the pacific oyster, as well as *Mytilus edulis*, or the Salish mussel (Photo 2).

**Photo 2 – Salish mussel, *Mytilus edulis*, and Pacific oysters, *Crassostrea gigas*, are present.**

Mitigation - Given the increase in urbanization and habitat destruction of littoral areas, mussel and oyster populations are in slow decline. During the Lot 1 assessment, only a few oysters were found which suggests that the area has already experienced habitat loss. To help prevent further habitat impacts, the constructor will implement practices to prevent pollutant run off, erosion of sediments, and physical disturbances on the intertidal zone during construction.

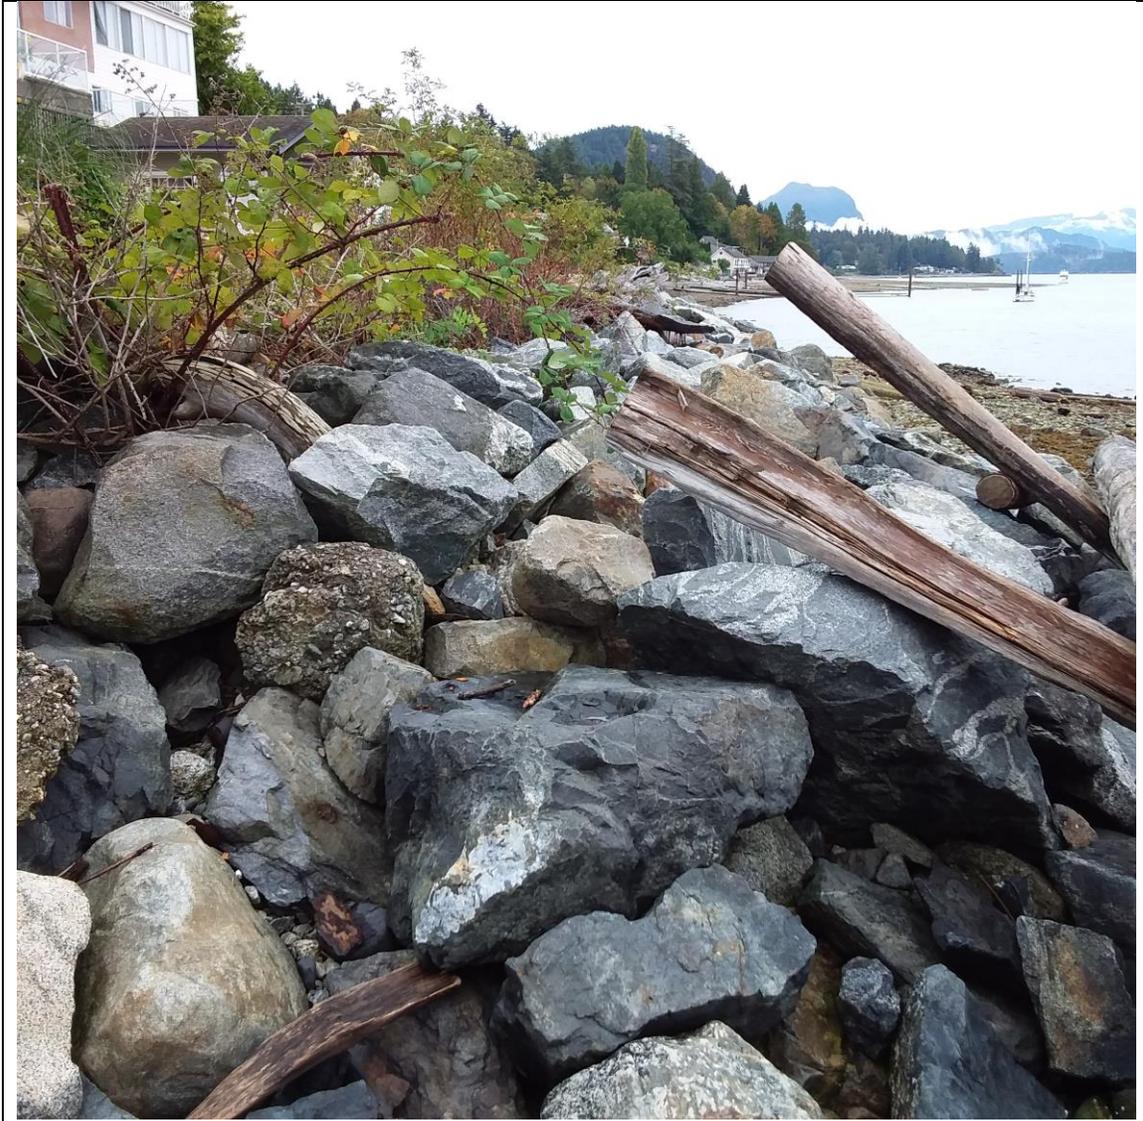
**Photo 4: Foreshore riprap stabilization. Viewing northeast from below Lot 1 at the water.**

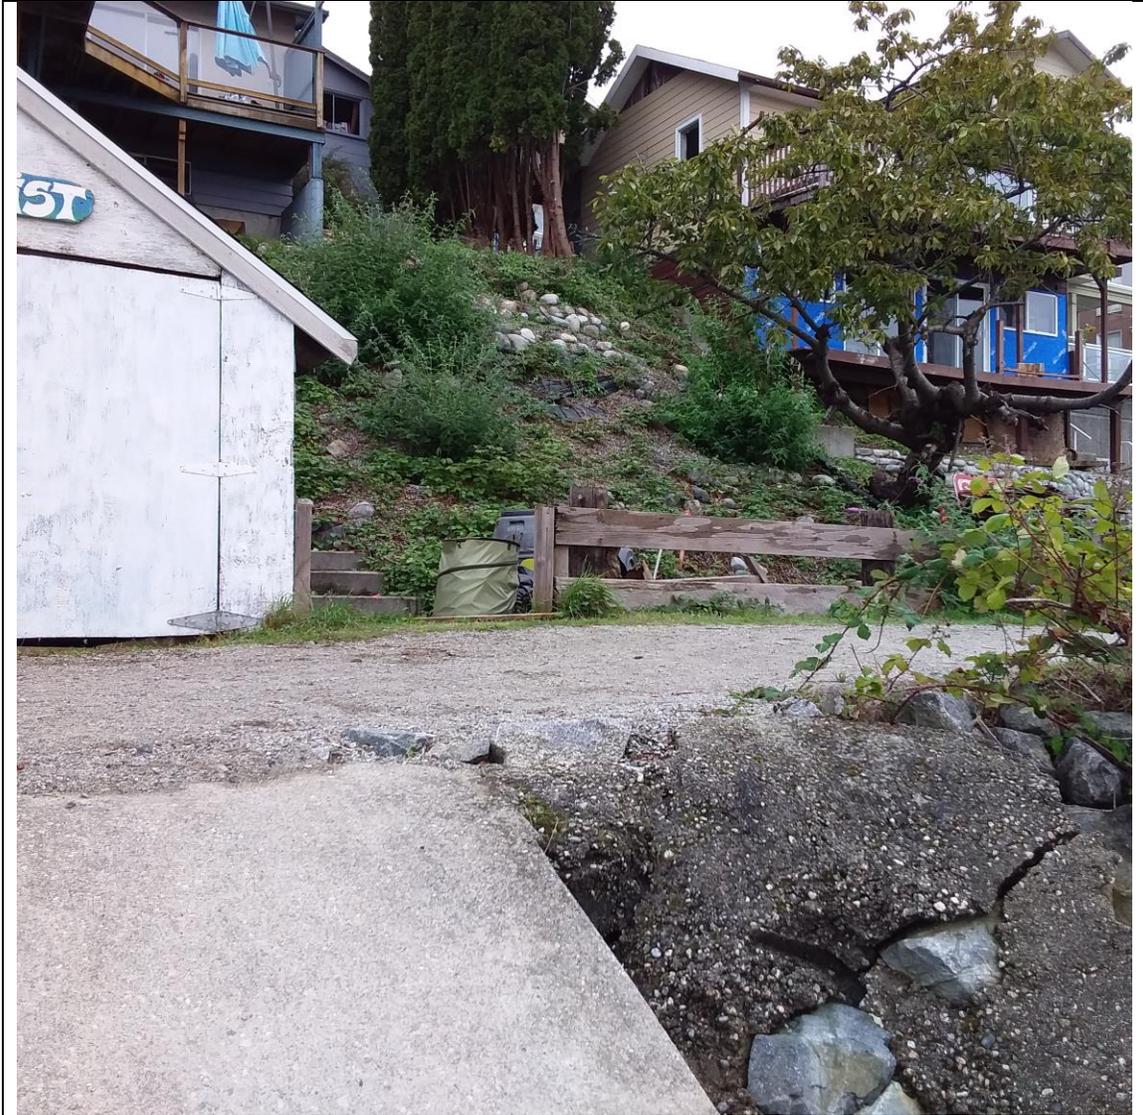
**Photo 5: Upland southeast portion of Lot 1, site of proposed tiered rock wall construction. Waterfront gravel pathway also visible in foreground.**

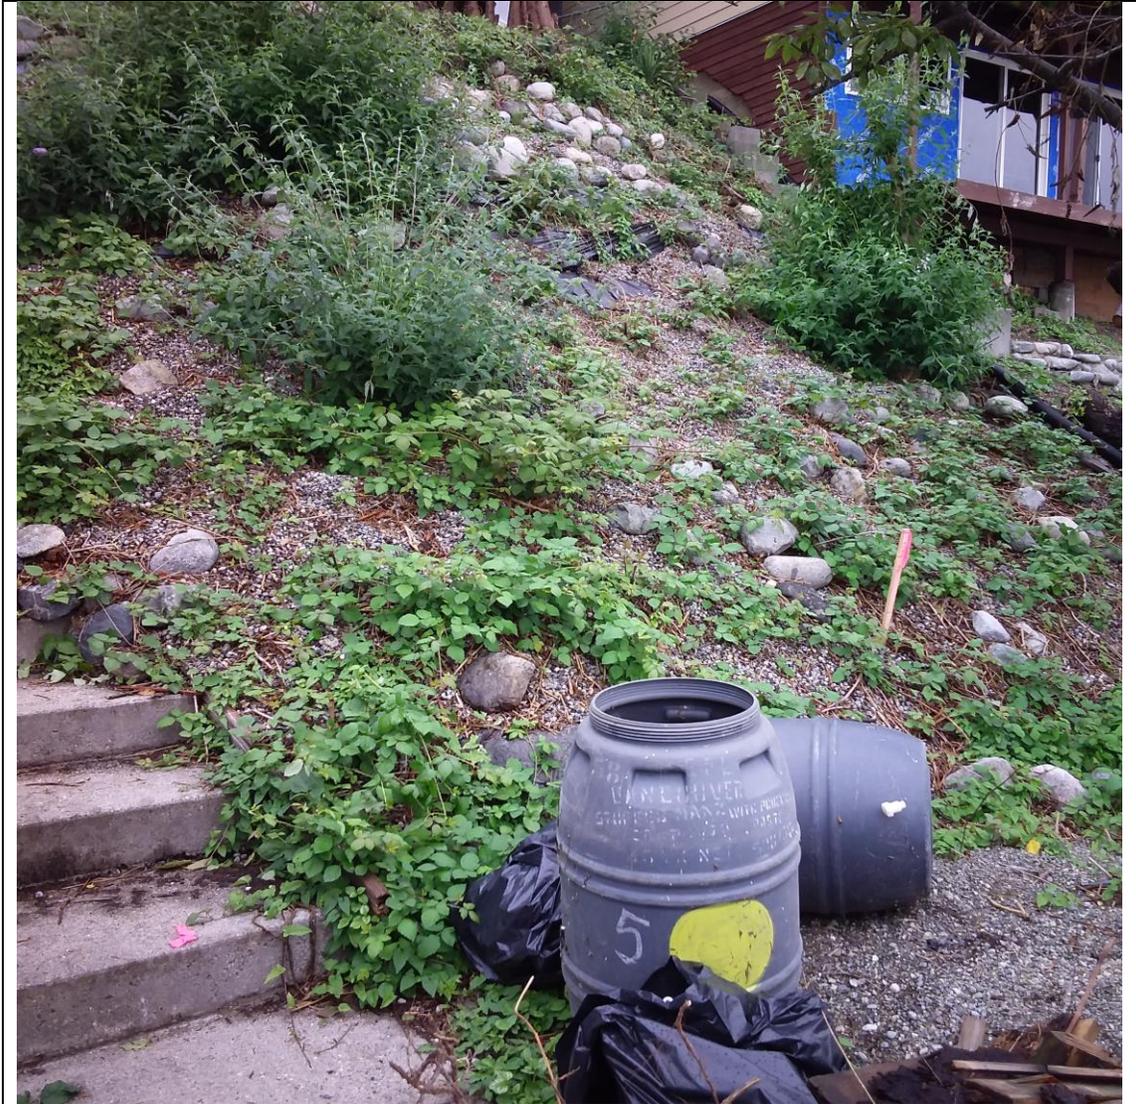
The slope directly above the pathway and overlapping the DPA 2 setback is characterized by a shallow soil veneer, with extensive areas of bare exposed soil, with sparse vegetation other than exotics and domestic volunteers. Also, beyond the setback zone and overlapping into the setback is a pre-existing rustic concrete pathway and remnant gardens. Soils are characterized by a disturbed organic layer over a 30-100 cm mesic, gravelly Bf horizon

**Photo 6: Upland southeast portion of Lot 1, site of proposed tiered rock wall construction. Pre-existing rustic landscaping within DPA 2, lack of native vegetation, disturbed ground.**

The pre-existing condition of the lot will not be materially changed with the construction of rock walls. The builder and owner will avoid unplanned trails, refuse dumping, soil disturbance, machine tracking, vegetation conversion or tree clearing in the setback zone. Paths should be constructed with granite or other natural steppingstone-style material placed in a fashion that directs traffic to decrease disturbance to erodible soils.

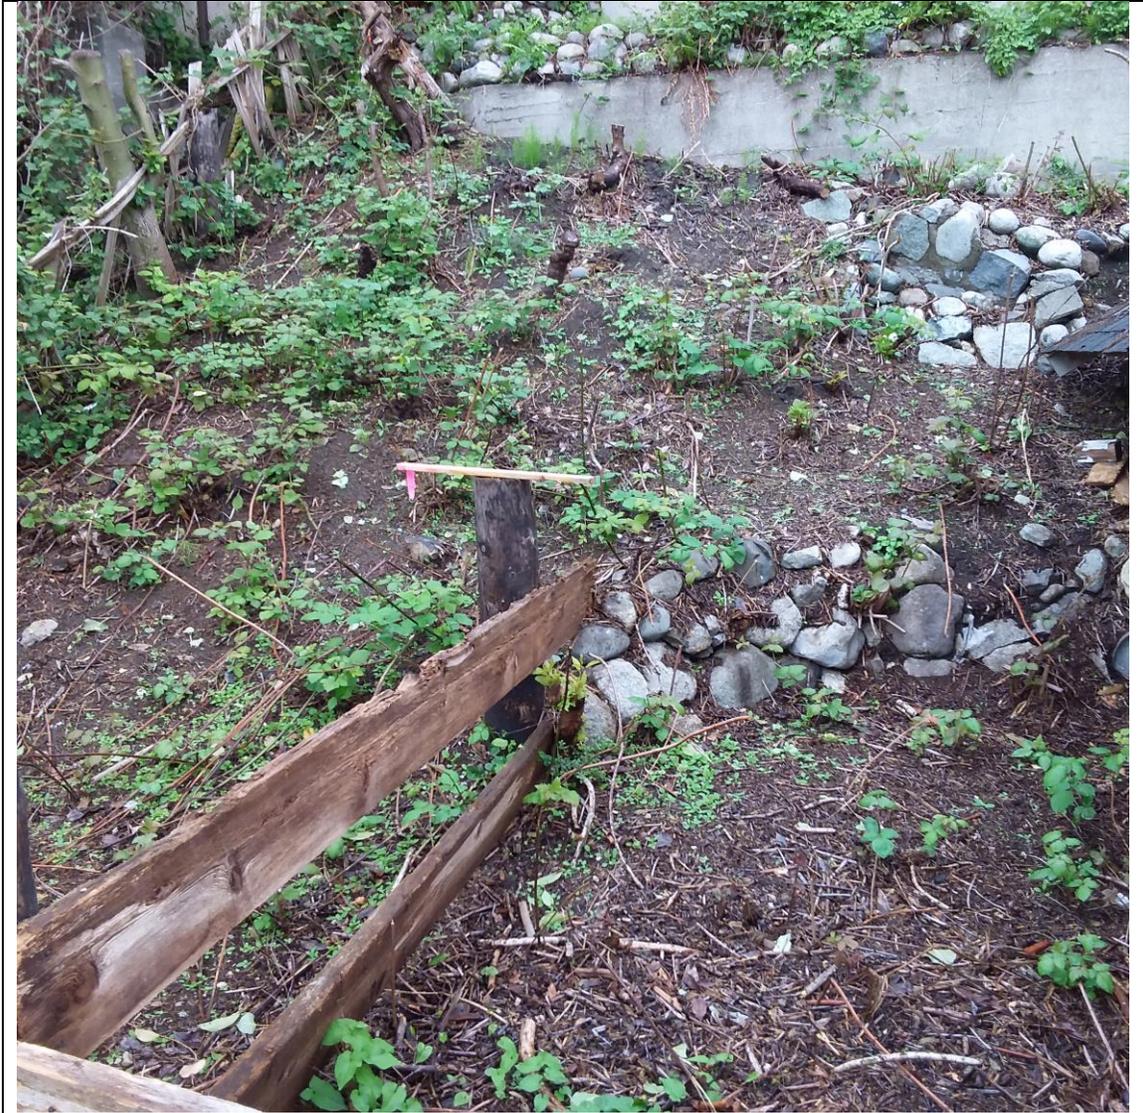
**Photo 7: Upland southwest portion of Lot 1.**

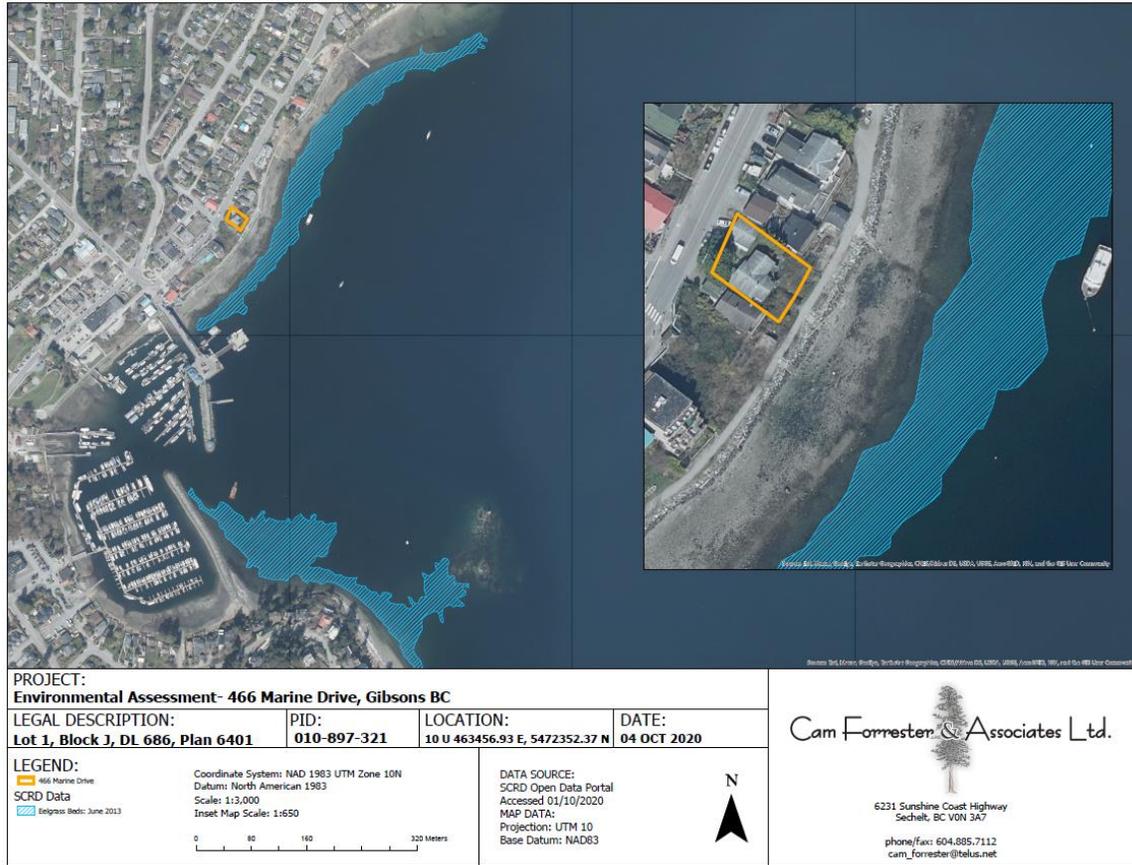
Figure 1 DPA 2 setback, and assessment area relative to construction.

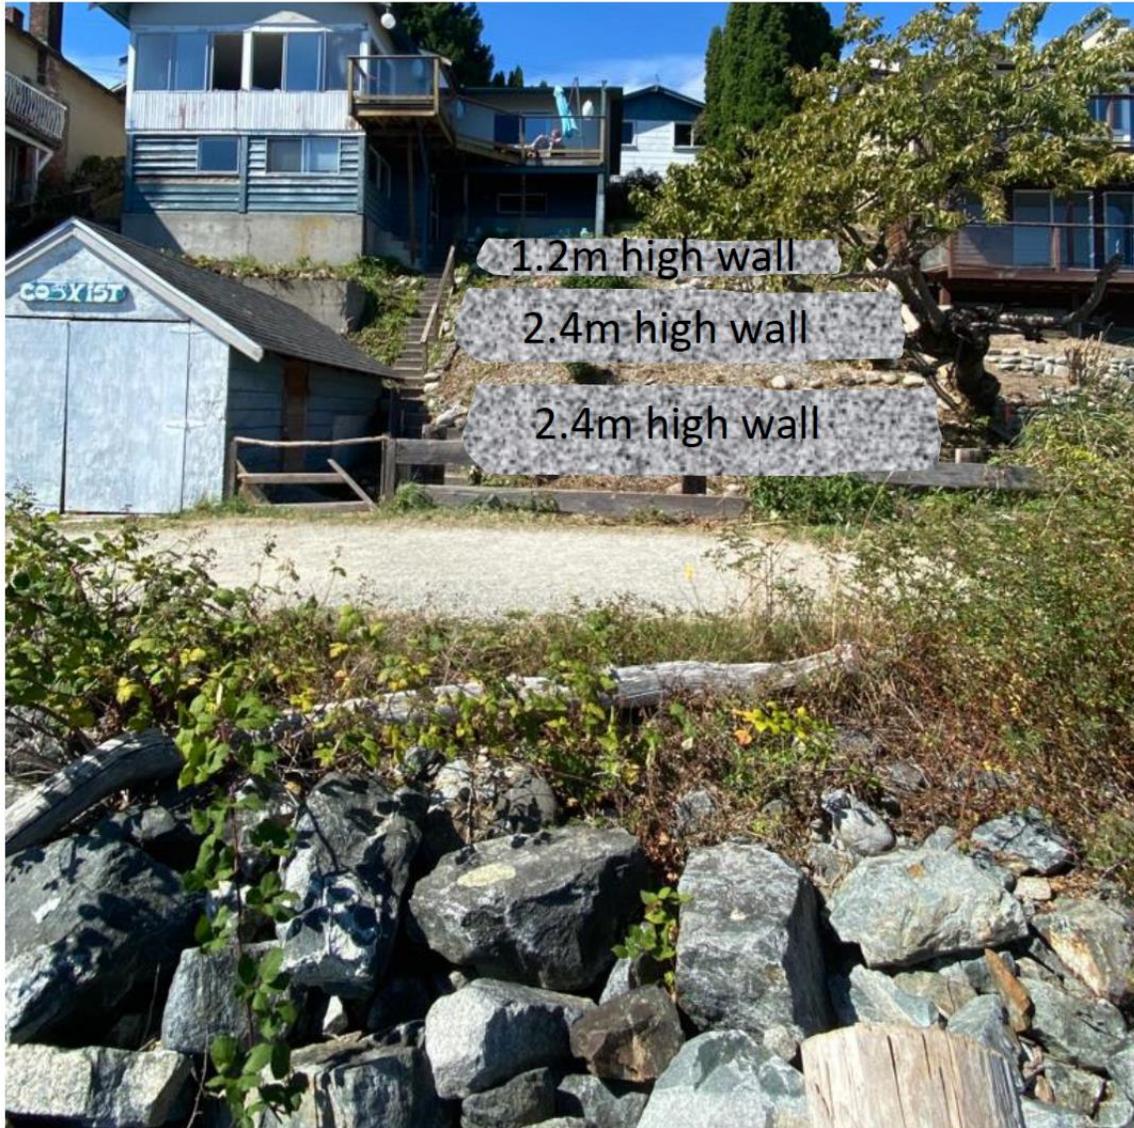
Proposed retaining wall location & configuration.
