The SBRs were an upgraded wastewater treatment process for the Town of Gibsons, which came online in 2006. The treatment process has been operating extremely well, but like all equipment requires regular maintenance and replacement. Wastewater is hard on equipment! To continue to provide treatment, the membrane diffusers in the SBRs needed to be replaced recently, as they were over double their lifespan.

In 2020, the same work was done on SBR #1. With careful planning, the work was done in a safer fashion than in the past, and with minimal odour upset to Town of Gibsons' residents!

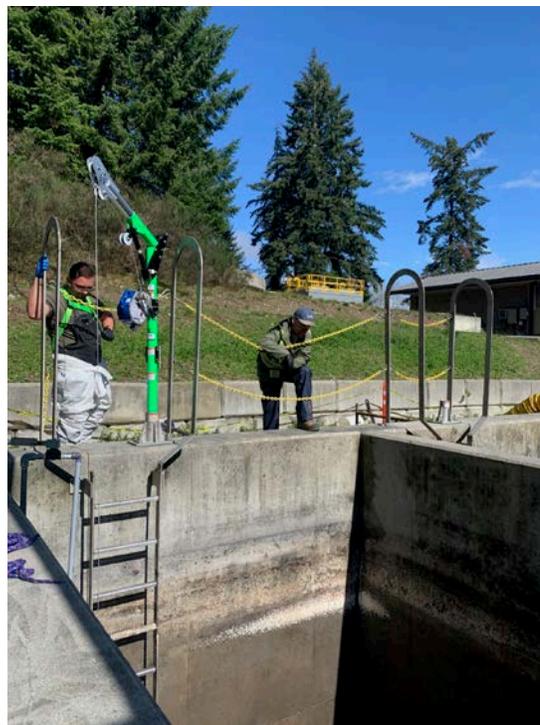
***Davit Arm with Self Retracting Lanyard and Rescue Line***

- The Town of Gibsons operators took numerous days of safety training in lockout safety, confined space entry, and confined space rescue.
- The Town of Gibsons purchased new safety equipment to be compliant with WorksafeBC regulations including a davit arm, tripod, self-retracting lifeline, and a rescue winch. In addition, mounts for these devices had to be secured and engineer approved for safety.

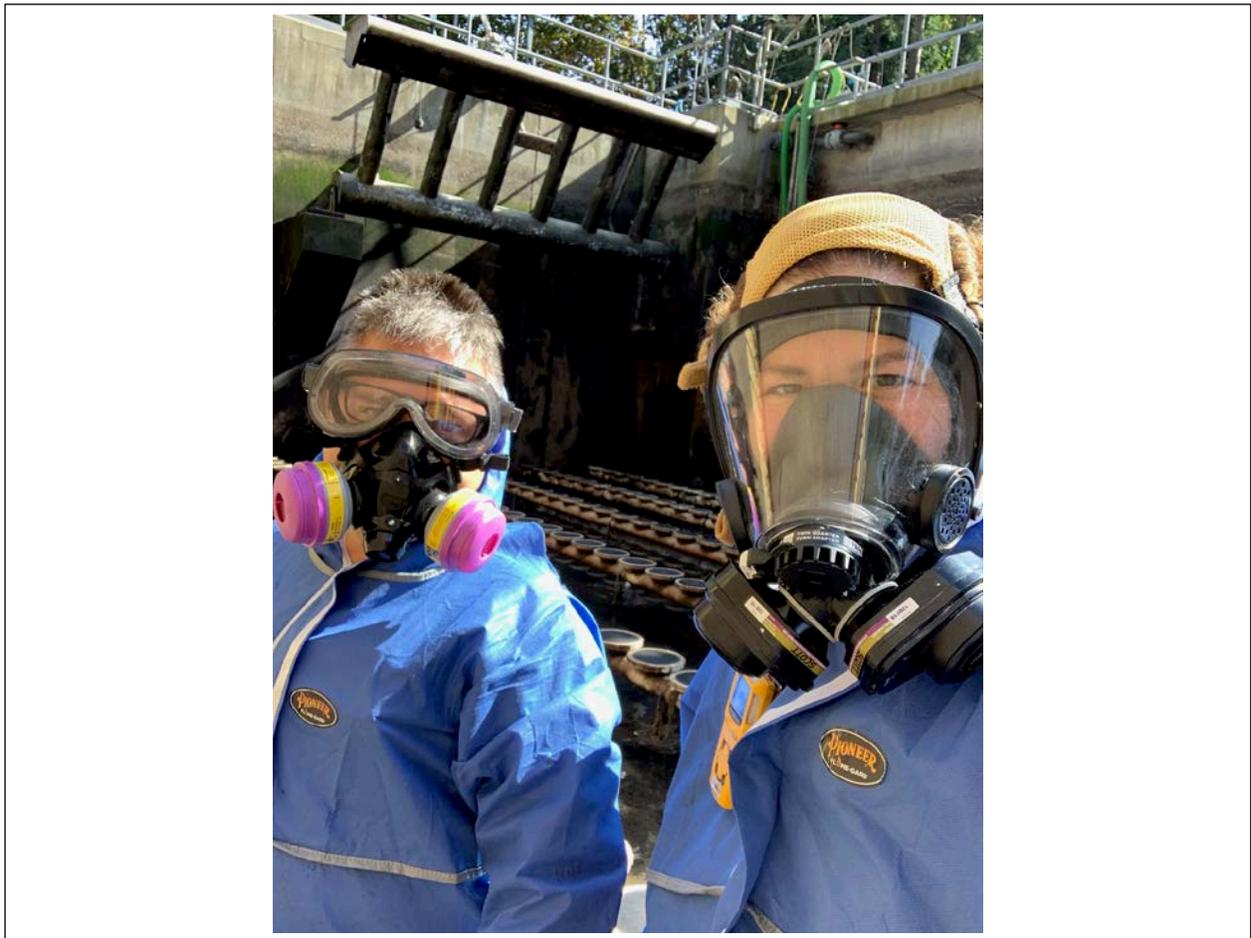
- We brought in a specialist to change some logic set points on the computer logic program that operates our water and wastewater operations, so that we could efficiently run the treatment process on one SBR tank.

- We rented extra pumps to pump down SBR #1 as fast as SBR #2 treatment could handle the flow, this was to reduce odour for residents.

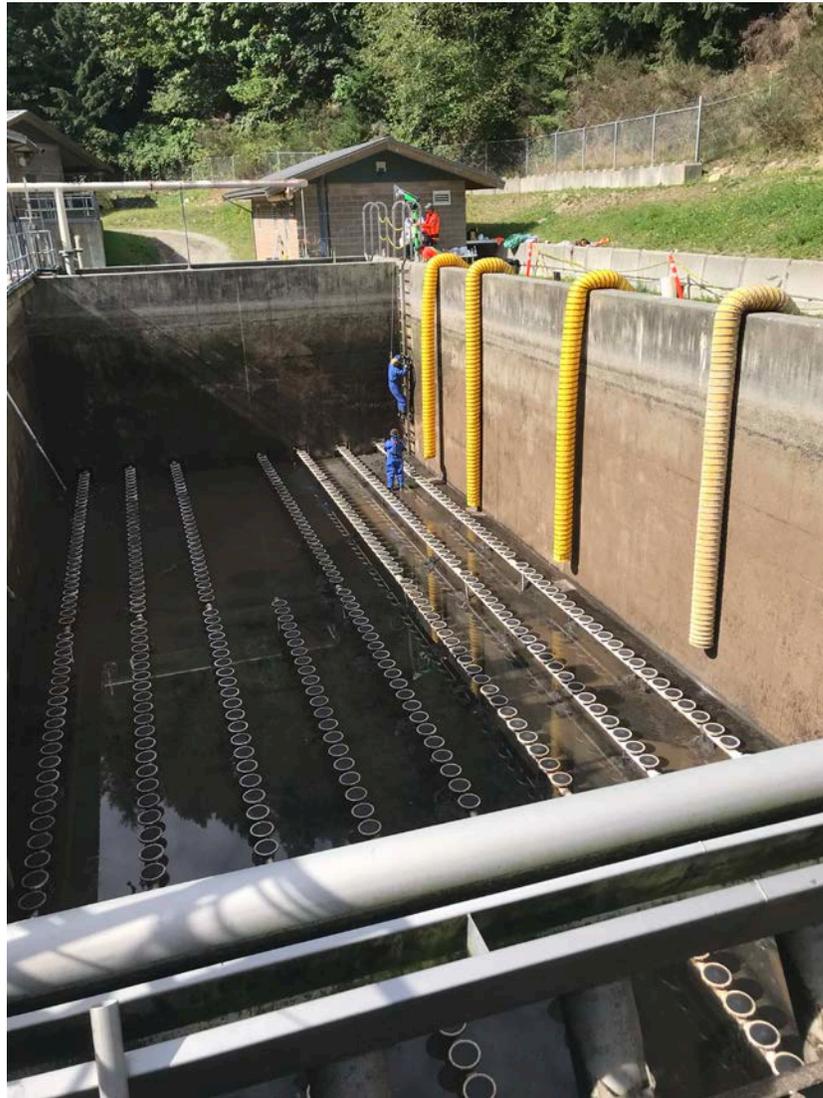
***Initial practice rescue test prior to any work being conducted in the SBR – required by WorksafeBC***

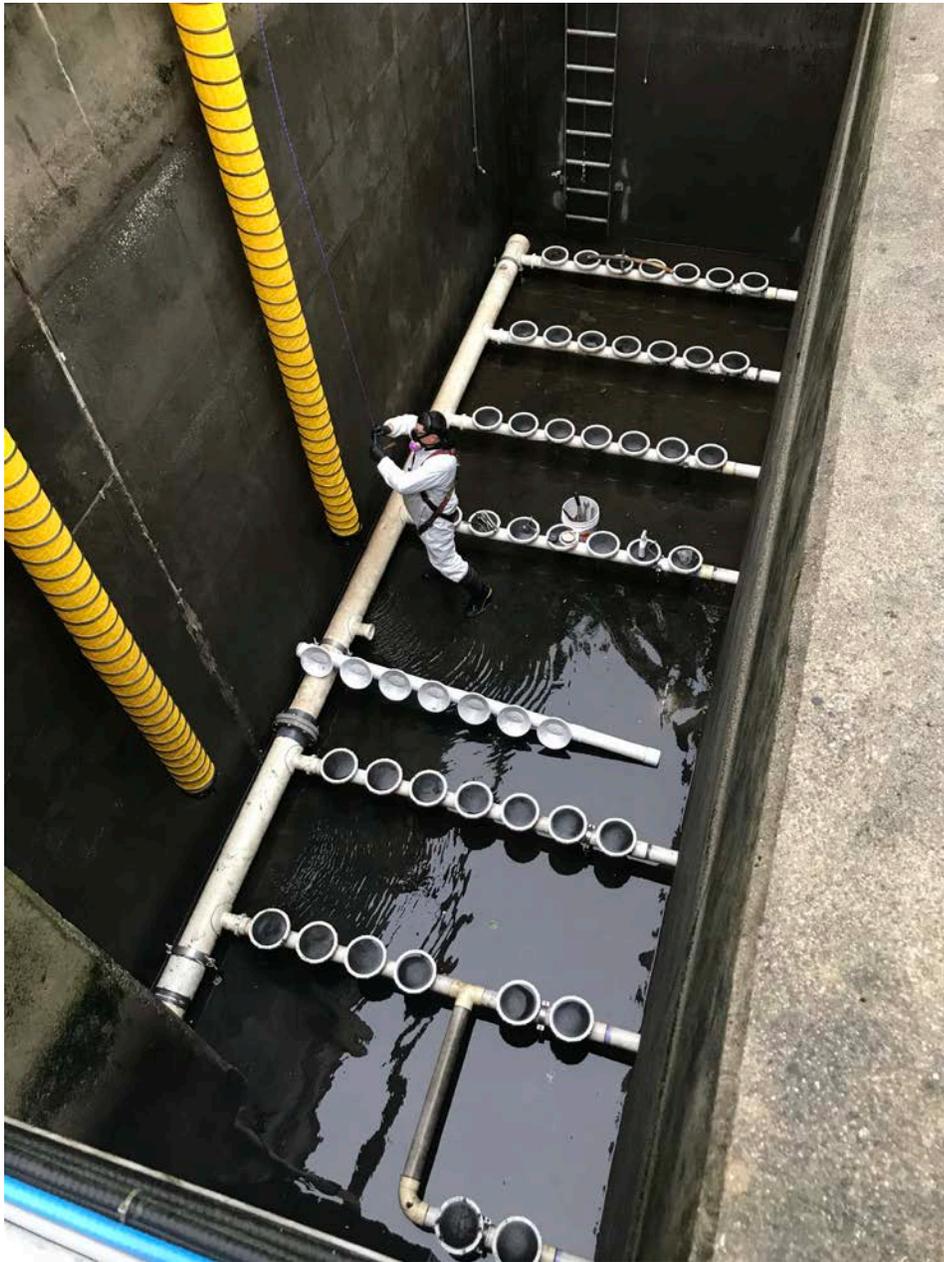
***Replacing broken diffuser piping***

- The first day of entry was spent removing debris from the brackets of the network and diffuser piping. Even though we try remove all the rags and grit, some does get through to the SBRs—in this case there was fourteen years of accumulation! We used tongs and scissors to safely remove the rags and to keep us safe. There were a lot of needles wrapped up in the rags, therefore we were extremely careful to protect ourselves from infection. We used a bucket and rope system to haul up the debris for disposal.
- We had two sections of broken piping to replace, and the brackets that secure piping were loose and needed to be repaired and tightened. We also needed to replace a coupling in the aeration inlet heading in the inlet section of the tank.

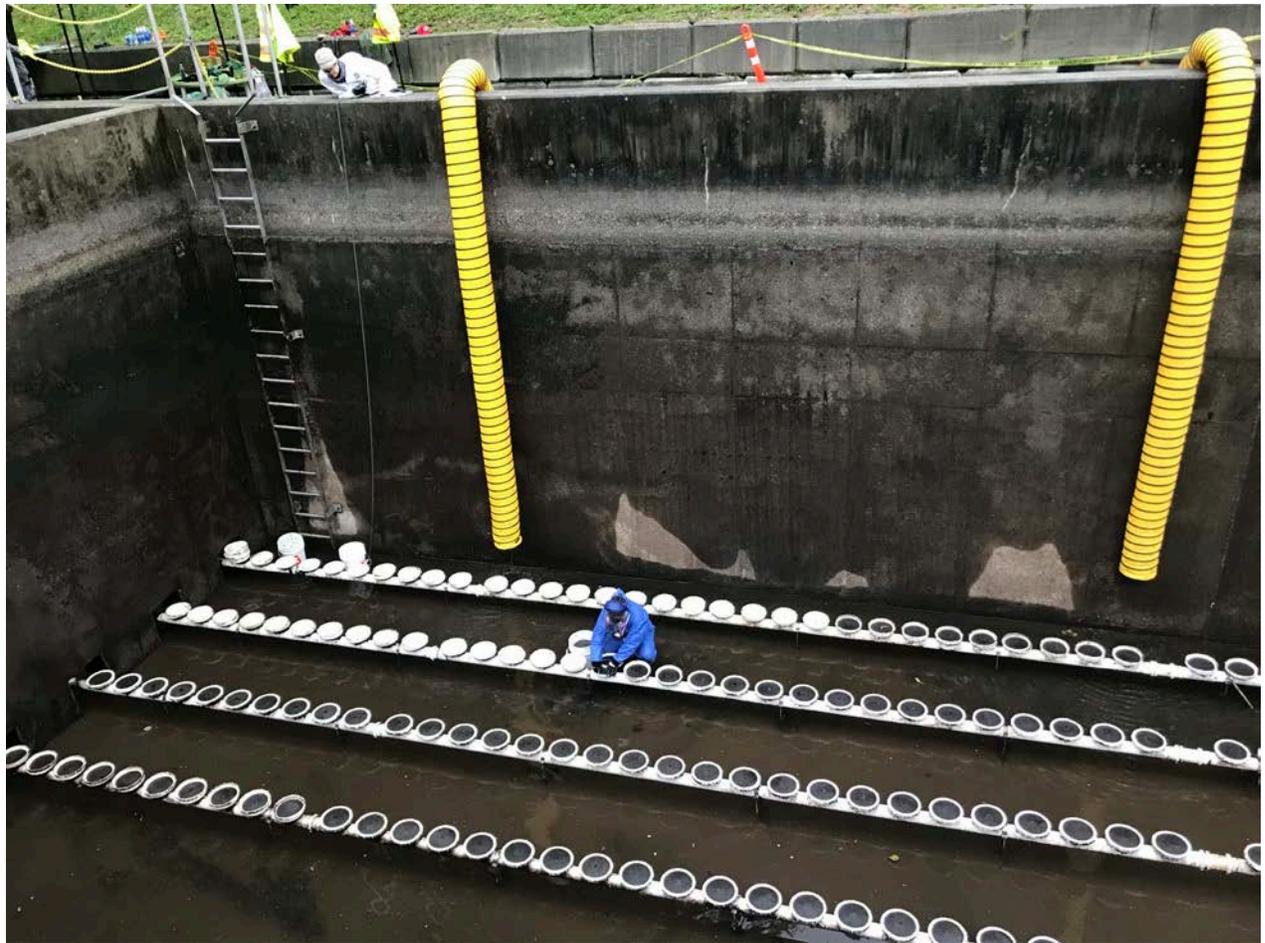
***Operator replacing the membranes on the diffusers***

- On day two and three we removed ALL 660 diffuser ring assemblies, cleaned and washed them, and replaced every membrane! We used a bucket/rope system to haul and transfer the parts.
- We also installed new caps at the ends of the air laterals in the diffuser piping to facilitate easier cleaning in the future.

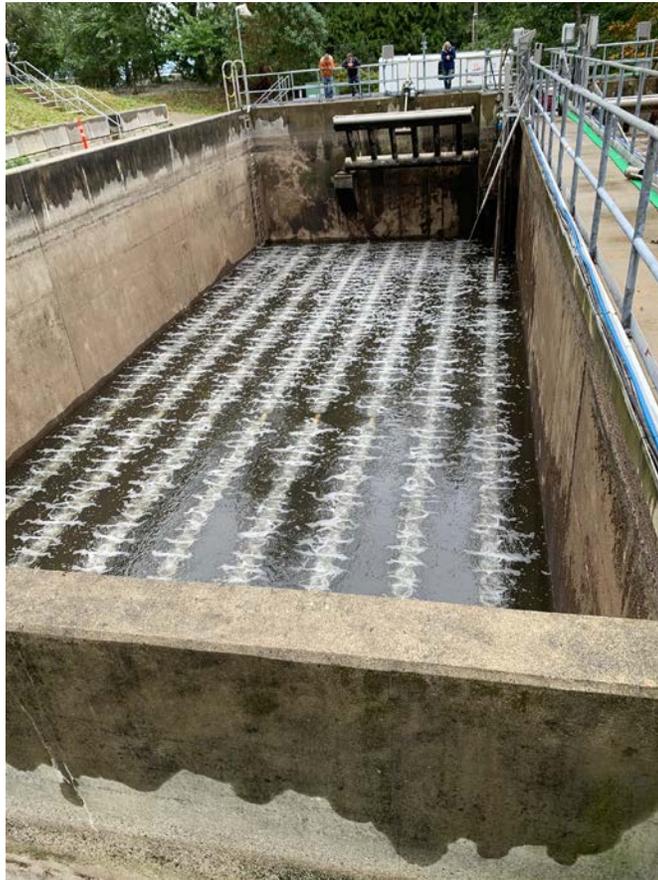
***Inspecting the diffuser operation with clean water***

- Once the work was completed, we filled up the SBR with clean water above the diffuser piping and air header coupling to ensure the workmanship was properly done and there were no apparent leaks.  
When we were satisfied with the work, we unlocked SBR #1 tank and started filling it with wastewater once again! We transferred some microorganisms from SBR #2 to SBR #1 to accelerate the biological treatment in SBR #1. Ultimately, the goal of the work was not only to repair and replace broken parts, but also to improve treatment quality by replacing the diffusers.
