STONEHURST

529 GIBSONS WAY, GIBSONS, BC

CONSERVATION PLAN

NOVEMBER 2024

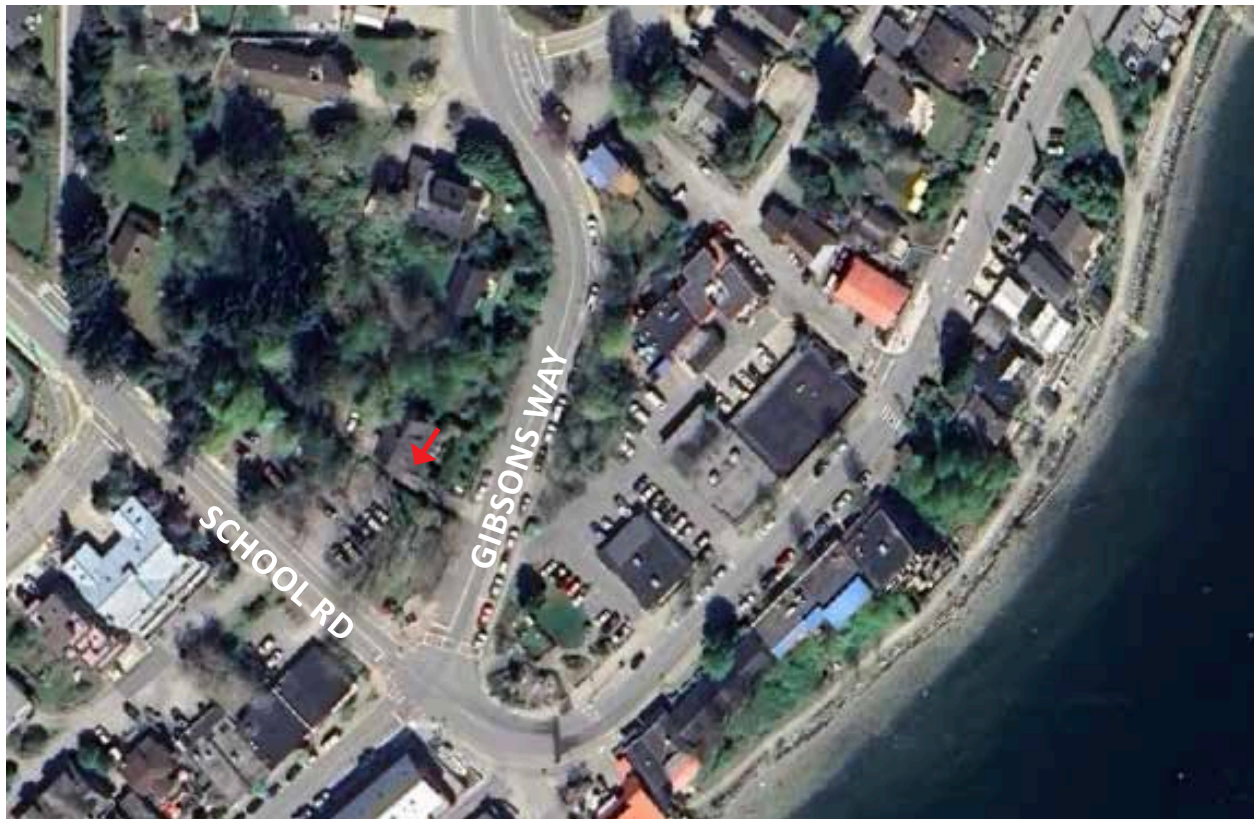
Aerial view of Stonehurst site, 2024 [Google Earth]

Landing of the town of Gibsons, British Columbia. Formerly known as the Inglis Residence, this heritage building finalized construction in 1914 and occupies a prominent position at the front of the property, facing Gibsons Way with views of Howe Sound and the Gibsons Harbour. The building is situated on an elongated rectangular lot characterized by steep slopes, with a noticeable front setback that features a retained front yard. Access to the building is provided via a gated driveway from Gibsons Way. Behind the historic building stand two small wood-frame sheds near the back property line, a sizable garden mid-lot, and an interior residential parking lot.

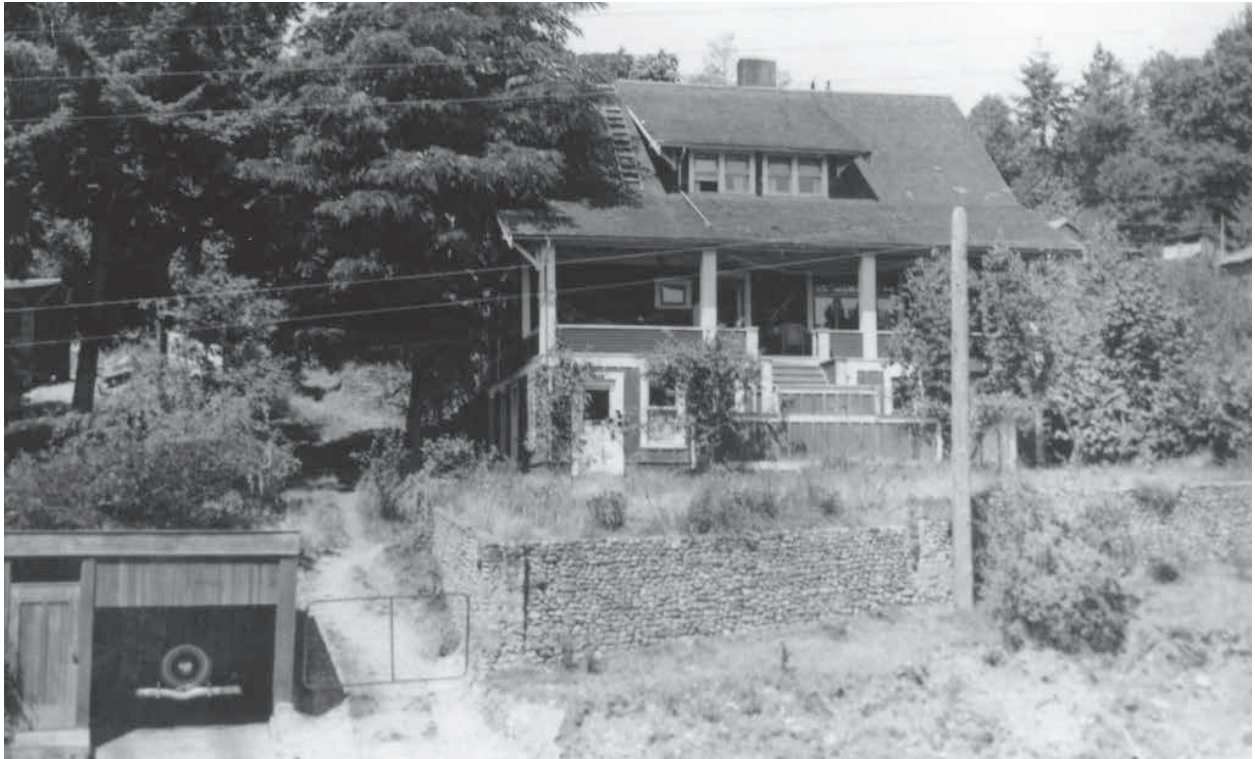
Stonehurst as viewed from Gibsons Way in 1940 [Sunshine Coast Museum Archives 2089]

Historically, Stonehurst featured a small wood-frame garage located at the site's southern corner entrance, adjacent to the then-unpaved driveway, which was secured by a small metal gate. The residence boasted an open frontage and a spacious front yard enclosed by a stone retaining wall. The name Stonehurst aptly

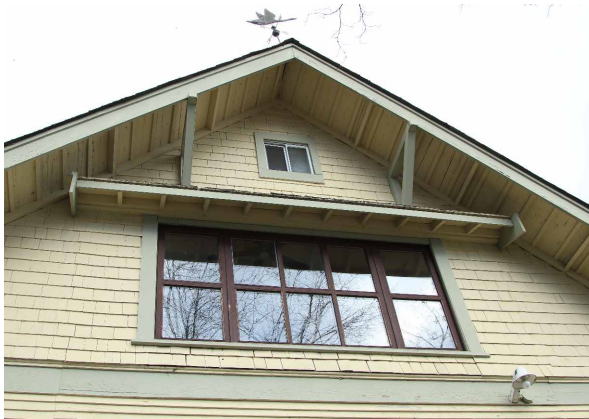
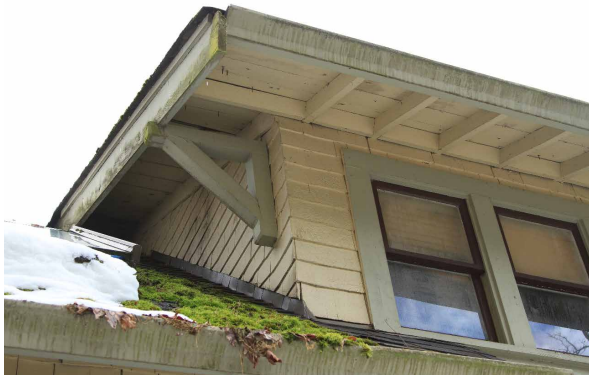
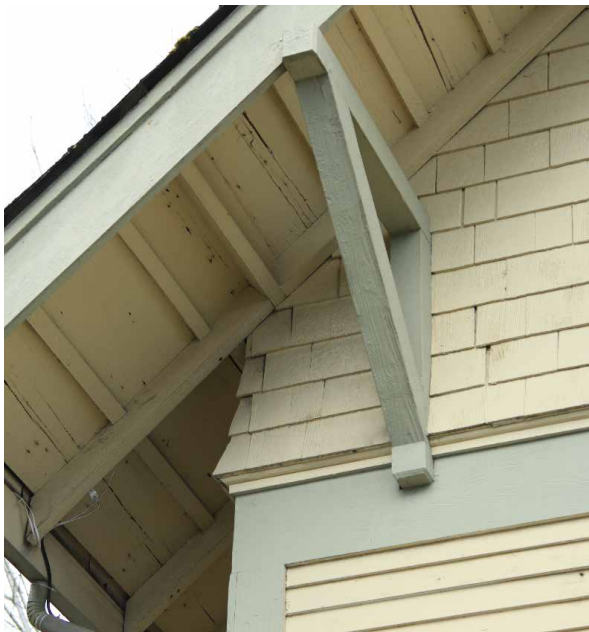
Condition of wood trim elements: triangular knee bracket, exposed rafter tails, pointed bargeboards, 2024. [Donald Luxton & Associates]

- At the rear wall dormer, implement concealed structural supports within the existing framing to accommodate the new glass corridor connection.
- Repair or replace original roof elements, including rafter tails, knee brackets, and bargeboards, using in-kind materials that match original profiles and finishes.

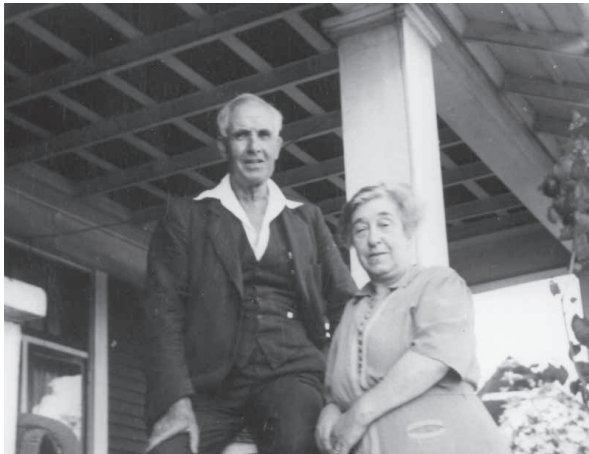
Archival image of Frederick and Alice Inglis at Stonehurst, dated 1940. Original verandah elements can be seen behind the couple, including contrasting coffered ceiling and robust column with capital. [Sunshine Coast Museum Archives, 2073]

- Remove large multi-pane window inserts to restore open verandah configuration.
- Preserve original lower height balustrade. Implement alternate compliance methods to achieve the required 42" height under current safety codes.
- New possible alternative materials may be glass panels, metal pipe rails or a combination of both.

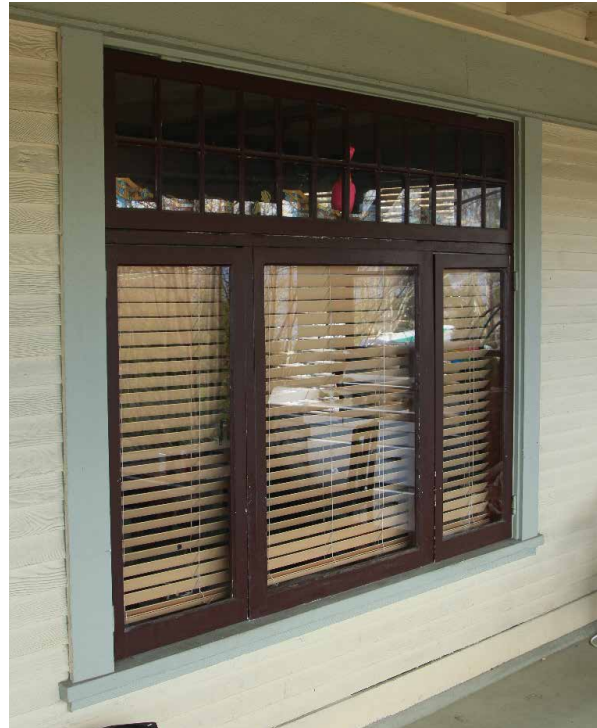
Tripartite casement window with awning style multipane transom above at porch level, 2024. [Donald Luxton & Associates]

- Preserve and repair existing window sashes as required, using in kind repair techniques where feasible. Each window should be made weather tight by re-puttying and weather-stripping as necessary.
- Where new windows are required, introduce new wooden windows that are compatible with the style, era and character of the historic place, or a replica based on documentary evidence including sash horns.
- Window repairs and replacements should be undertaken by a contractor skilled in heritage restoration.
- Prime and repaint as required in appropriate colour, based on colour schedule devised by Heritage Consultant.

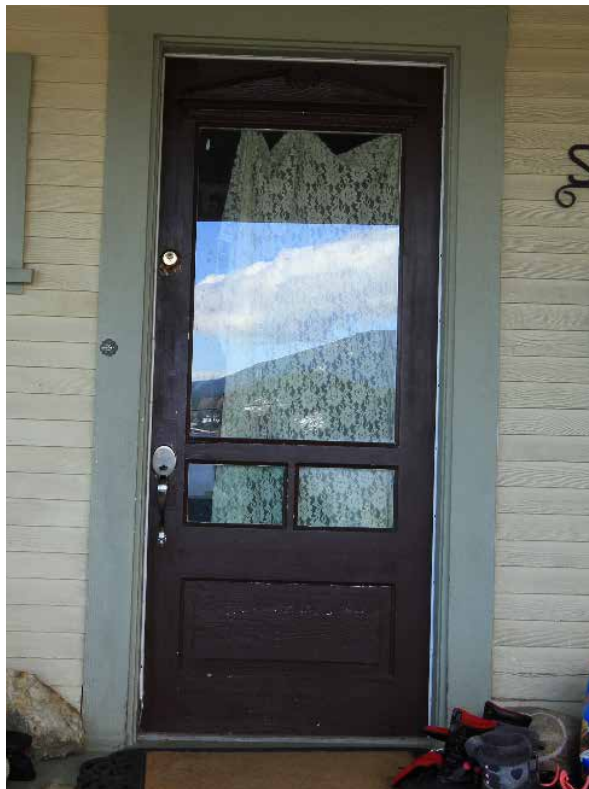
*Existing front door with inset glazing and moulded design, 2024.
[Donald Luxton & Associates]*

- Retain the door openings in their original locations, where possible, and preserve and repair all original doors as needed. Limit interventions to door openings and assemblies to the rear façade of the building.
- New doors should be visually compatible with the historic character of the building.

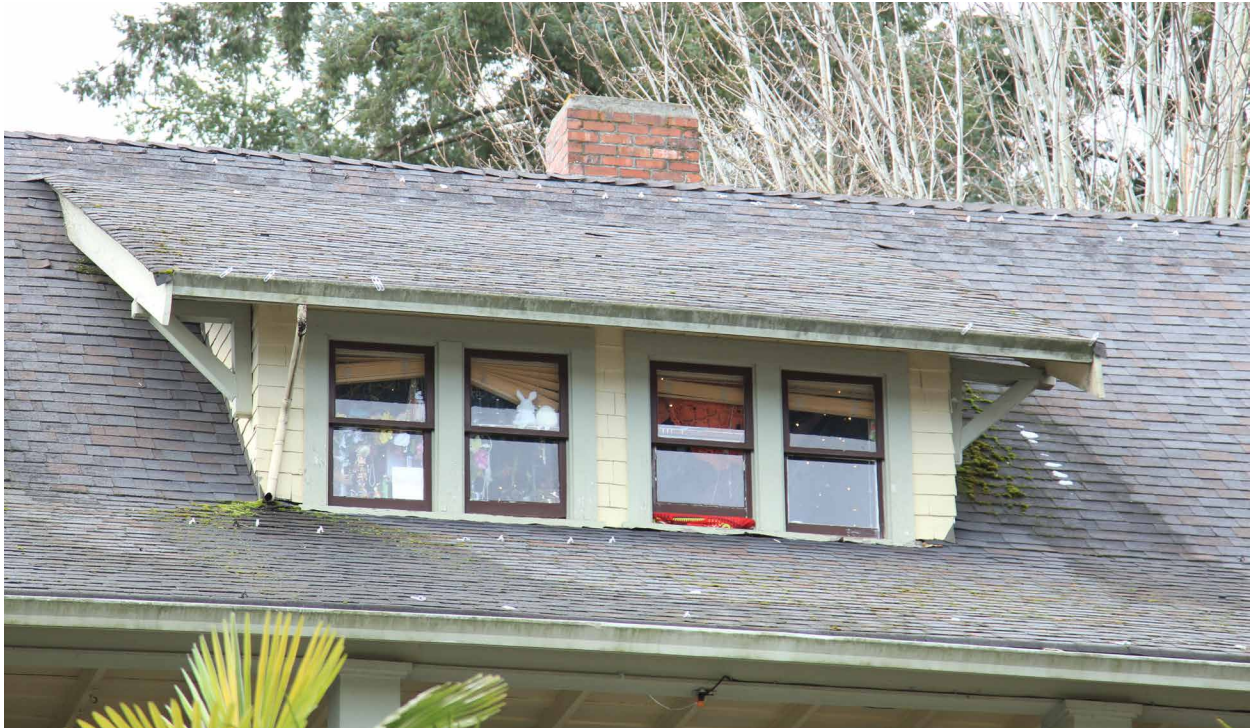
Front elevation central shed roof dormer. [Donald Luxton & Associates]

- Preserve the overall historic roof form as viewed from Gibsons way, limiting major interventions to the rear of the building.

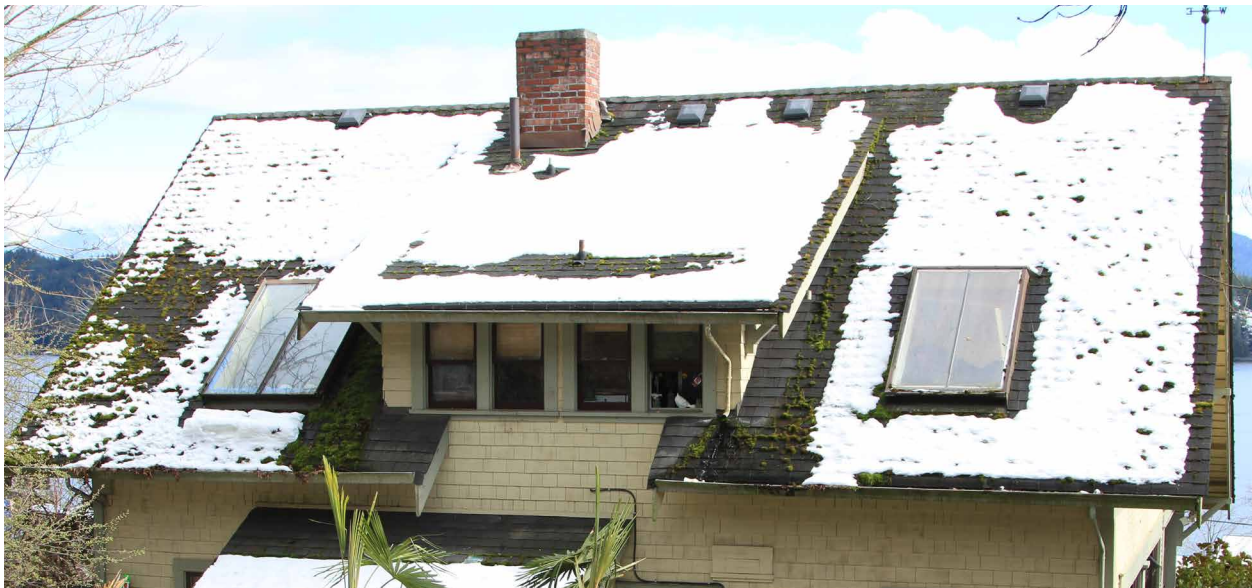
Rear wall dormer with shed roof. Side skylights are not original to the building. [Donald Luxton & Associates]

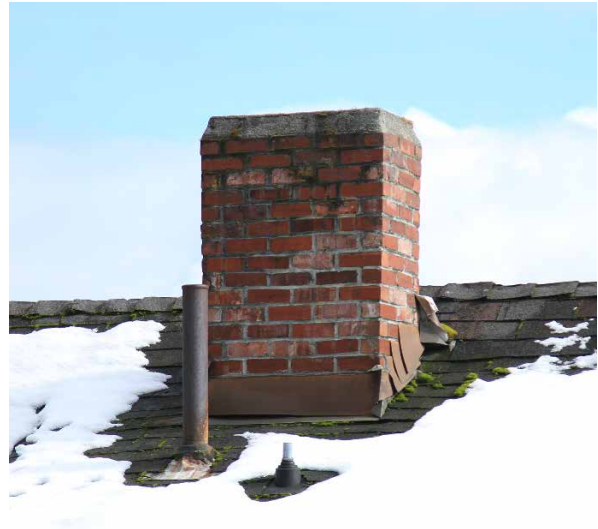
Condition of internal chimney [Donald Luxton & Associates]

- Preserve the chimney above the roofline, along with the internal fireplace in its original location within the interior.
- Chimney may require structural stabilization or dismantling and reconstruction as part of the house relocation plan. Existing brick should be salvaged and used in the reassembly of the chimney above the roof line.

- If required, brickwork may be repointed and cleaned using a natural bristle brush and mild rinse detergent.
