November 30, 2021

Our File No.: FSCI-21-0023

**Re: Habitat/Condition Assessment of Charman Creek, Gibsons, BC, an Urbanized Stream**

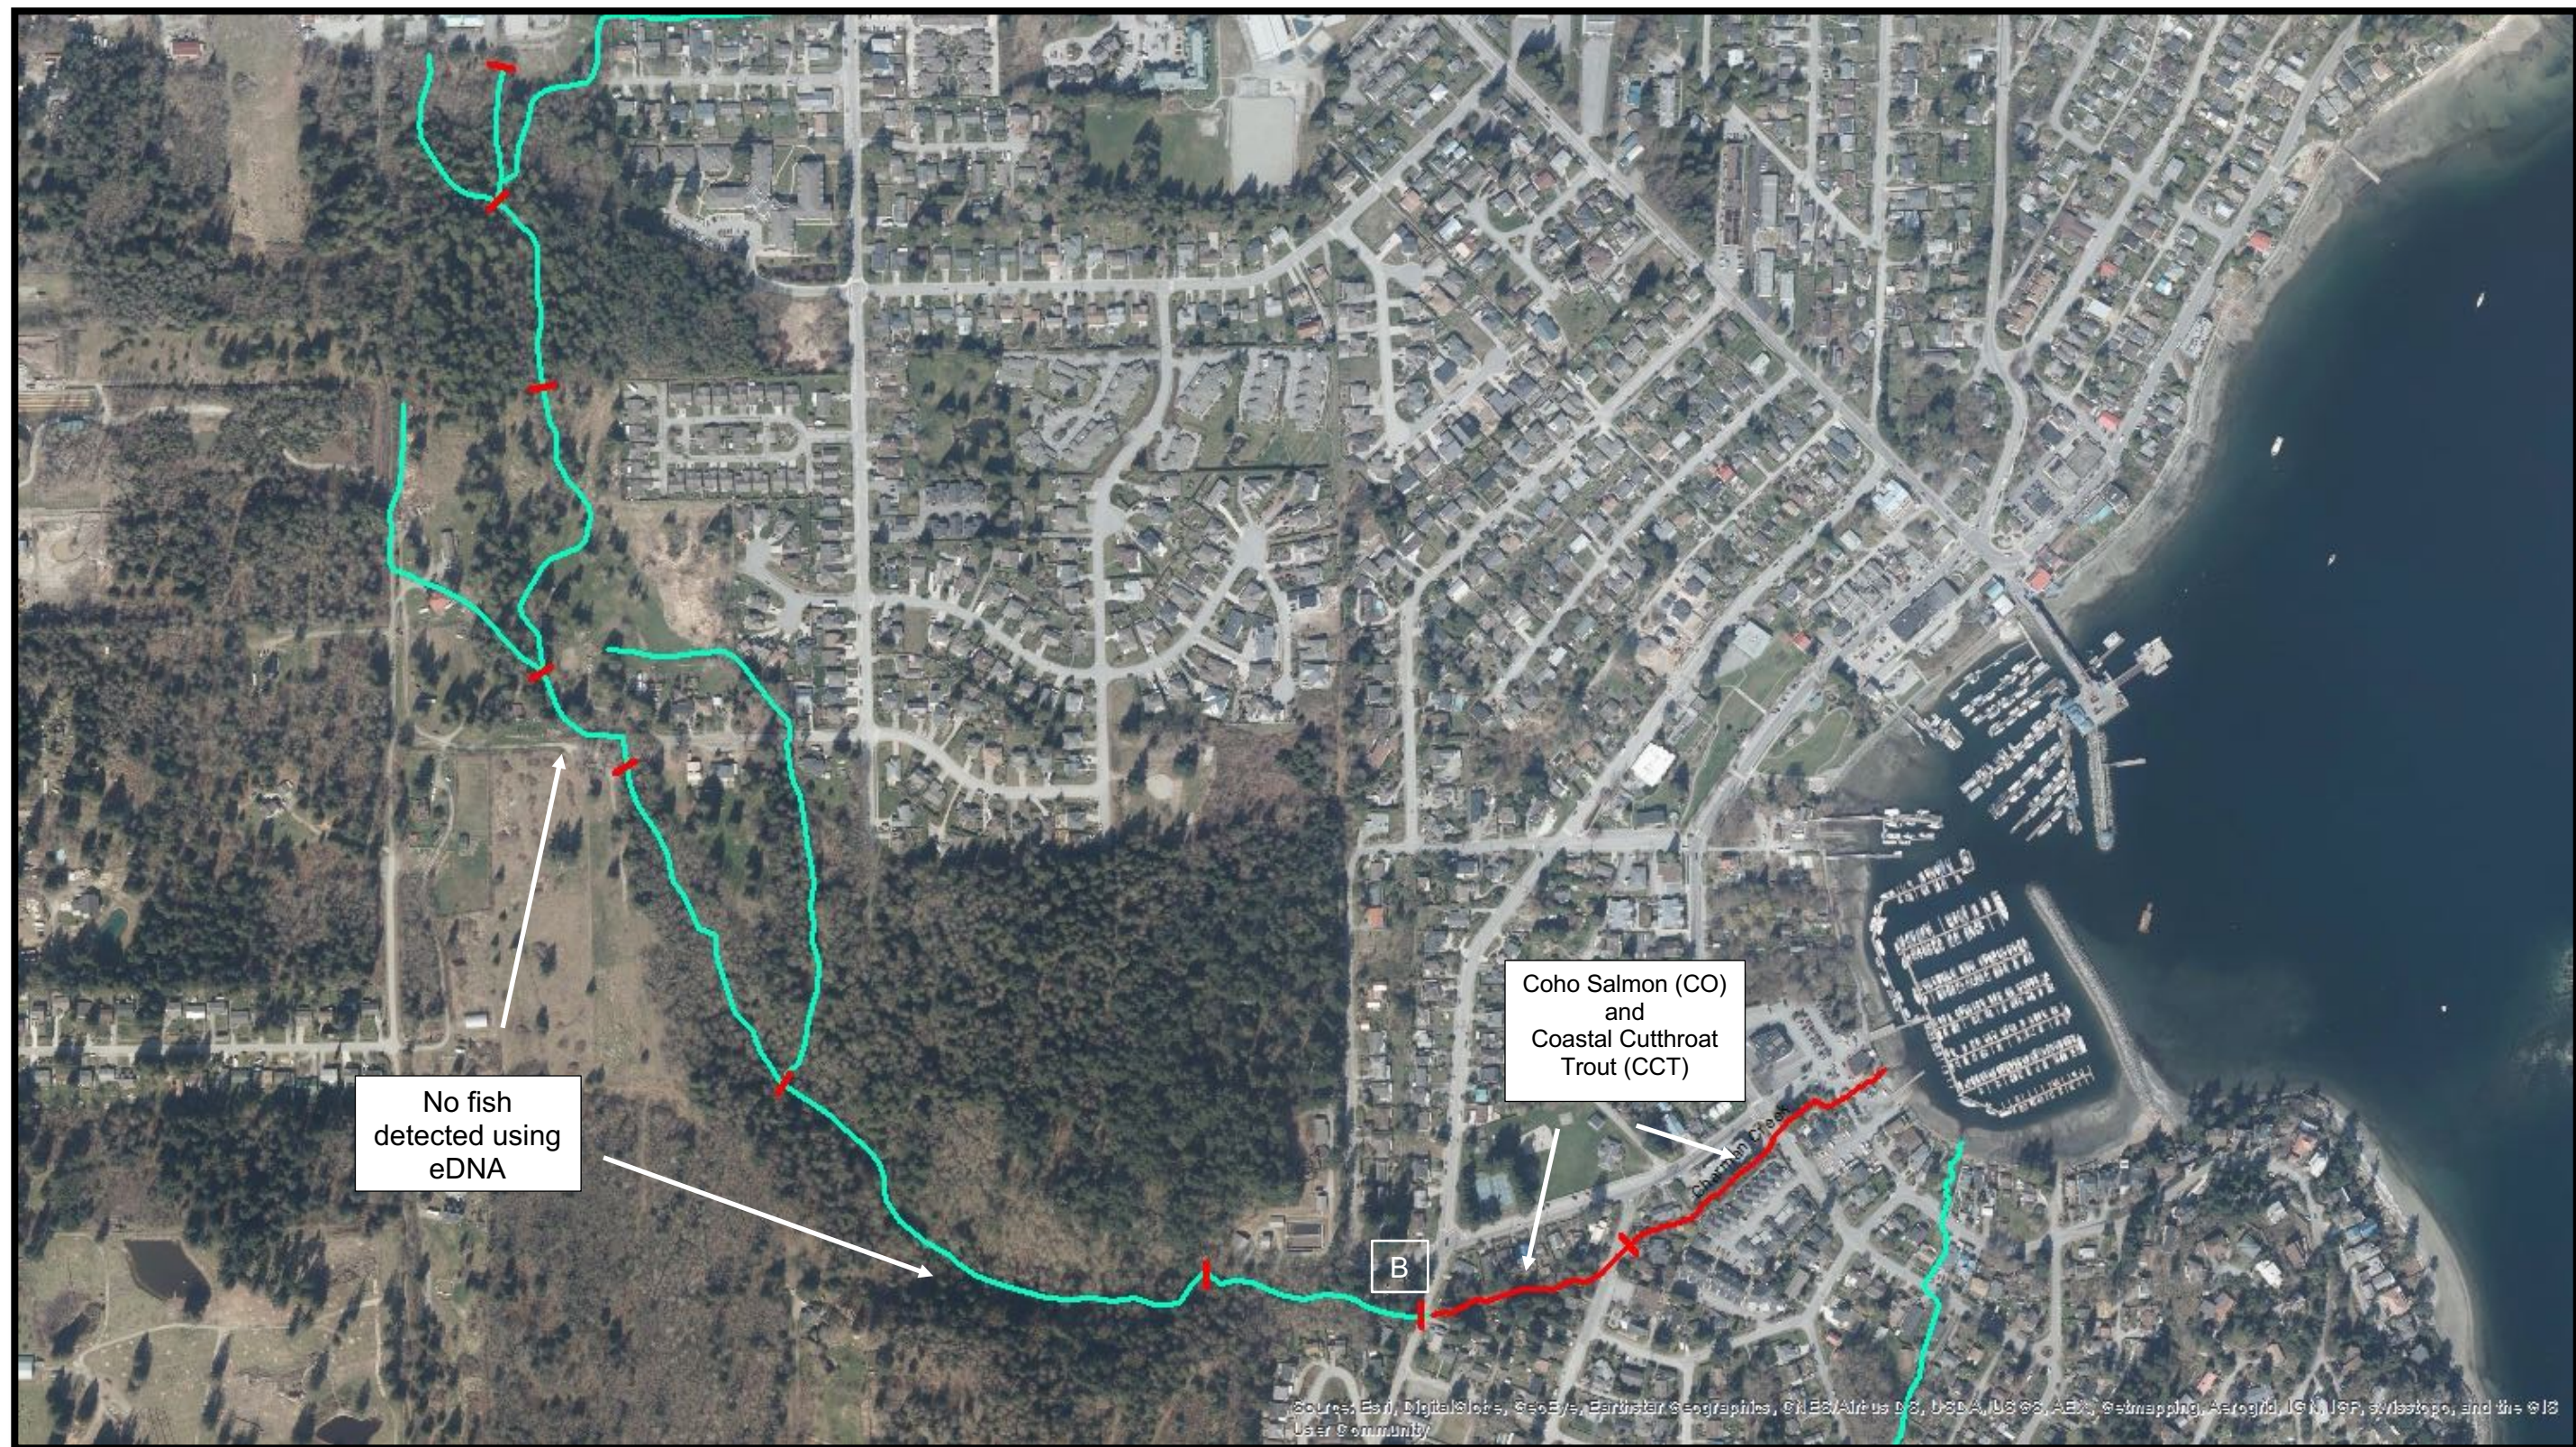
completed by Fisheries and Oceans Canada (J. Wilson pers com). **Figure 21** shows the current distribution of salmonids in Charman Creek

**Figure 21:** Distribution of salmonids in Charman Creek based on eDNA results and the locations of sample collection for eDNA analysis. The presence of salmonids (CO and CCT) were found in the lower most reaches (1 and 3). The upper extent of distribution has been set at the Gower Point Road culvert (B=barrier).

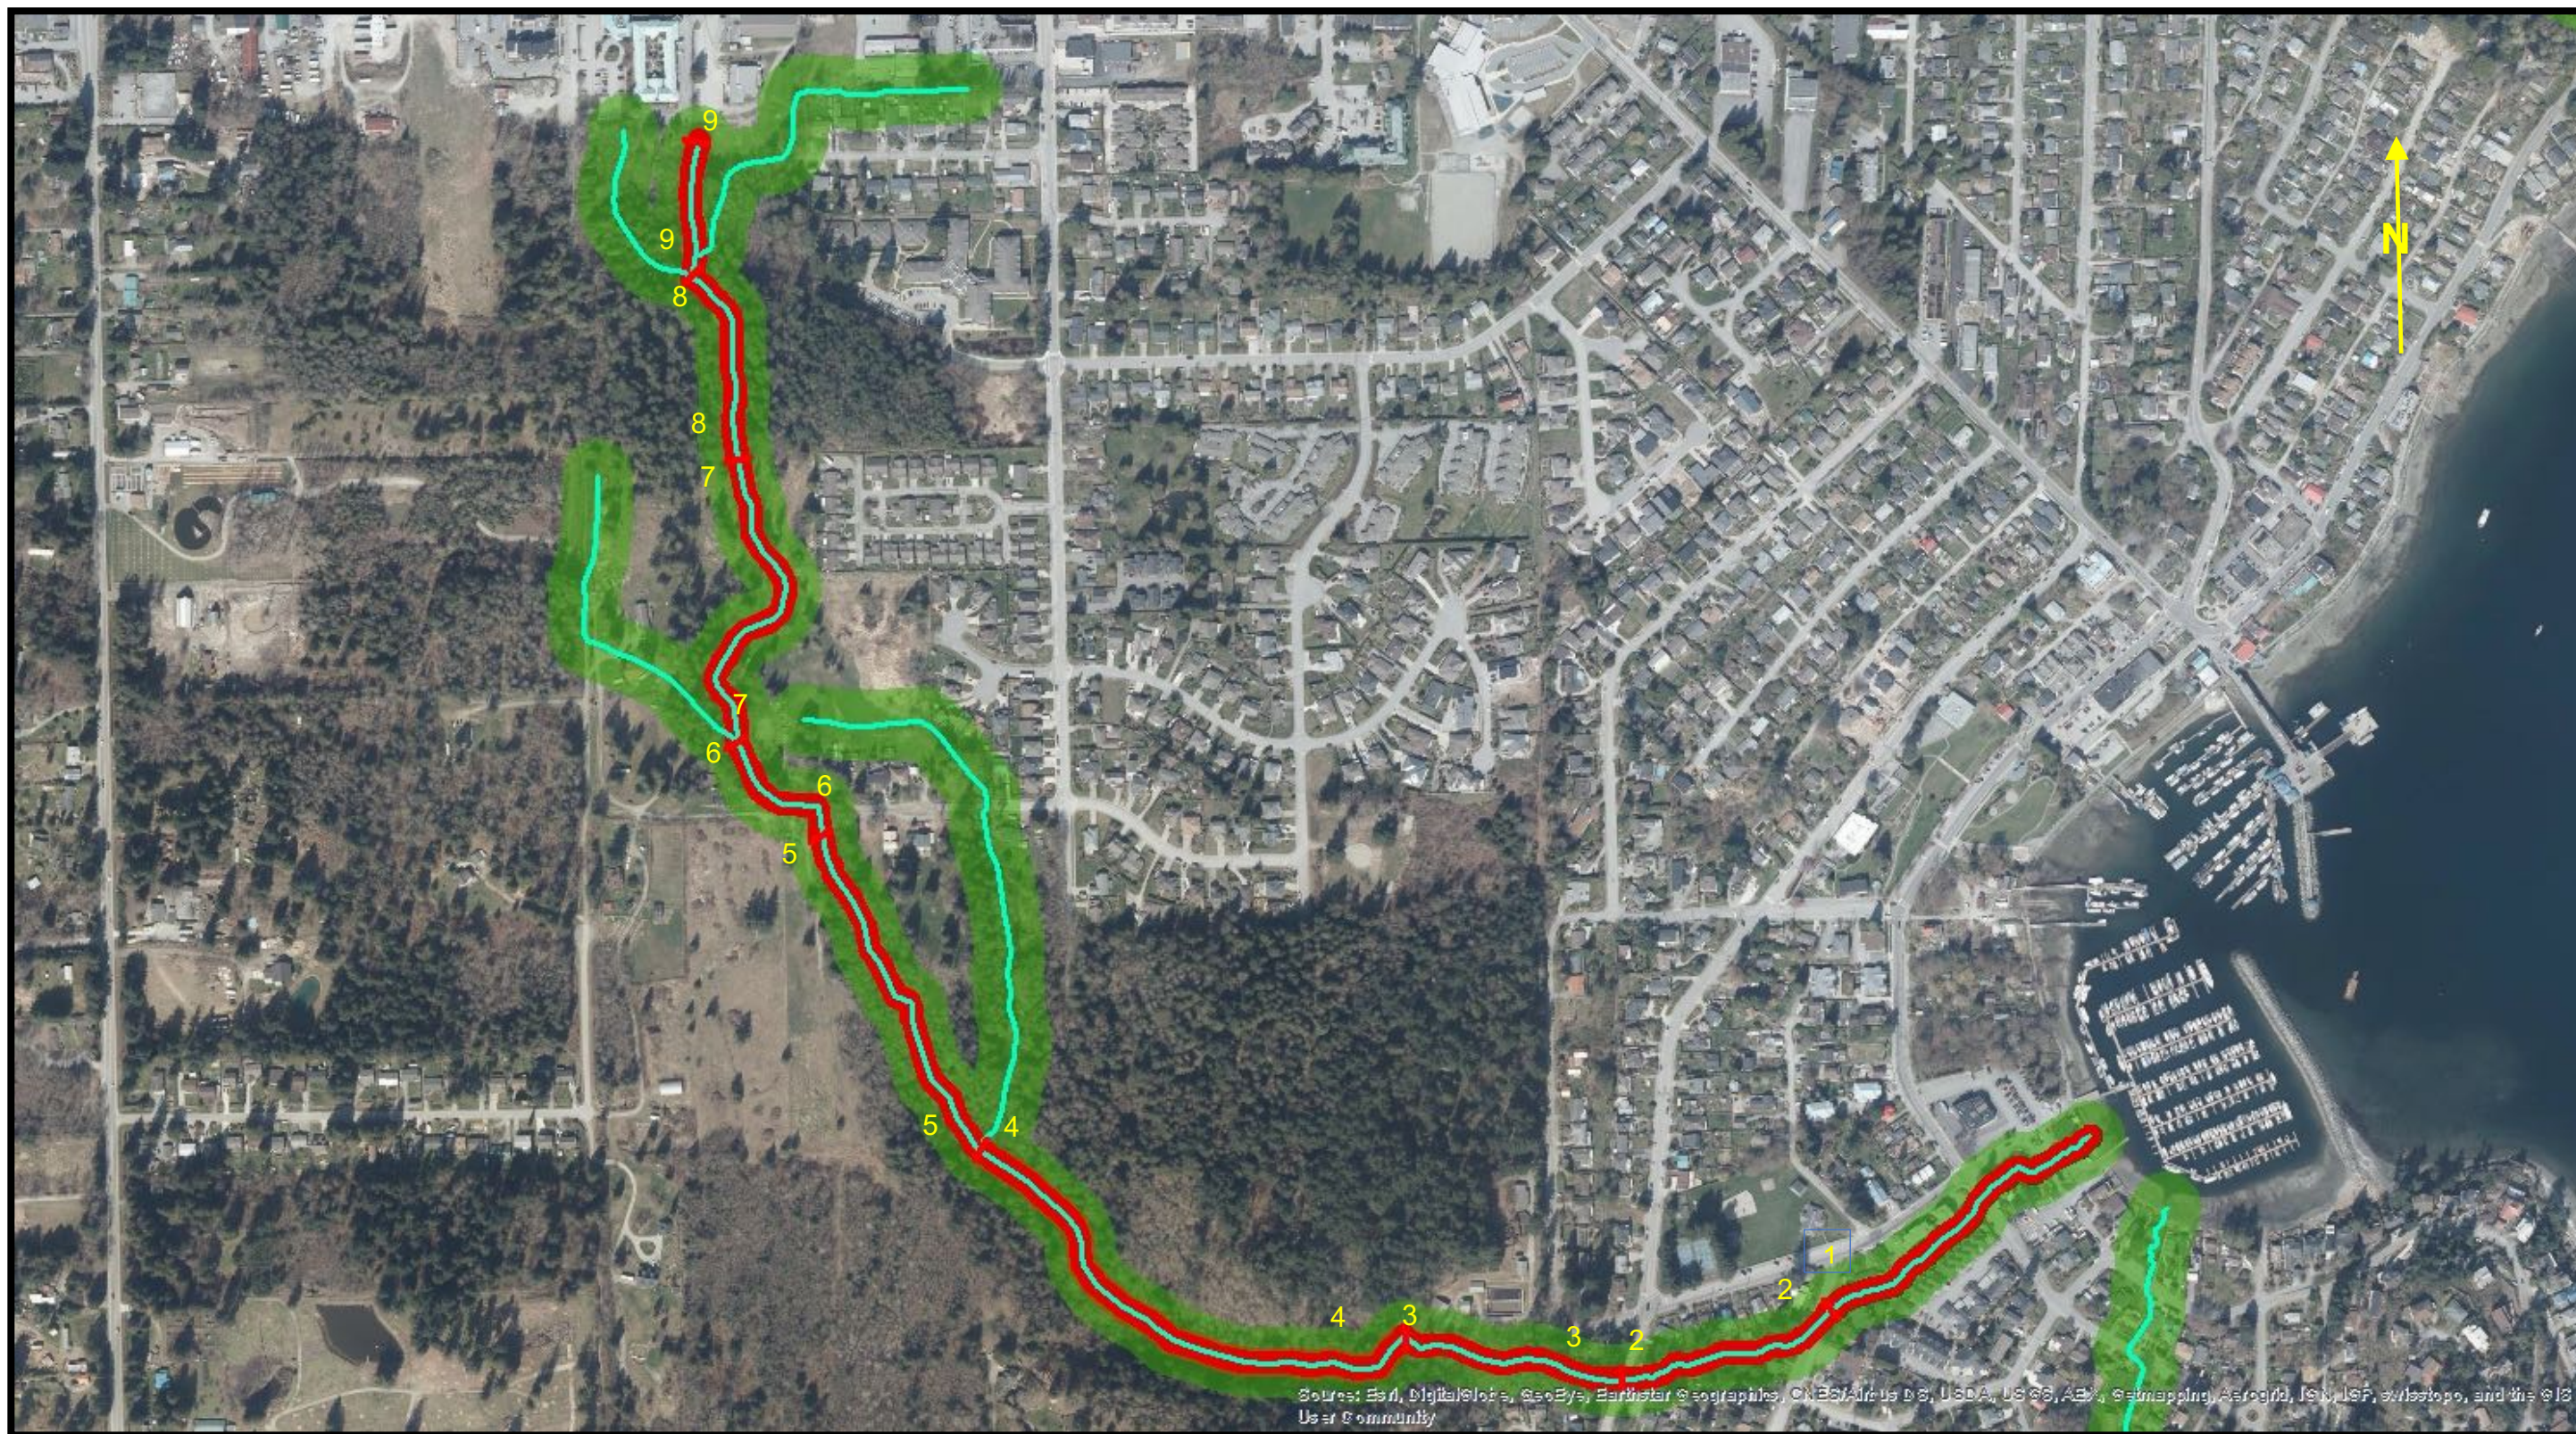
In using the detailed approach the measured bankfull width is required. This measure, used with the channel type was used to determine the possible SPEA for each reach in Charman Creek. **Table IV** provides the possible SPEA using the channel width, channel type and Zones of Sensitivity. **Figure 22** shows the expected SPEA on a watershed map. The 30-m assessment trigger zone is also shown.

**Figure 22:** Map of Charman Creek and the possible SPEA setback of 10-m within each reach on the mainstem of the creek. The assessment area (30-m) or trigger zone is shown in green and the possible SPEA in red.
