**GEOTECHNICAL HAZARDS REPORT
DPA1 UPDATE – GIBSONS OFFICIAL
COMMUNITY PLAN
TOWN OF GIBSONS, BC**

CLIENT: TOWN OF GIBSONS

PREPARED BY:
RAM ENGINEERING LTD.

NOVEMBER 12, 2025
OUR FILE: 122-5203

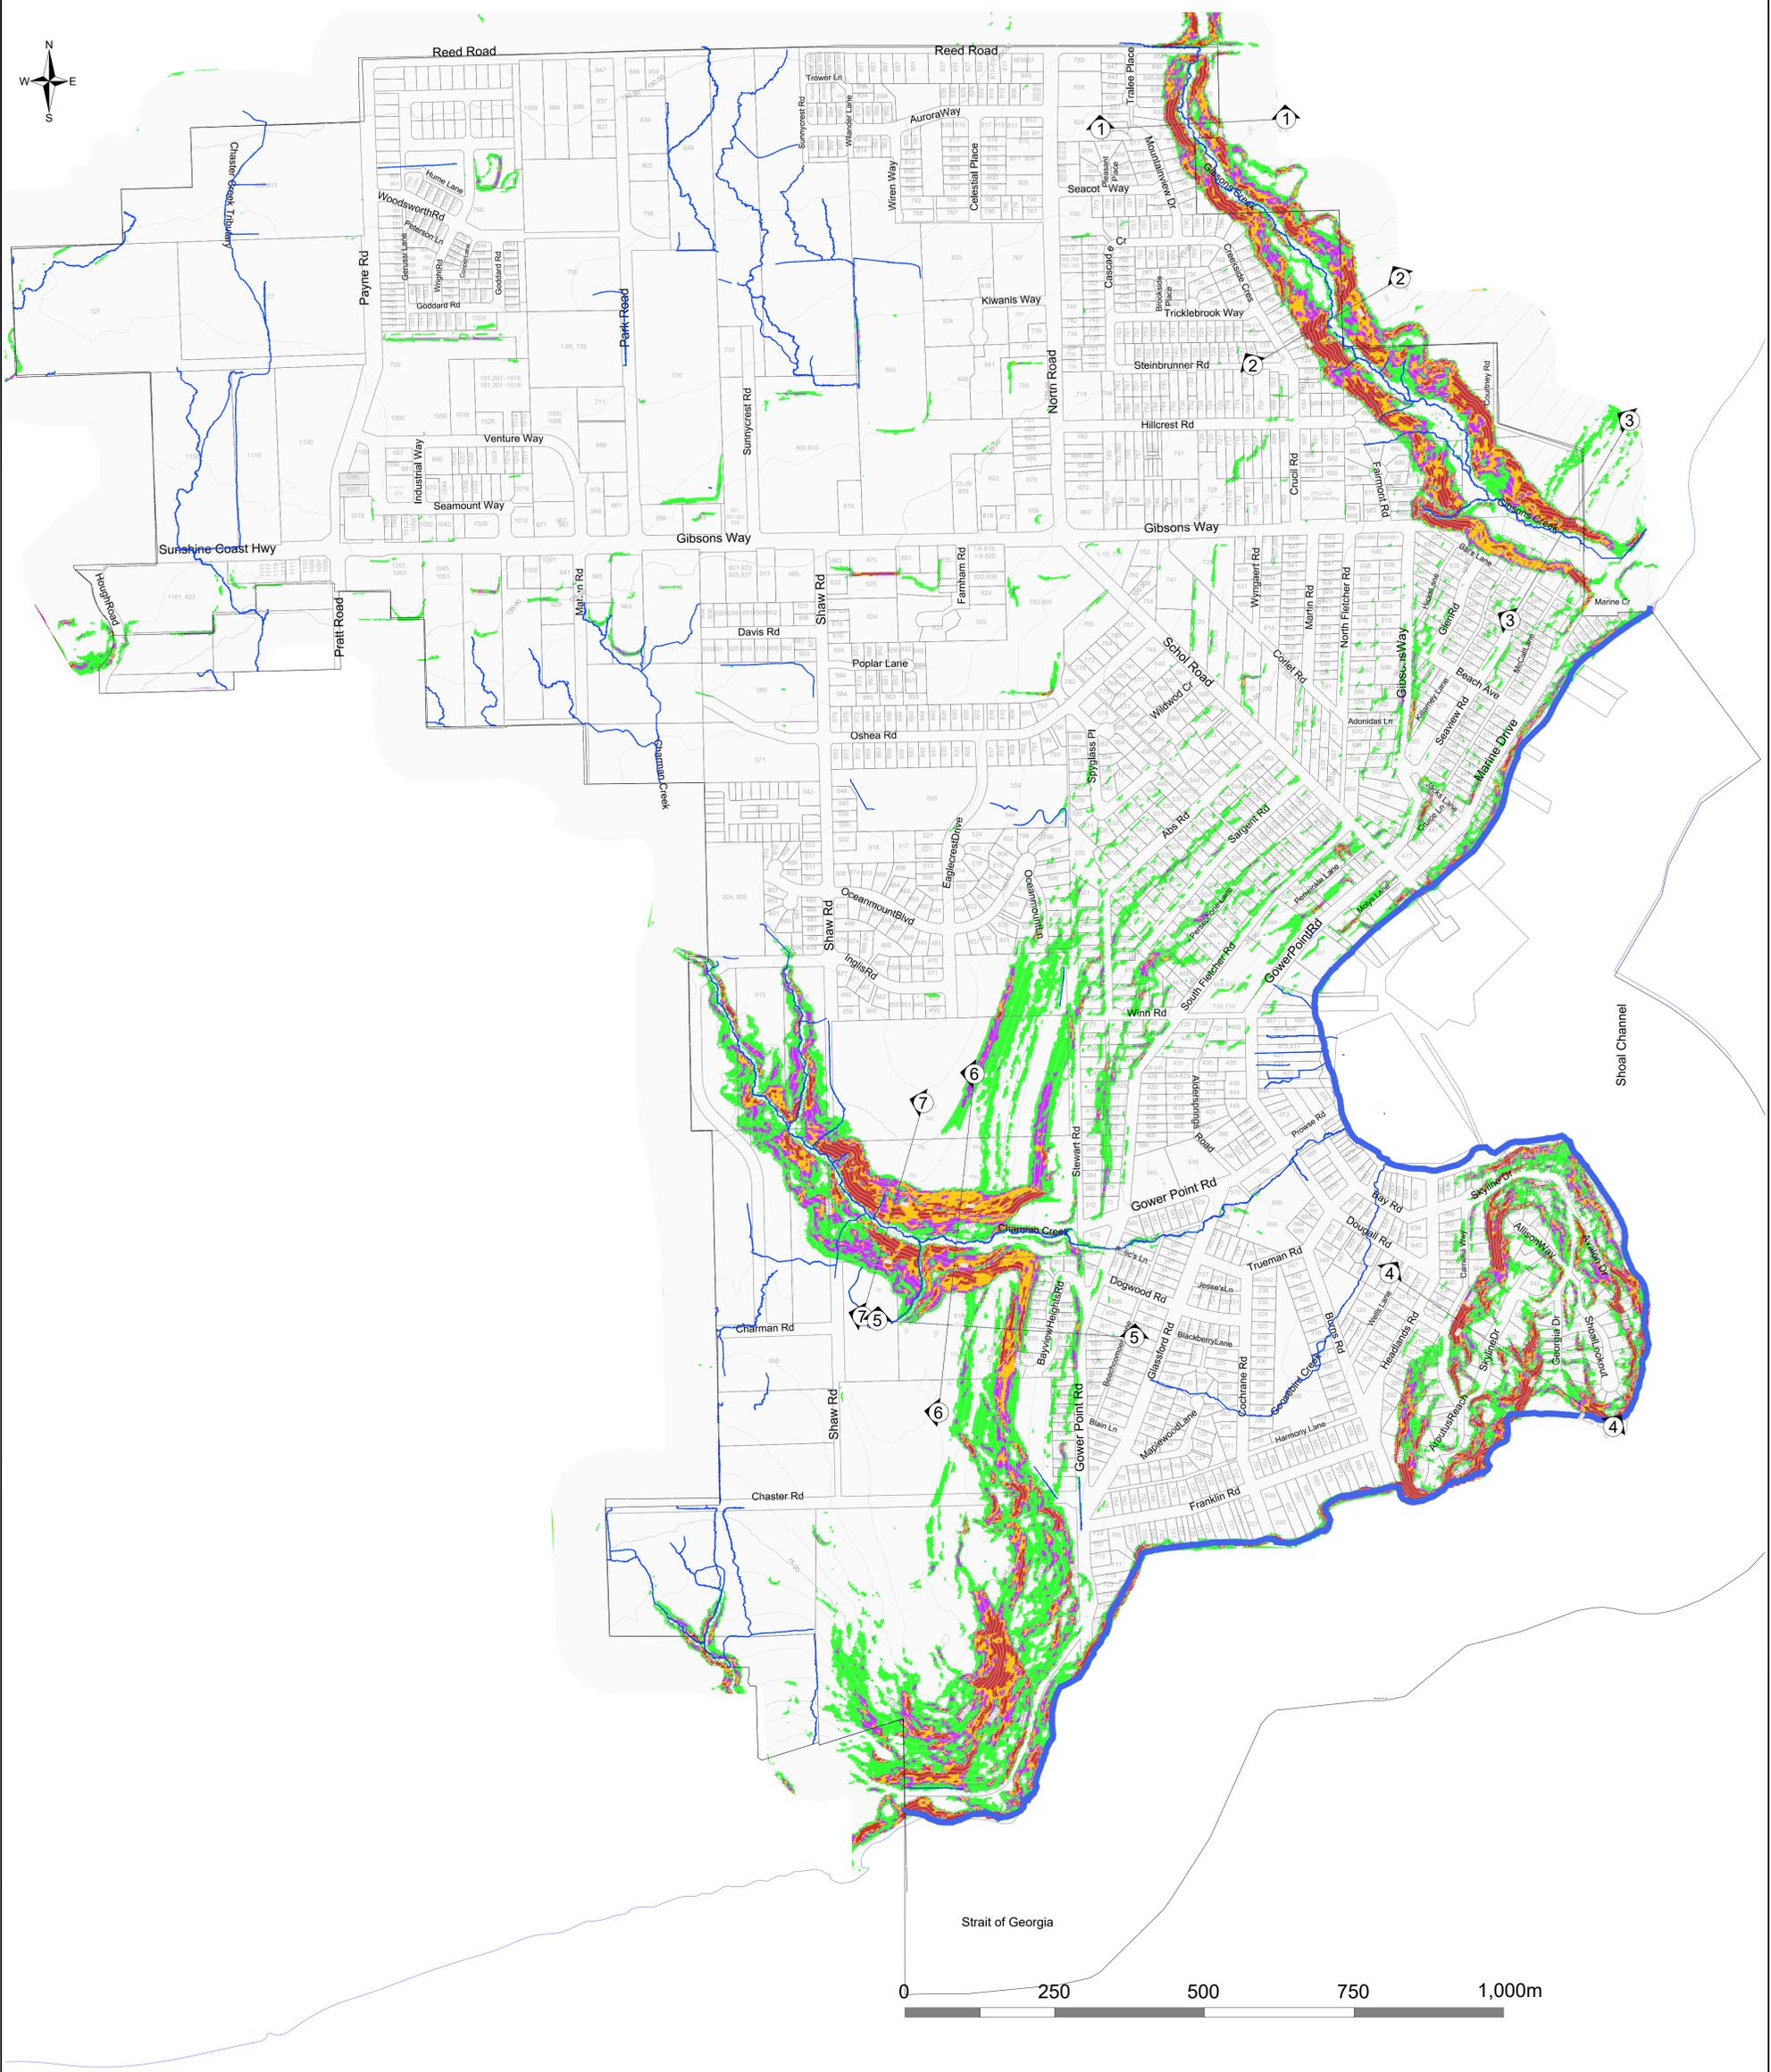
Drawn by: HN, Des by: NT, Ck by: KS
 Scale: 1:5000, File no: 122-5203
 Rev no: B, Rev date: 2025-09-25
 Figure: 1

As mentioned in Section 3.2, LiDAR data that were obtained in 2021 were provided to us by the Town of Gibsons. The 1 metre and 5 metre contour lines were defined in the aforementioned LiDAR data. Based on the aforementioned LiDAR data, a slope thematic map was prepared by RAM based on the slope gradients shown in Table 1. This slope thematic map is shown on Figure 1.

DEVELOPMENT PERMIT
 AREA 1 (DPA1)
 Slope Thematic Plan

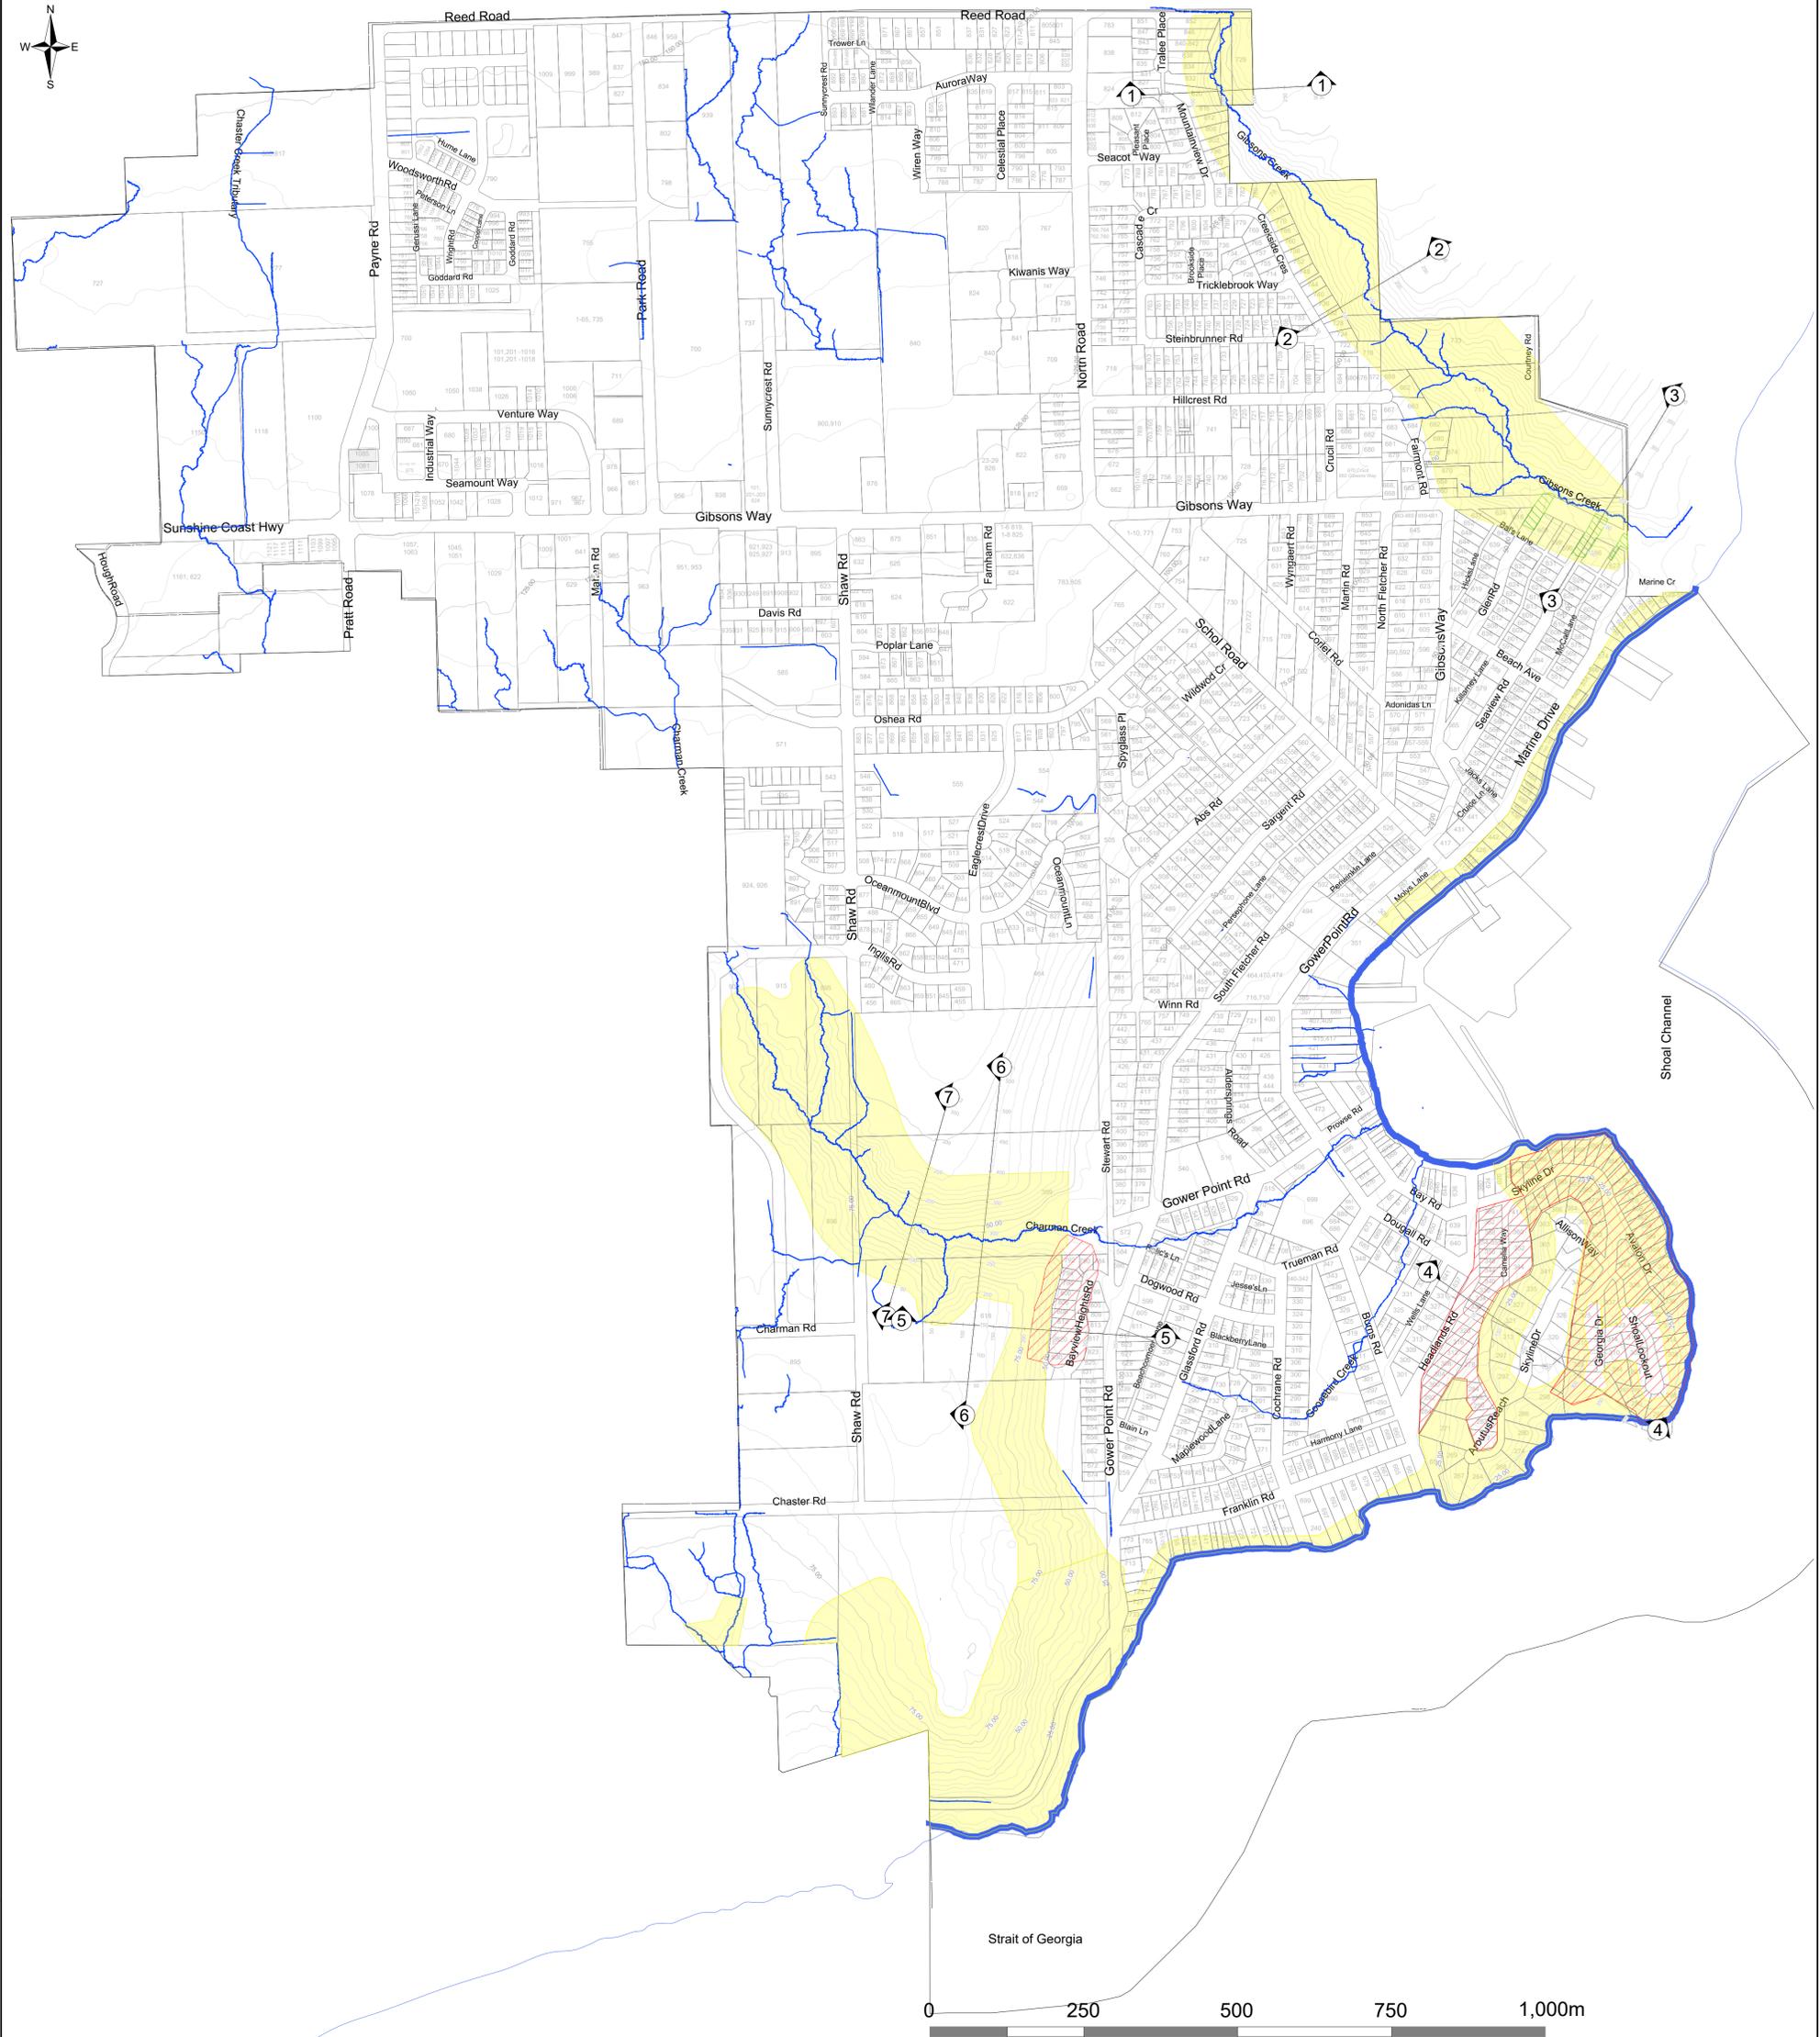
DEVELOPMENT PERMIT
 AREA 1 (DPA1)
 Slope Hazard Plan

Slope hazard due to proximity to crest
-

Slope hazard due to proximity to toe
